LKK Auto Consultants Pte Ltd

ADJUSTMENT ON REPAIR COST FOR VEHICLE NO. SHD 5965S

PHOTOGRAPHS FOR VEHICLE NO. SHD 5965S

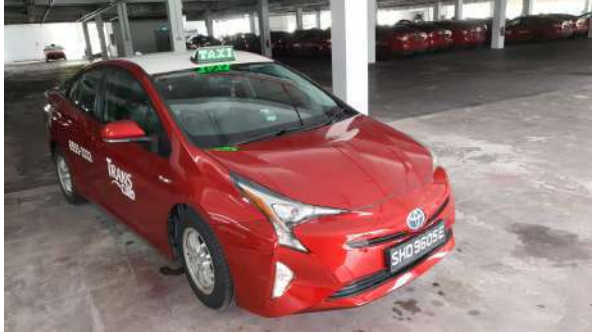
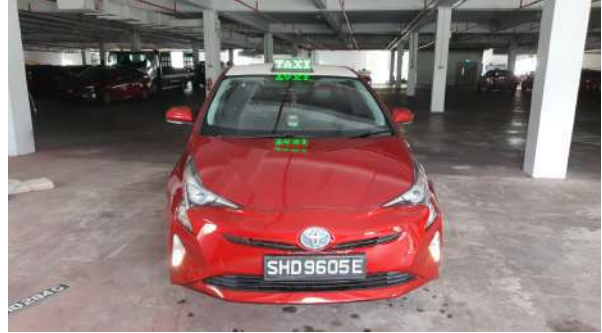
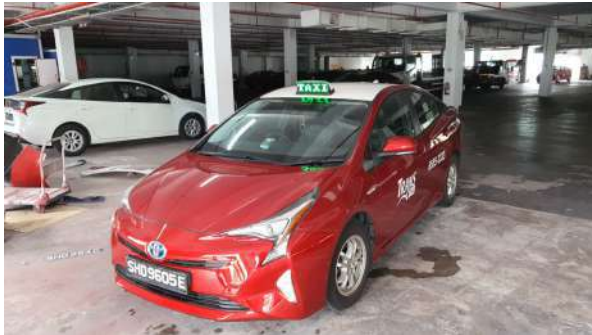
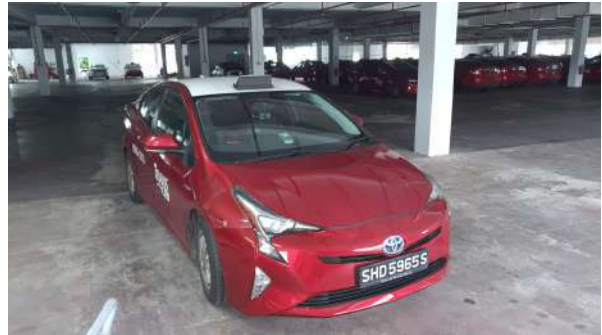
RE-INSPECTION

4. Description of Damages				
THE VEHICLE SUSTAINED DAMAGES AT THE FRONT PORTION. DAMAGES SEE DETAILS.				
5. General Information				
Accident Date	20/11/2021	Inspection Date	06/12/2021	
Survey held at	TRANS-CAB AUTO SERVICES PTE LTD NO.2 ANG MO KIO ST 63 SINGAPORE 569111			
5a. Remarks				
A)THE INSPECTION WAS CONDUCTED ON A"WITHOUT PREJUDICE" BASIS. B)IN ACCORDANCE TO YOUR INSTRUCTIONS, WE HAVE NOT AUTHORISED REPAIRS.				
5b. Estimate Days of Repair				
ESTIMATED NORMAL PERIOD FOR REPAIR:			2 Working Days
