Your Ref: SNM21D207649/C01/TANKW
Our Ref : CS4/CTI22000190/N

11 January 2022

**TECHNICAL INVESTIGATION REPORT OF FIRE INCIDENT INVOLVING THE
INSURED VEHICLE SJY 8264C ON 23 DECEMBER 2021**

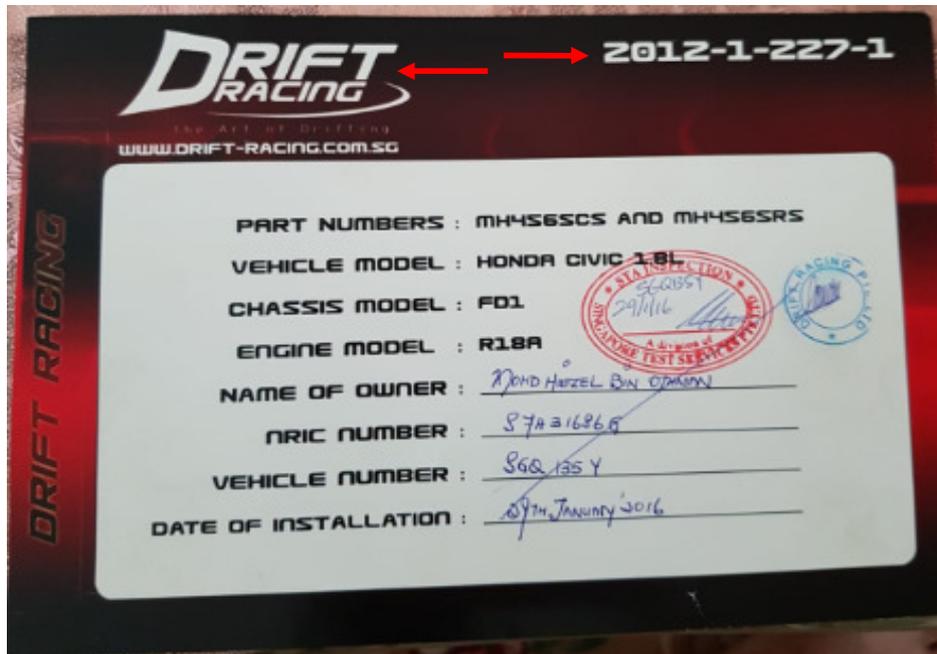
Photo 24 shows the front copy of the DRIFT RACING mid pipe and rear exhaust muffler authentication certificate with its serial number (arrowed).

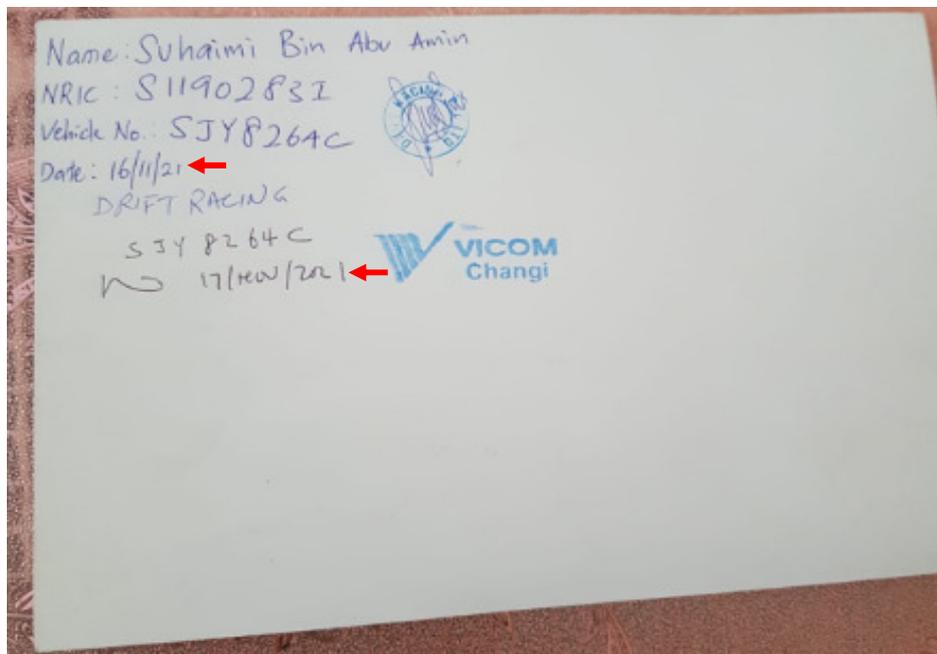
Photo 25 shows the rear copy of the DRIFT RACING mid pipe and rear exhaust muffler authentication certificate. The mid pipe and rear exhaust muffler were fitted onto the Insured Vehicle on 16 November 2021 and had passed the mandatory inspection at Vicom Inspection Centre on 17 November 2021 (arrowed).

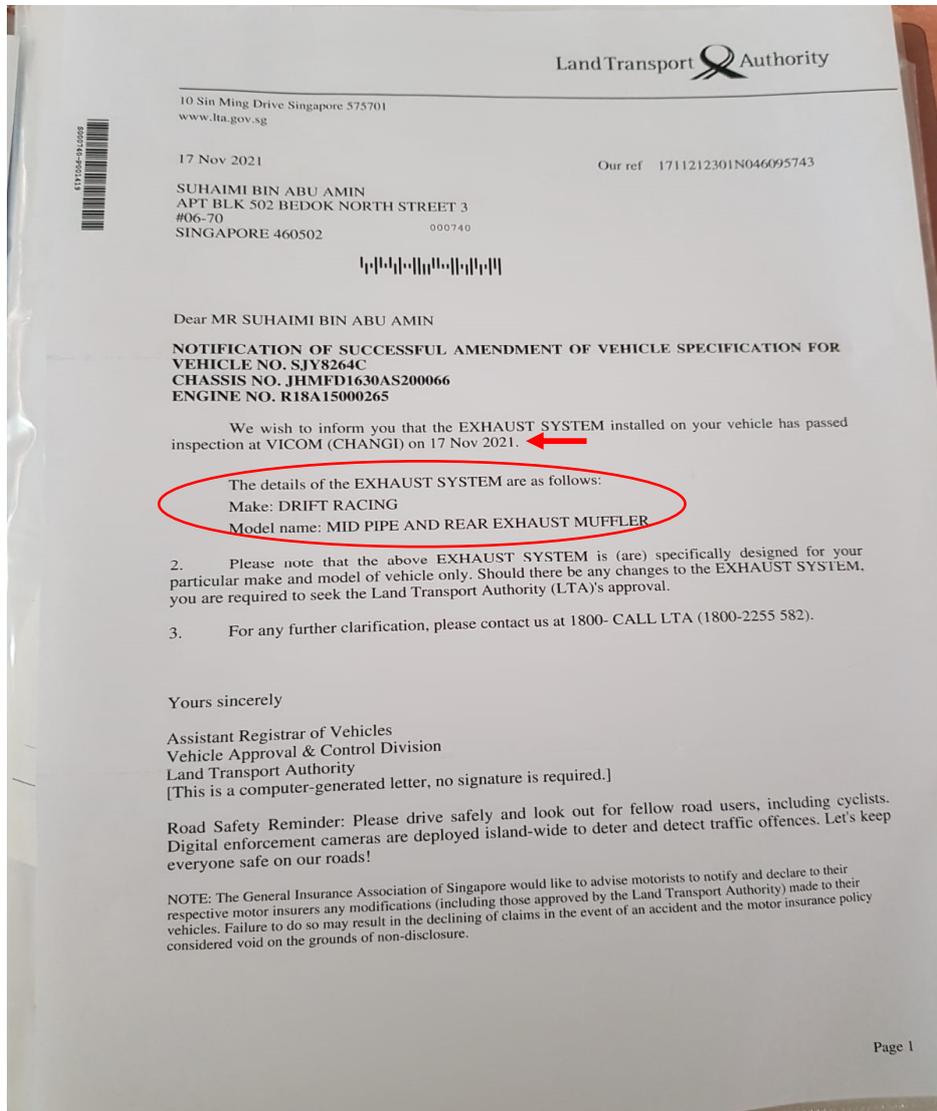
Photo 26 shows the inspection acknowledgement letter issued by the LTA to prove that the DRIFT RACING mid pipe and rear exhaust muffler fitted onto the Insured Vehicle (circled) had passed the mandatory inspection on 17 November 2021 (arrowed).

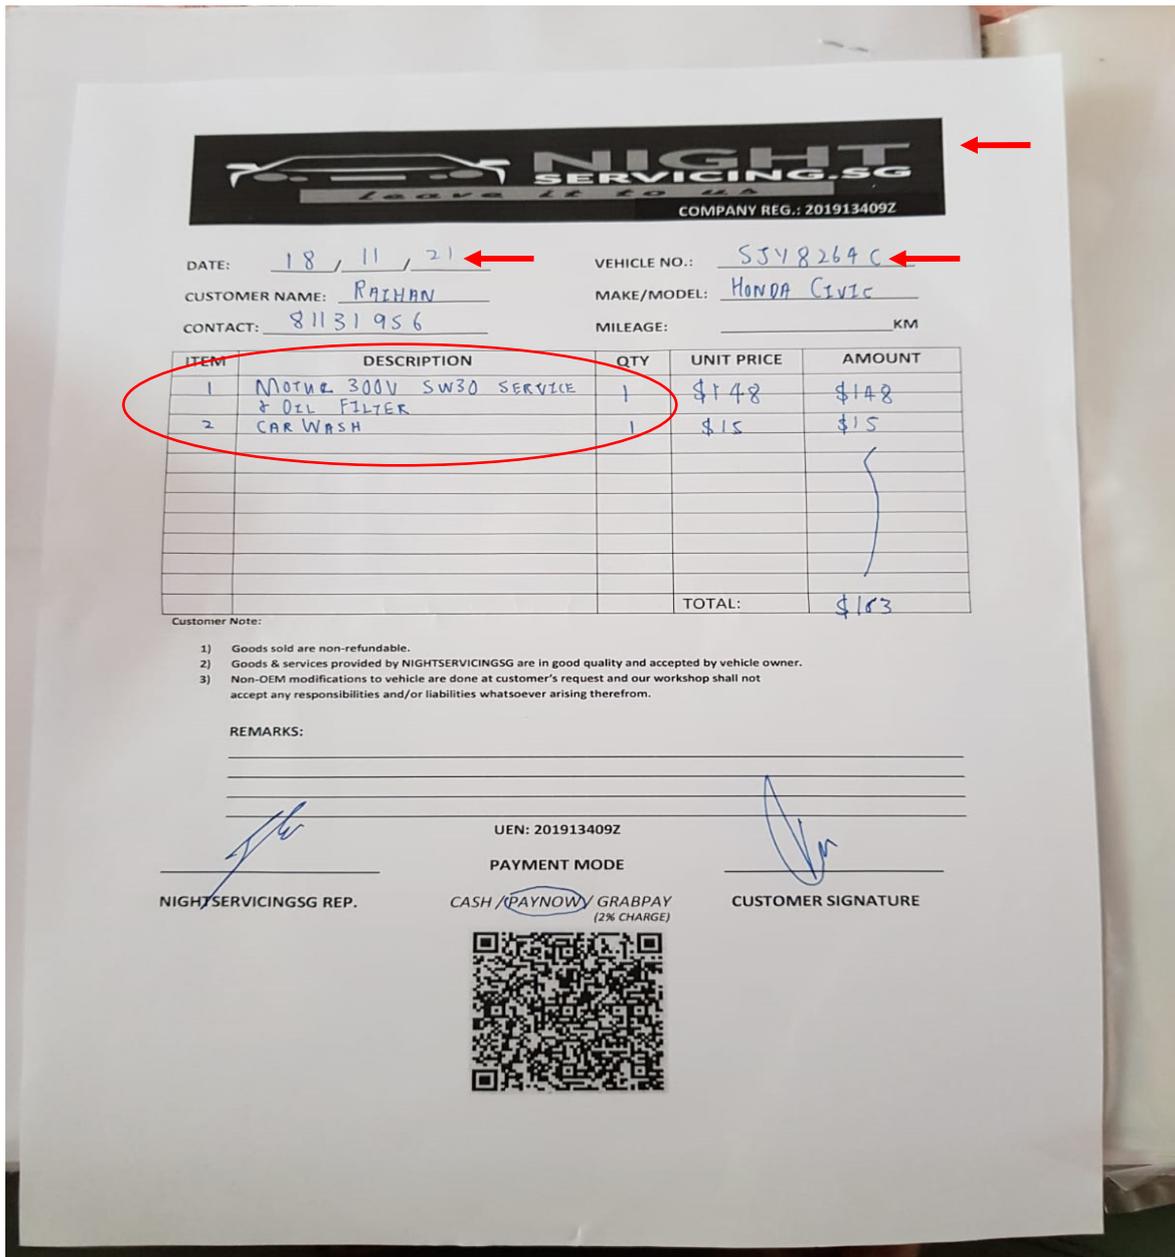
Invoice 1 shows the servicing and repairs done on the Insured Vehicle on 18 November 2021 (arrowed). The servicing package had included the changing of engine oil and oil filter (circled).

24. Based on the vehicle service record invoice provided, we are of the opinion that it is unlikely that the fire could have been caused by poor maintenance of the Insured Vehicle.
