ACCIDENT DAMAGED VEHICLE INSPECTION REPORT (WITHOUT PREJUDICE)

Registration Number	: SJR 5039 T	Mileage	: 350,461 km
Make & Model	: Hyundai HD Avante 1.6 A	Chassis Number	: KMHDU41BR9U771216
Date of Registration	: 26 June 2009	Engine Number	: G4FC9U661672
Colour	: Silver	Engine Capacity	: 1,591 cc

REPAIR DETAILS (SJR 5039 T)

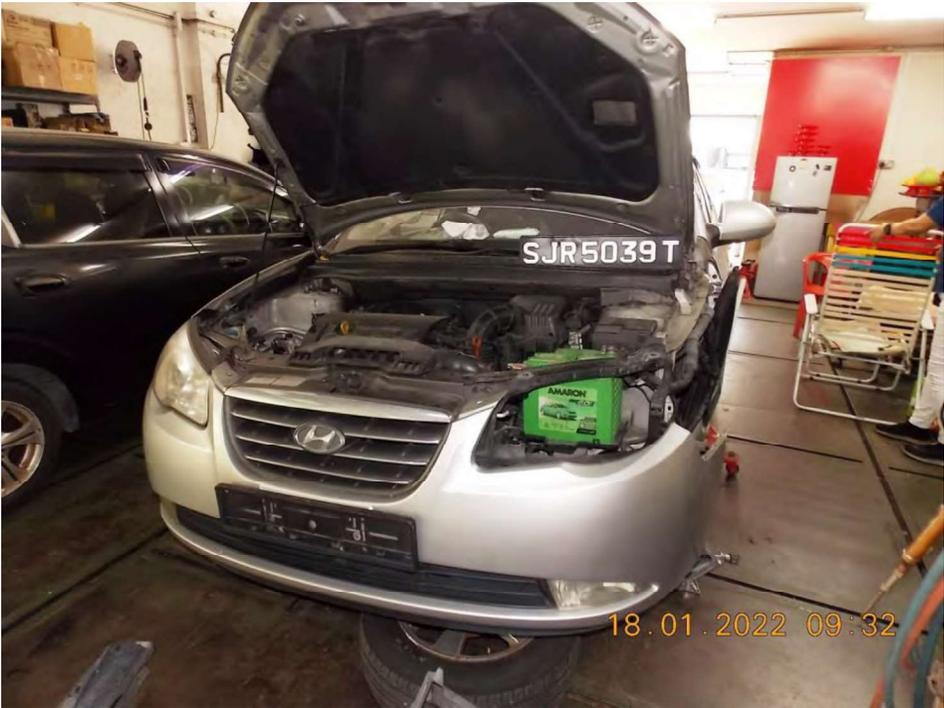
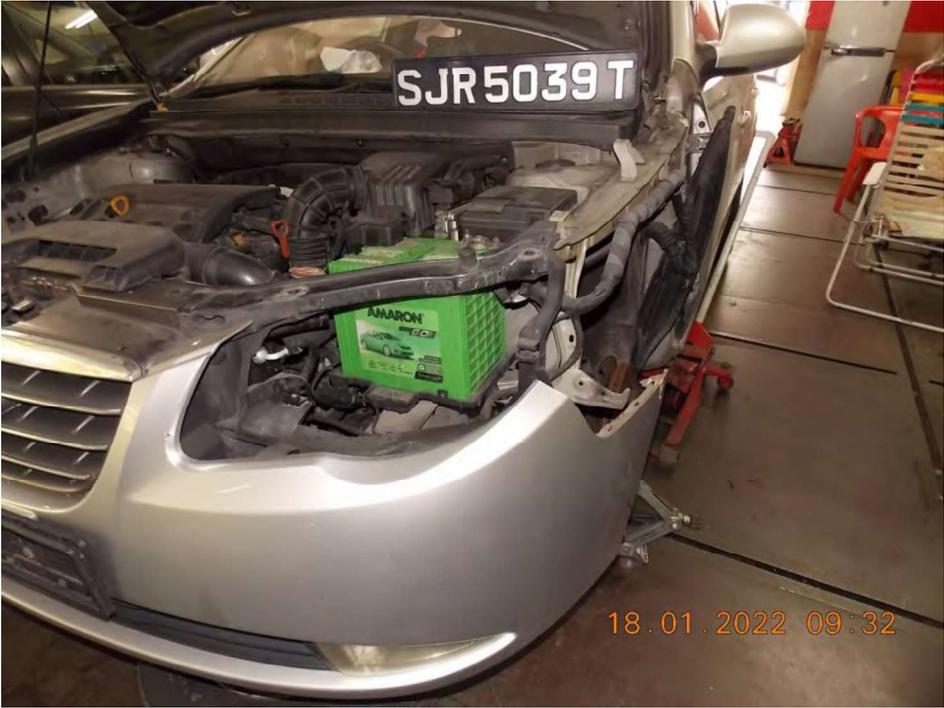
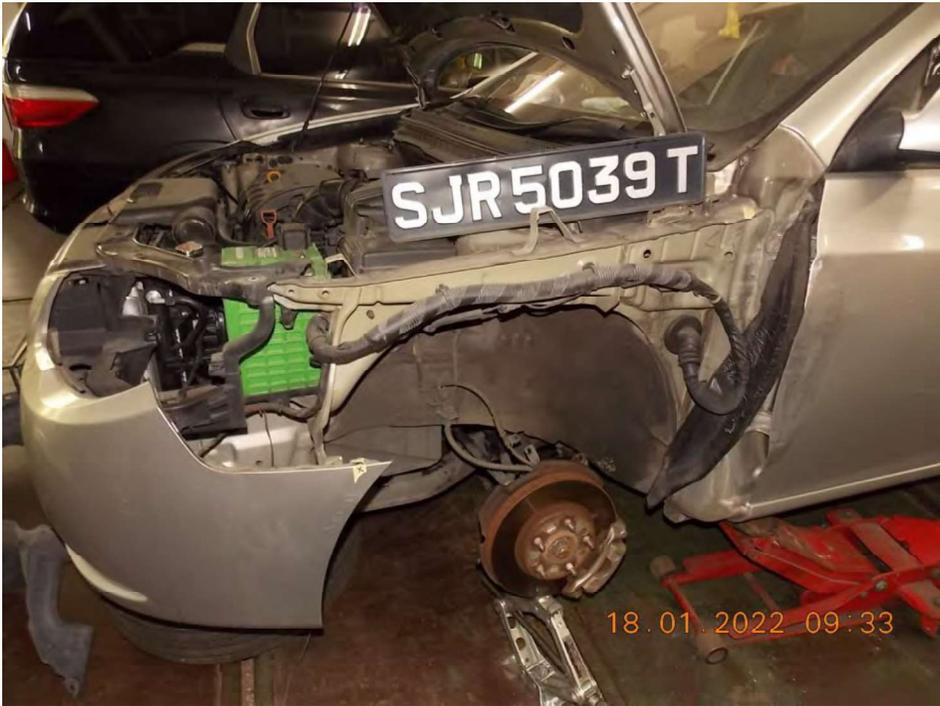
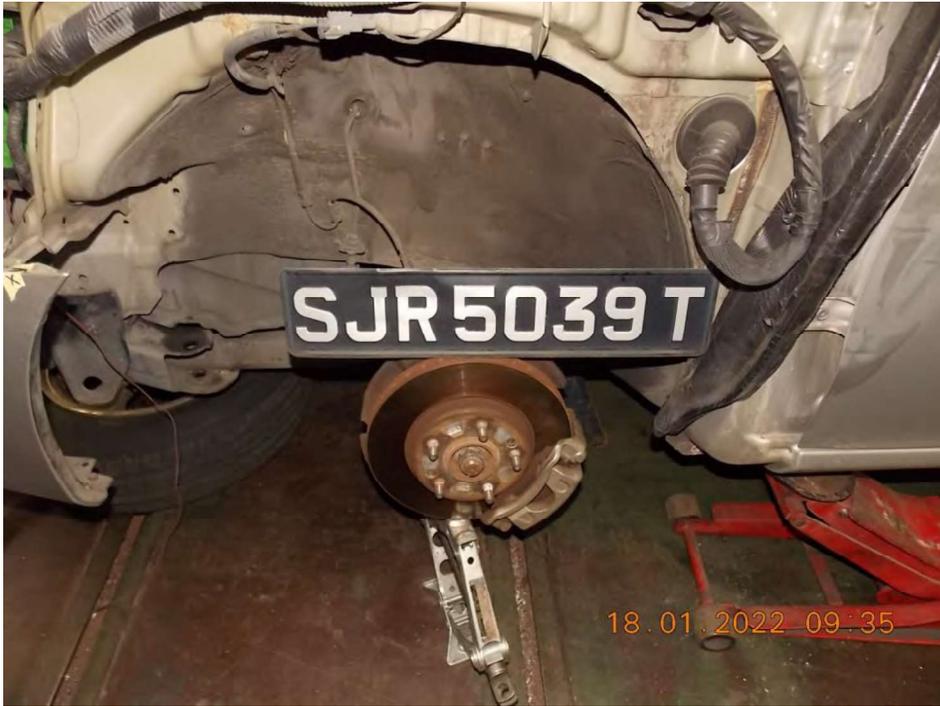
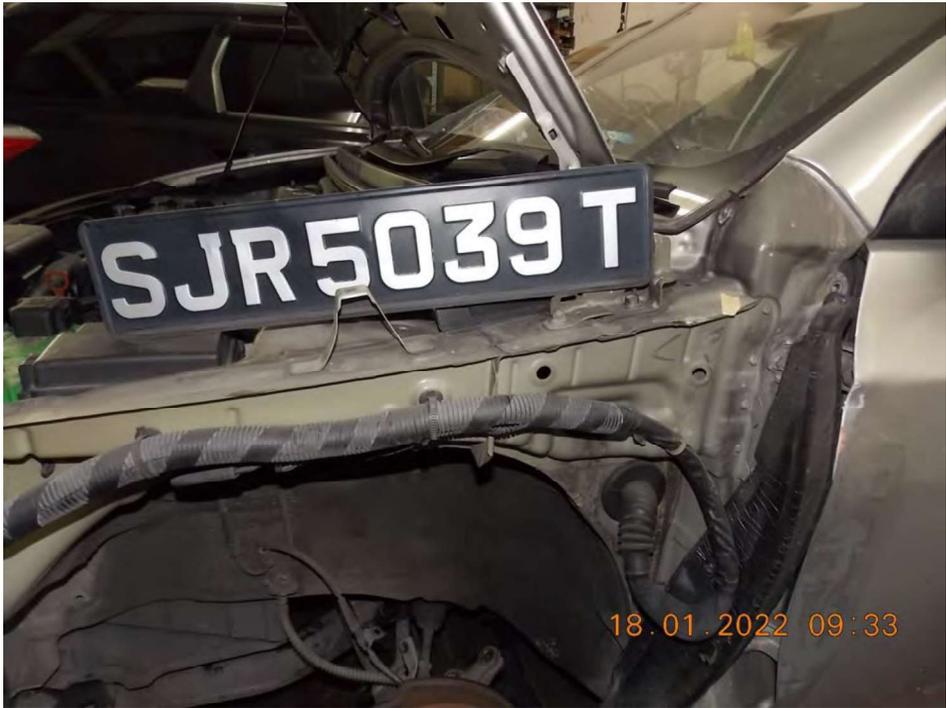
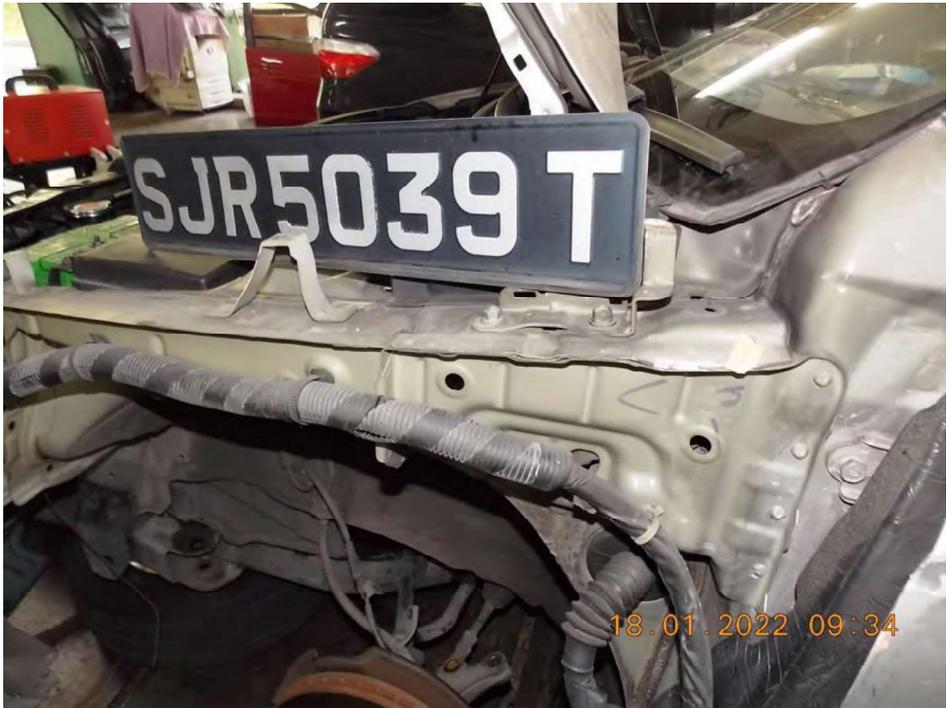
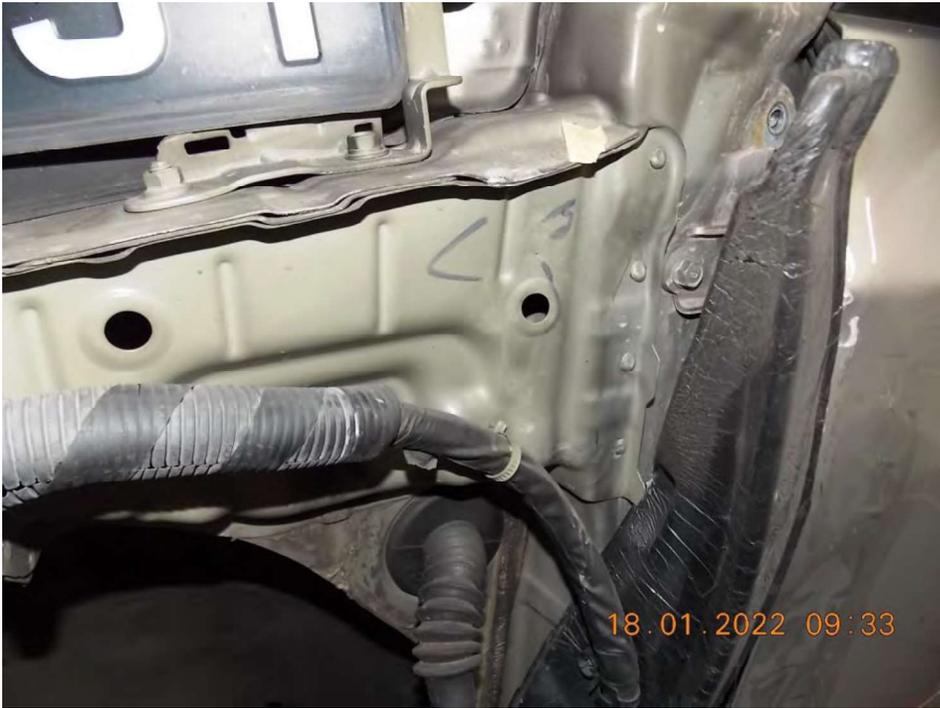
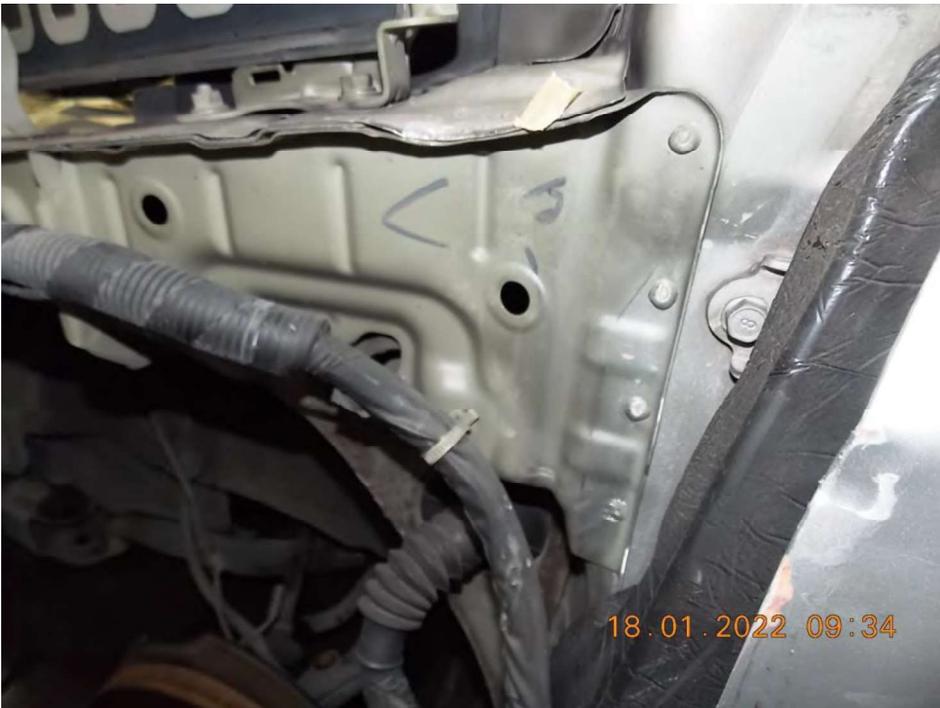
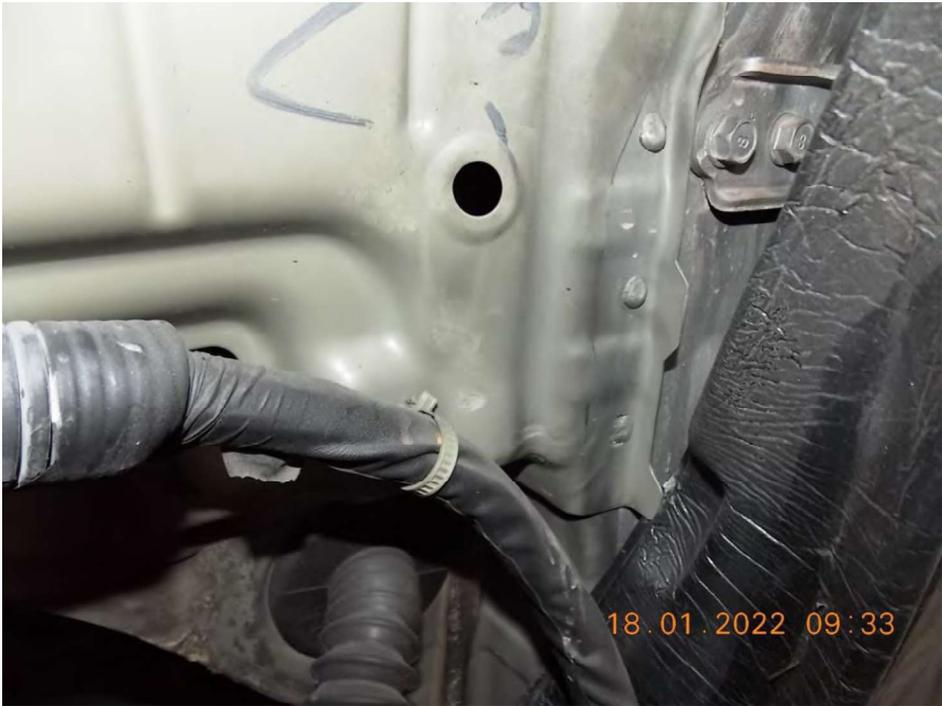
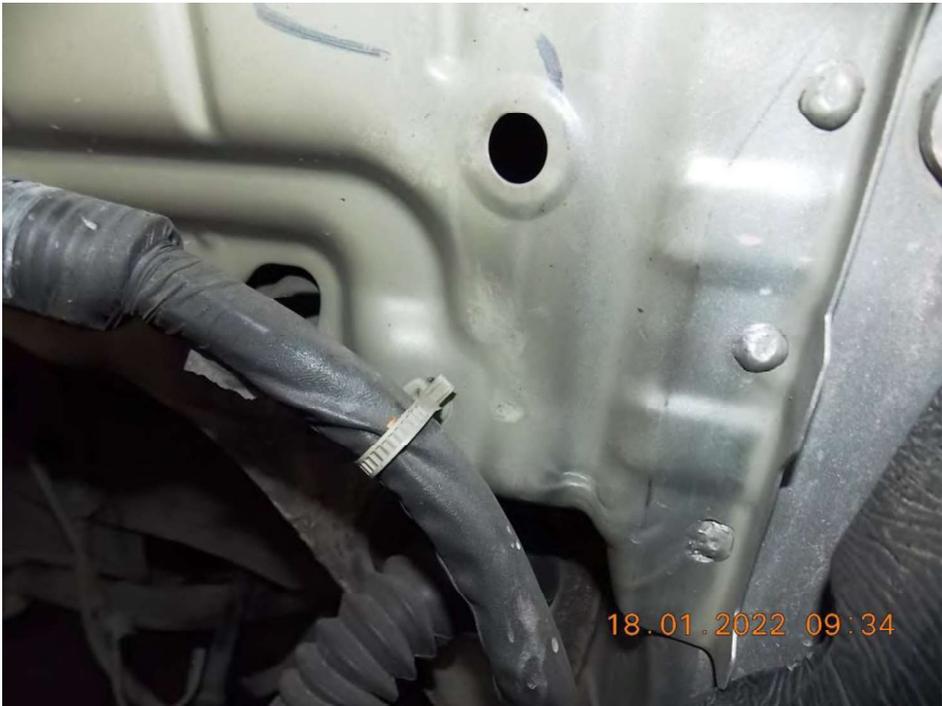
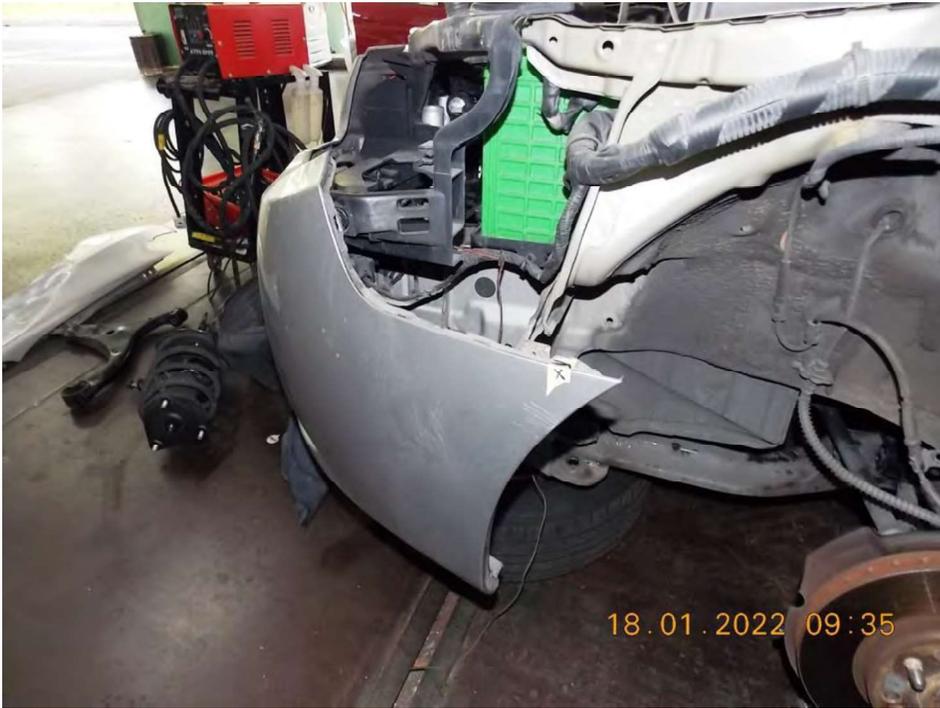
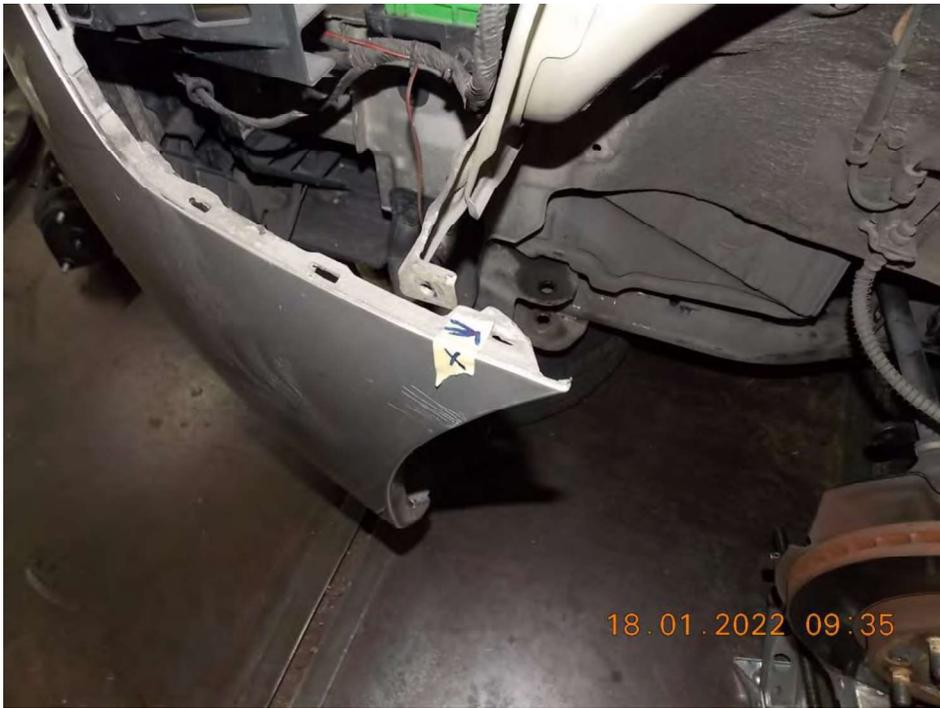
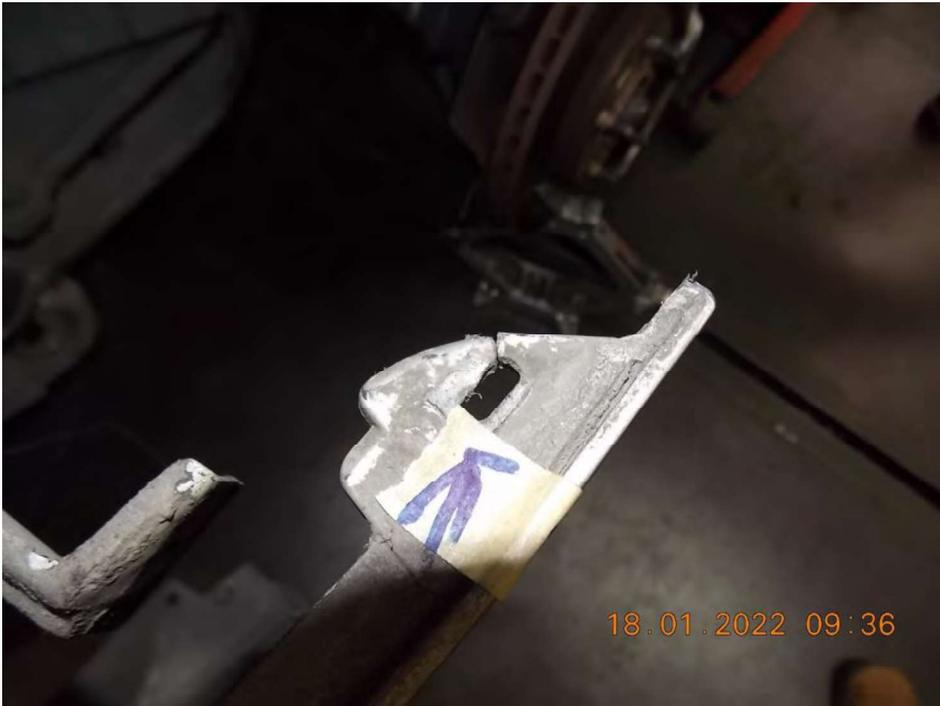
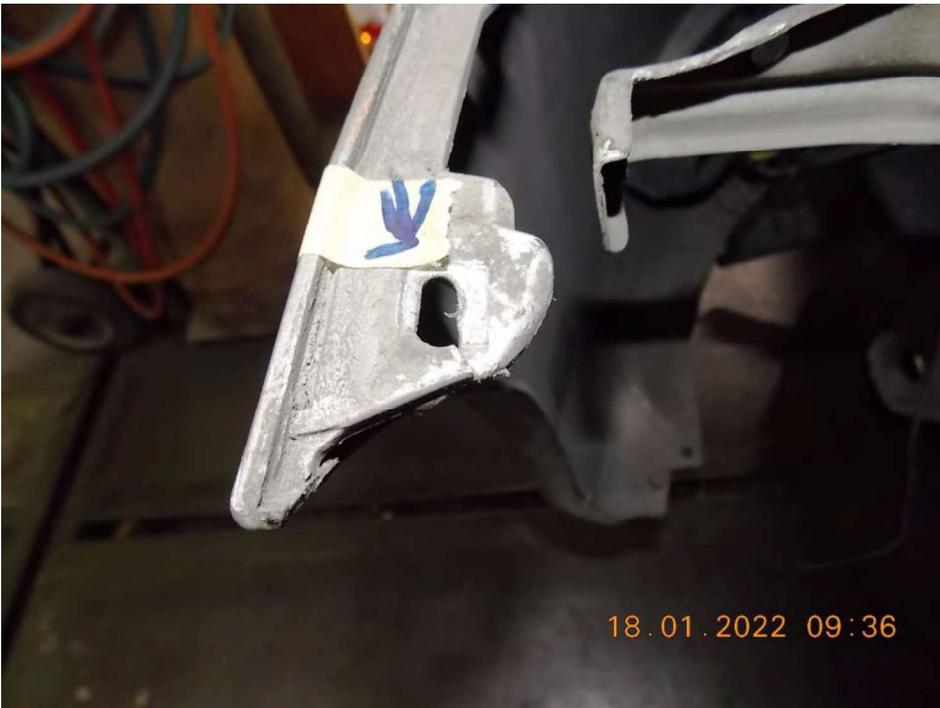
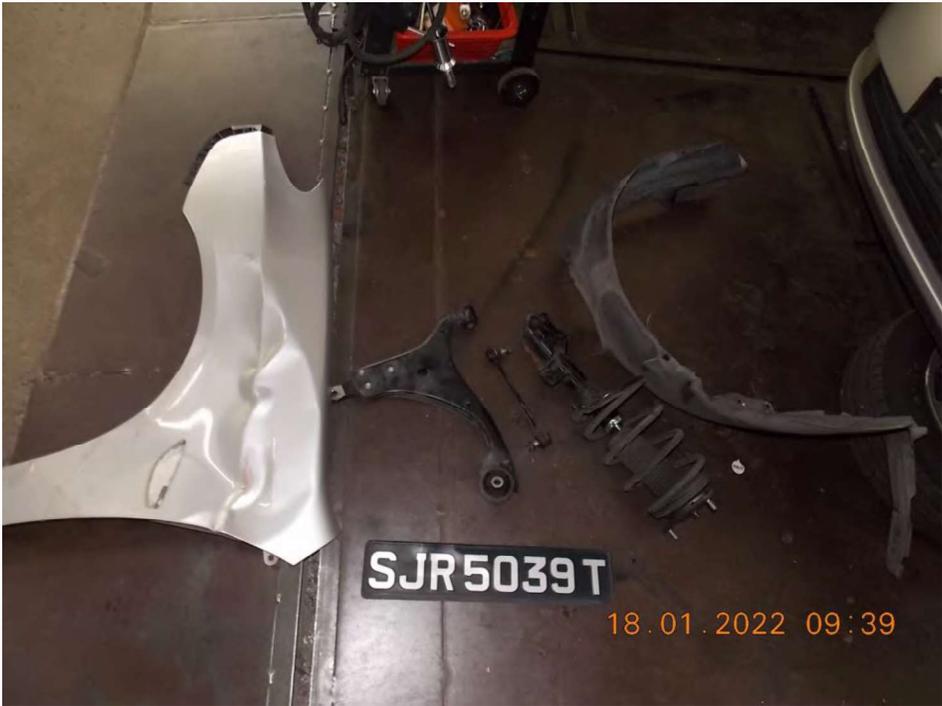
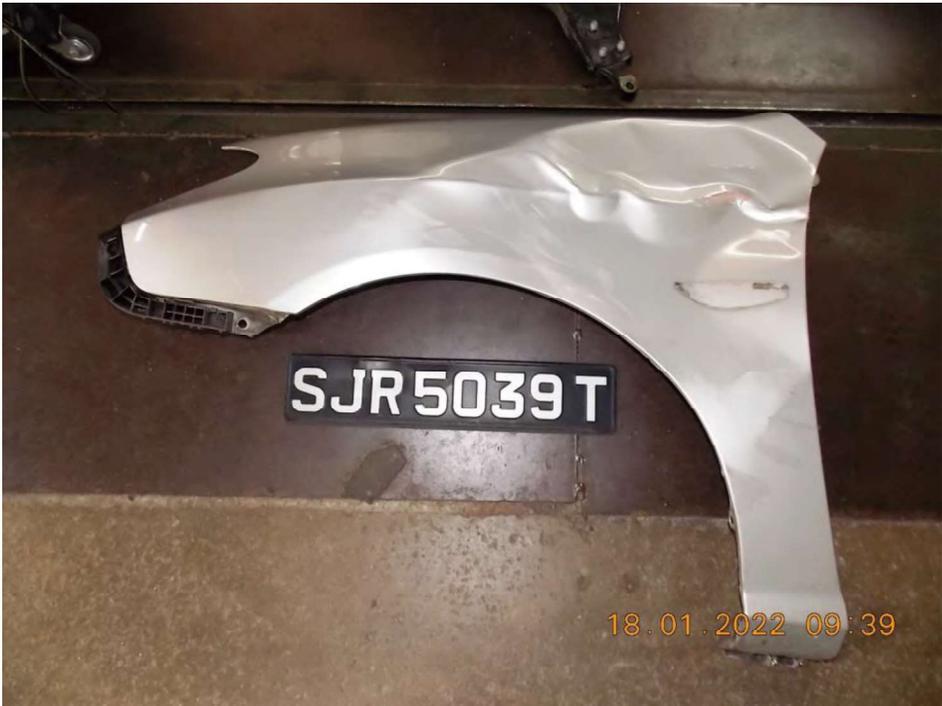
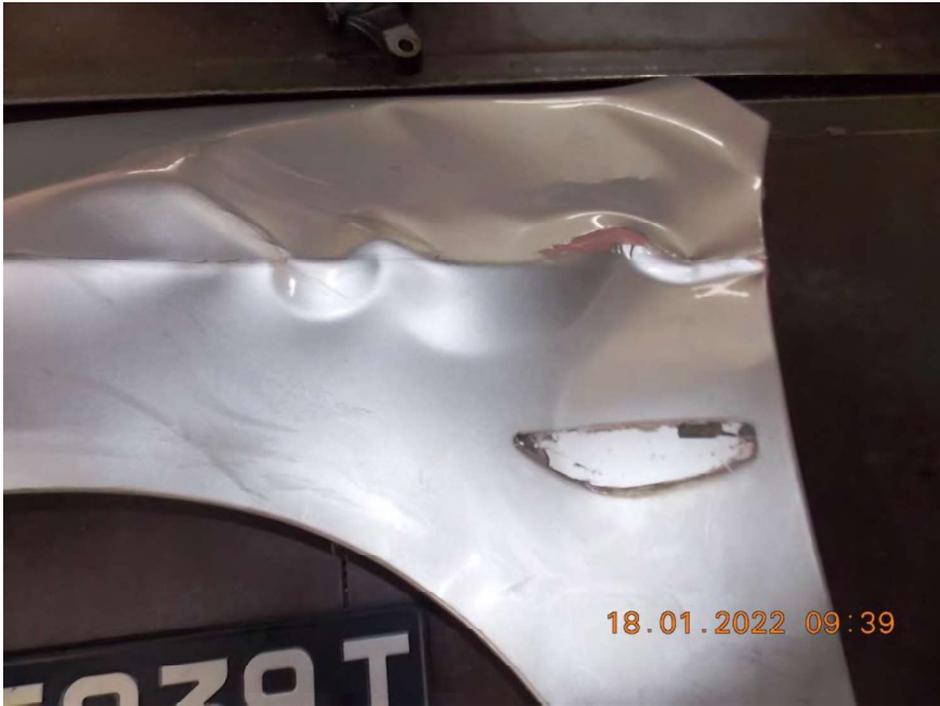
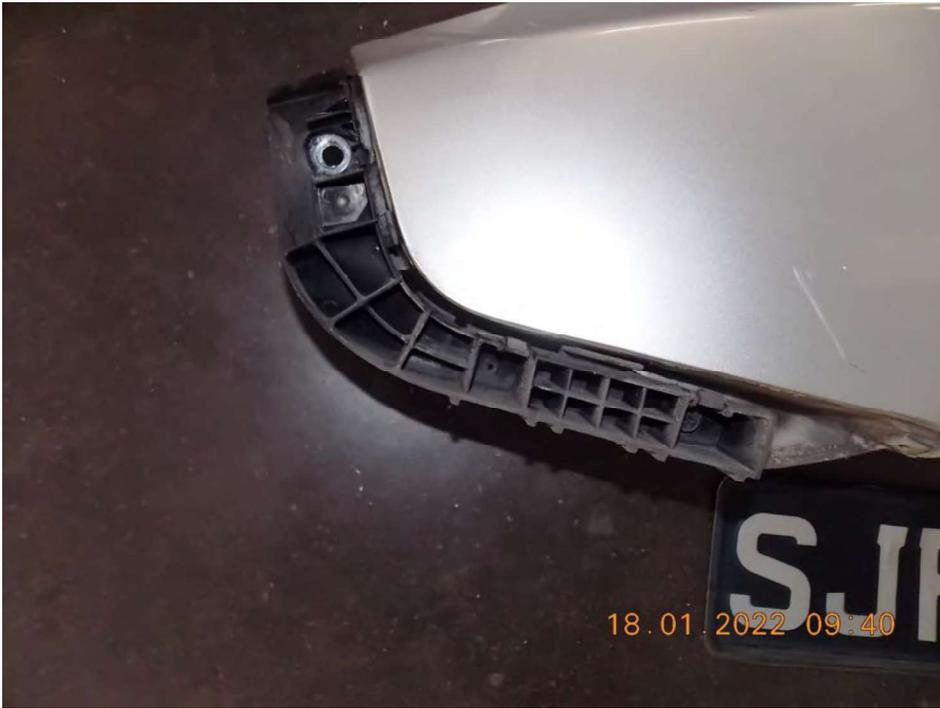
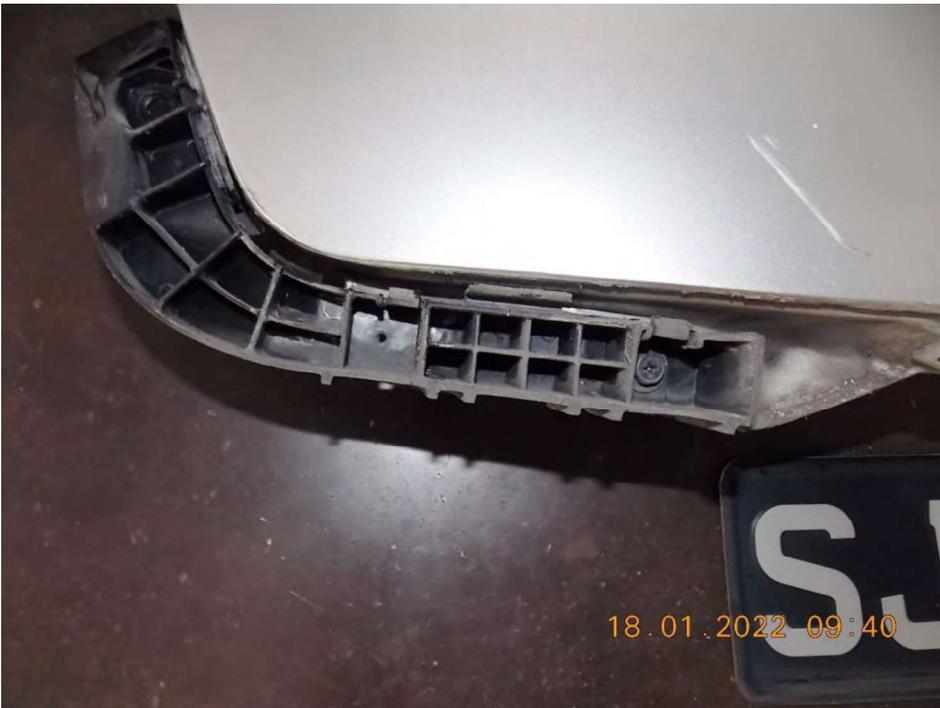
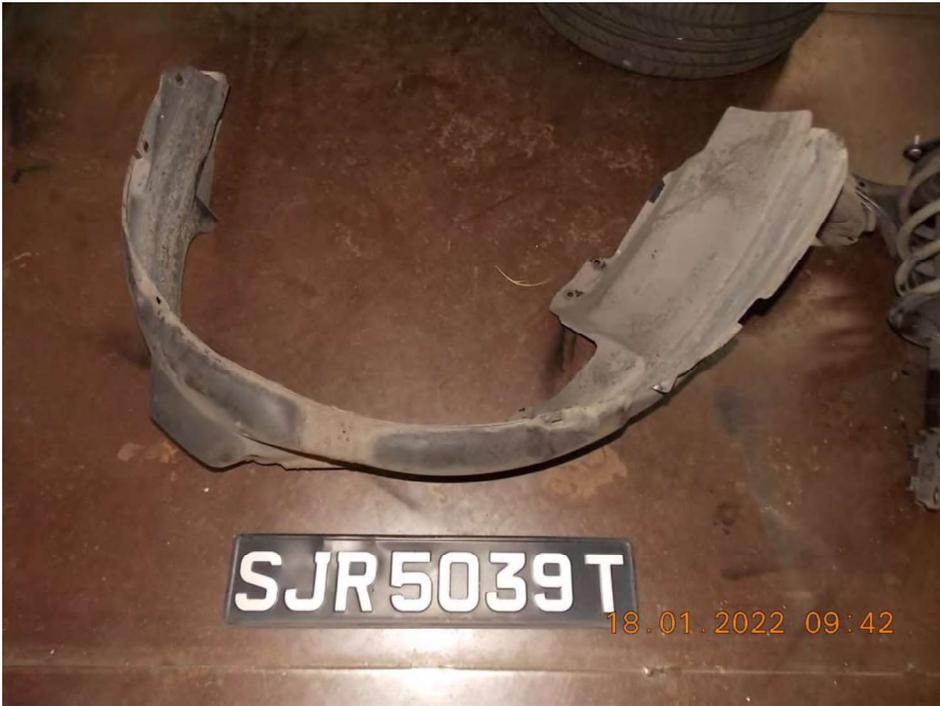
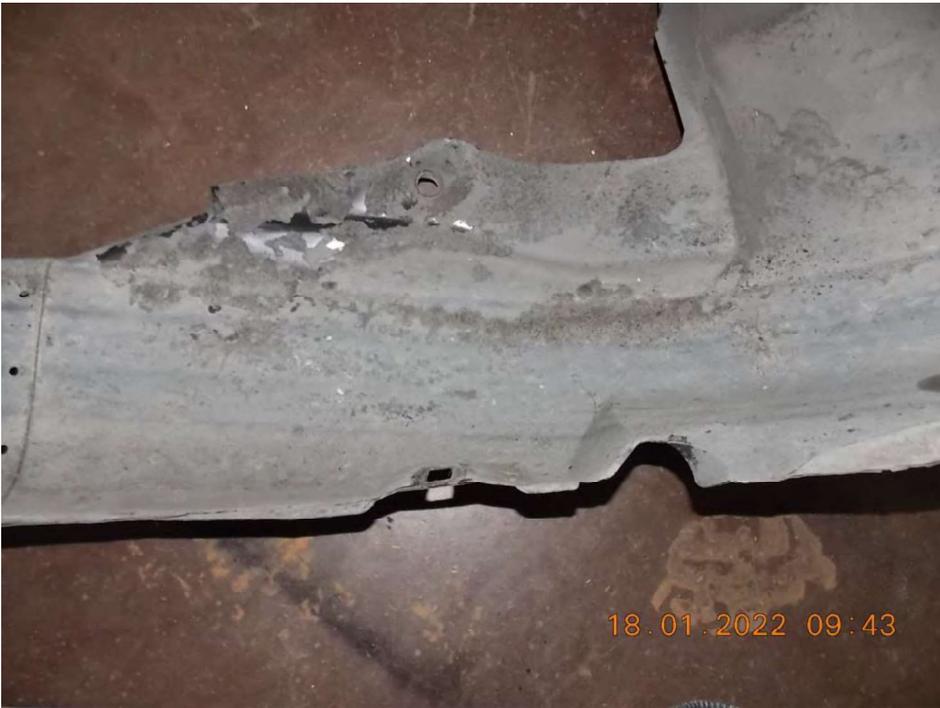
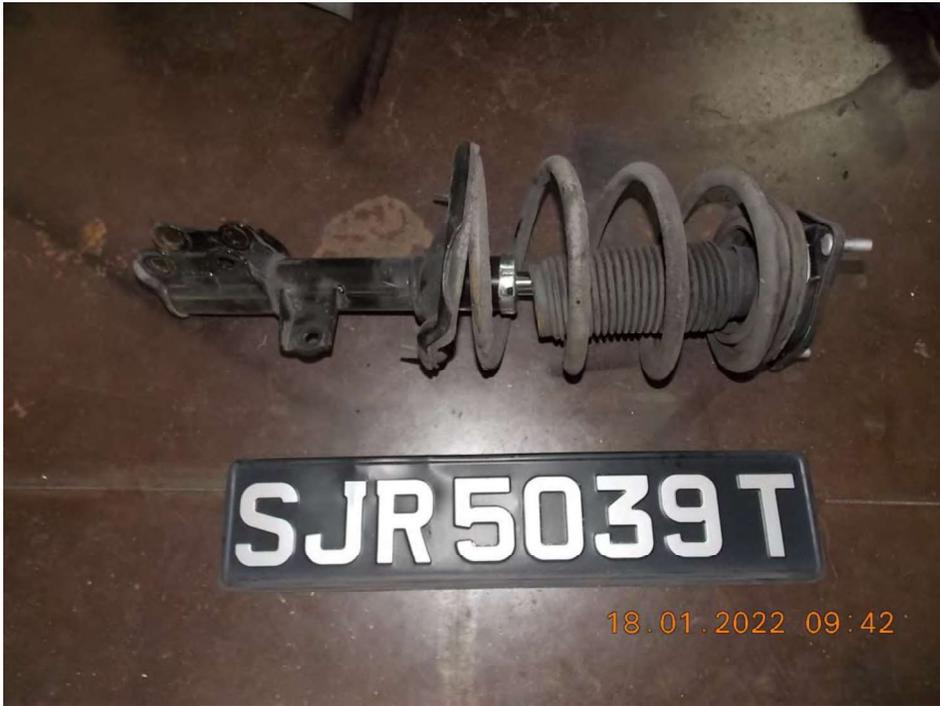
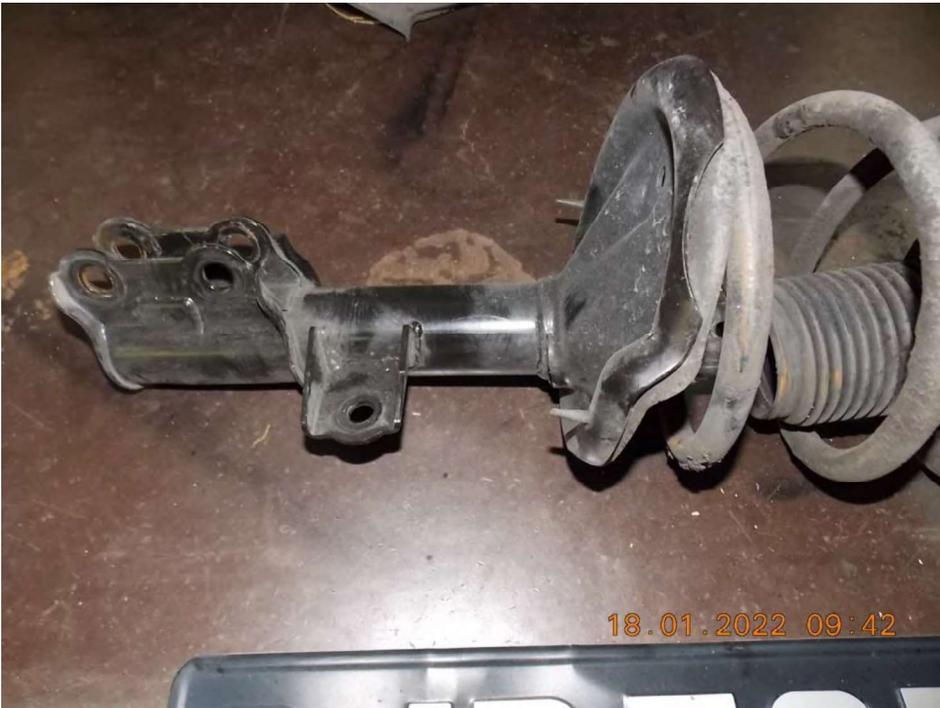
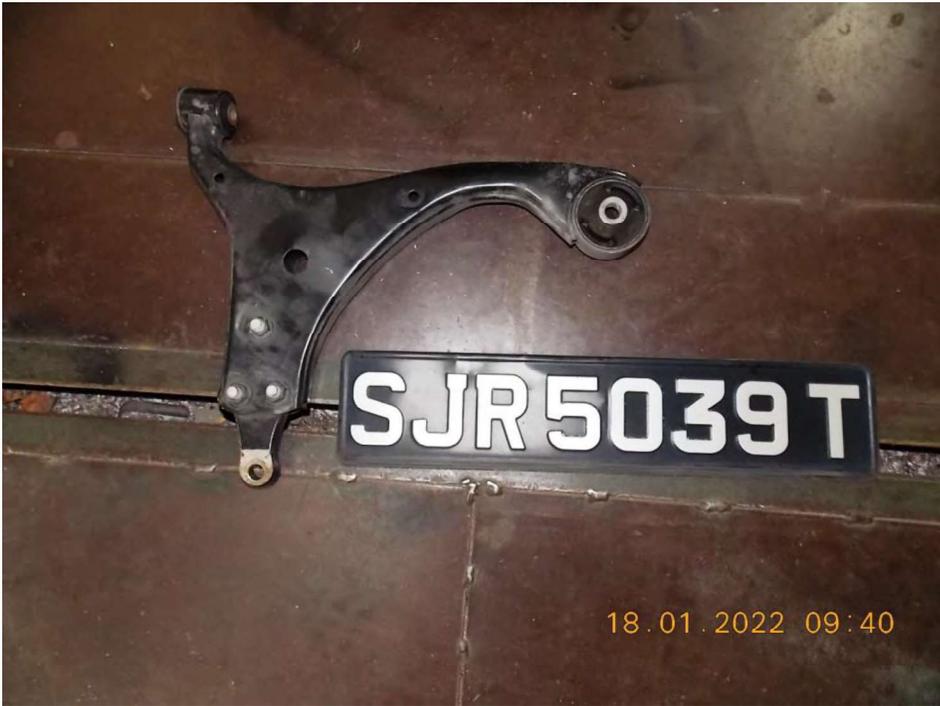
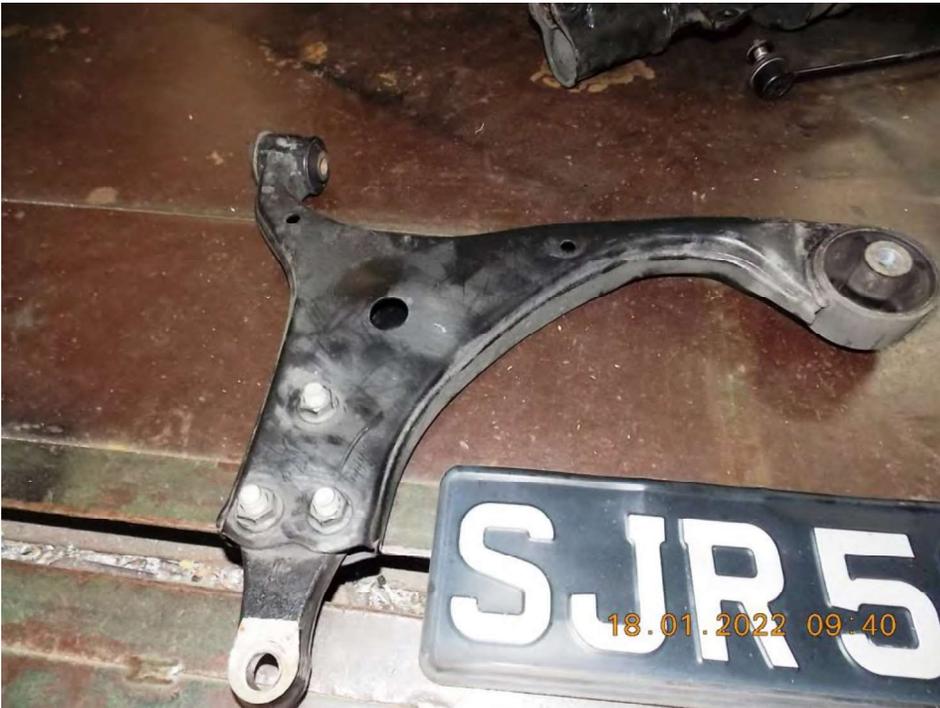
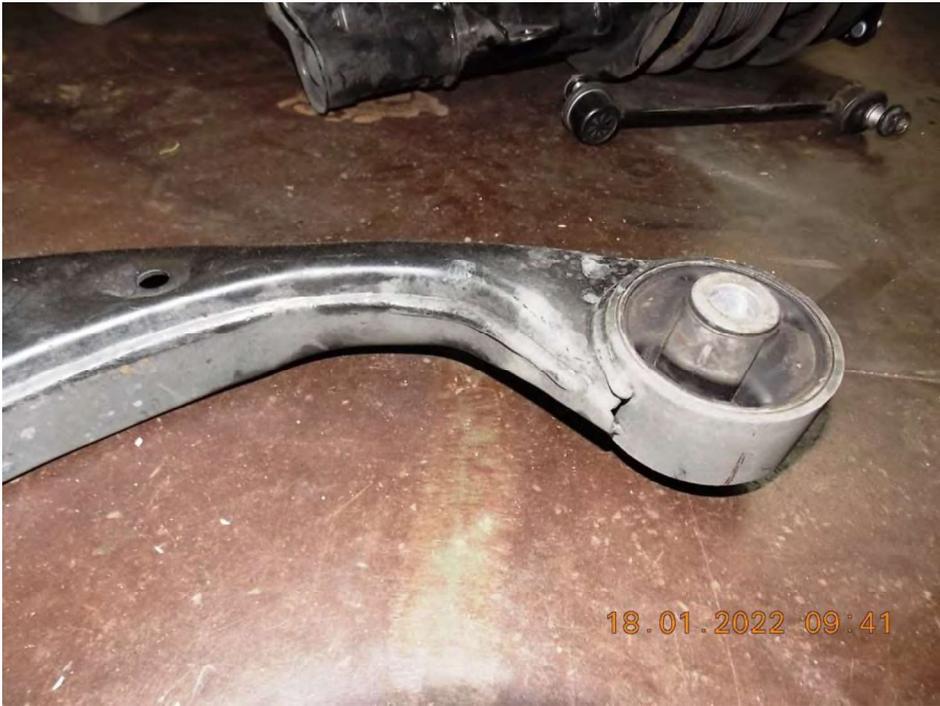
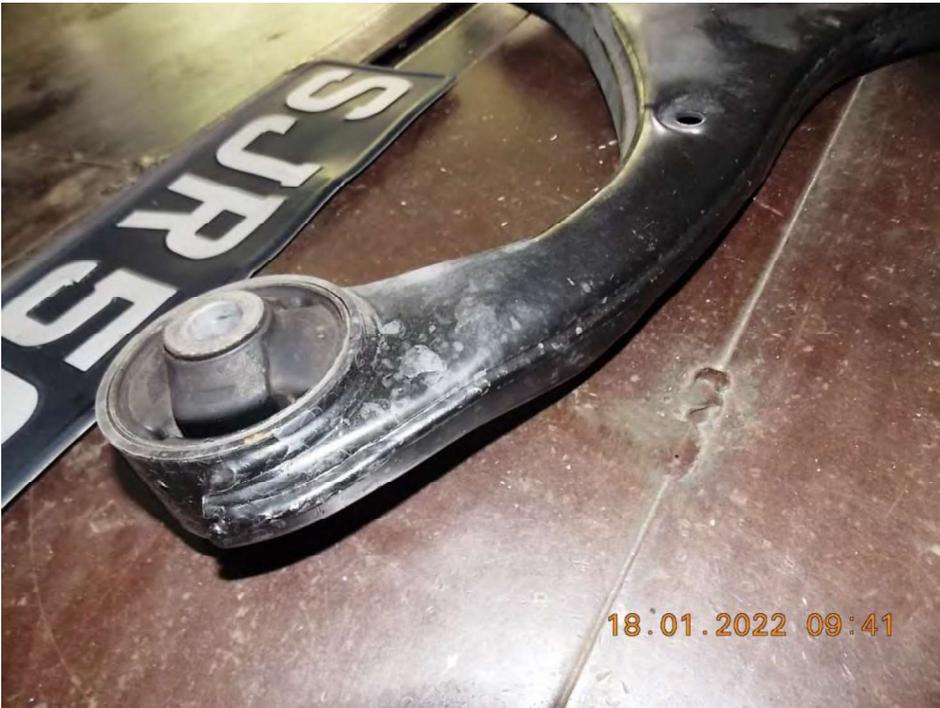
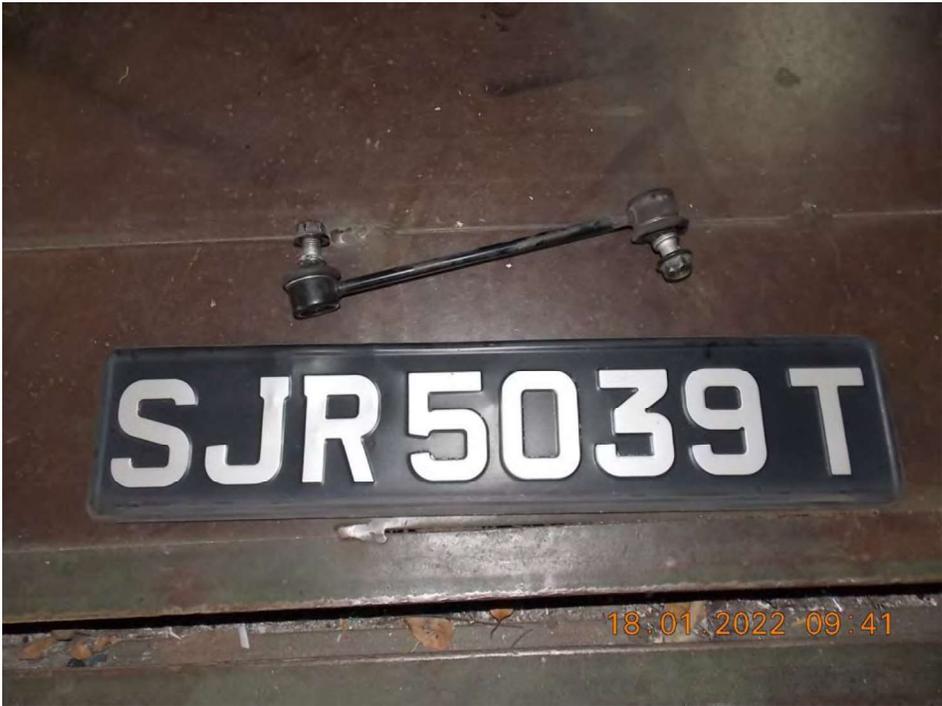
RESURVEY (17/01/2022)

The impact of the collision has damaged/affected the left front fender, left front wheelhouse reinforcement, left front door, left front wheel, left front undercarriage and front bumper face etc.
