INVESTIGATION REPORT:

Our Ref : CS6/AIS22001282/N
Policy No : SP2000580304-01
Insured : SND 5858Y
Date of Incident : 3 February 2022
Location : Whitley Road towards PIE (TUAS)

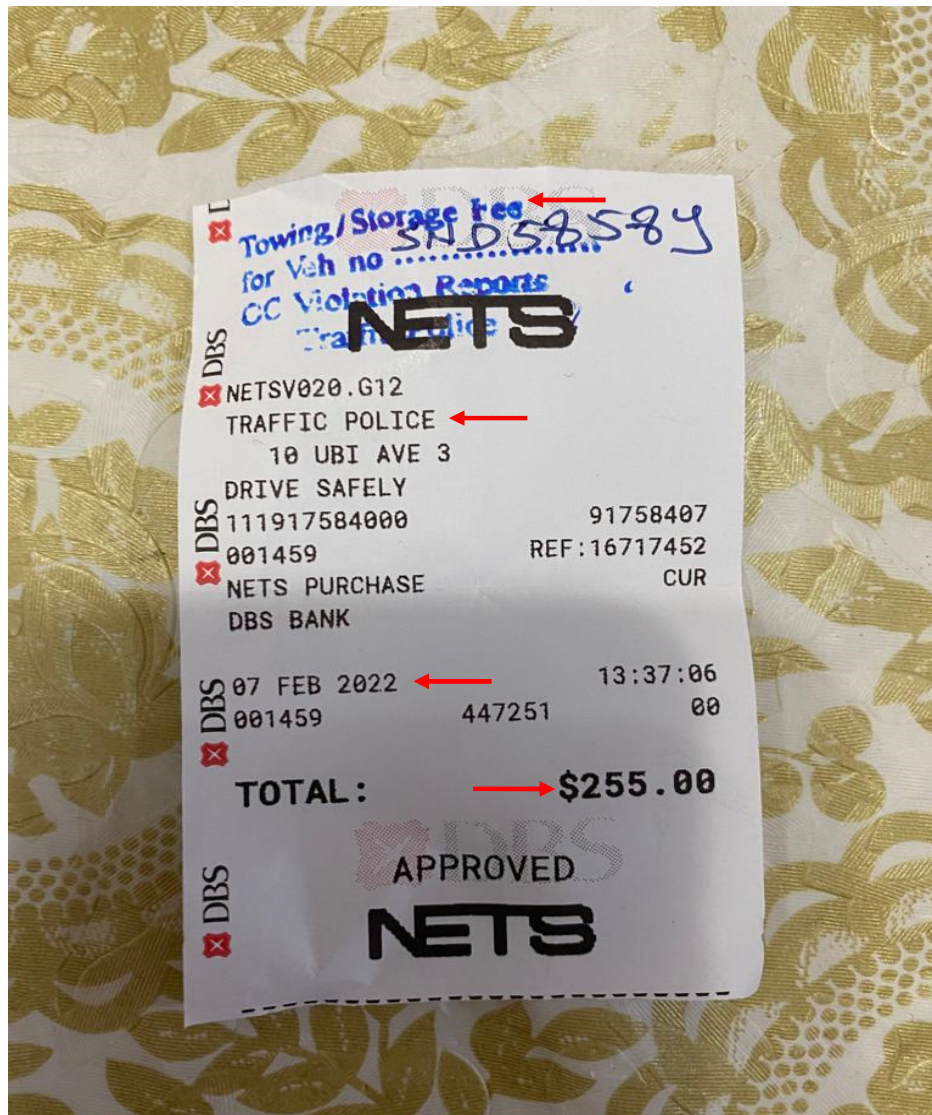
Receipt 1 shows that on 7 February 2022 Ms Pek had settled the payment of \$255.00 for the towing and storage fee of the Insured Vehicle which had been towed to the Traffic Police Pound post- incident (arrowed). The info gathered from the receipt would correlate with Ms Pek's statement that her case was assigned to the Traffic Police.
