Your Ref: TP/IP/56223/2021  
Our Ref : CI/TPD22002075/N

9 March 2022

**Fatal Accident Investigation Team**

**INSPECTION REPORT OF PERSONAL MOBILITY AID PMA  
TRAFFIC POLICE POUND REPORT NO. 3986/21**

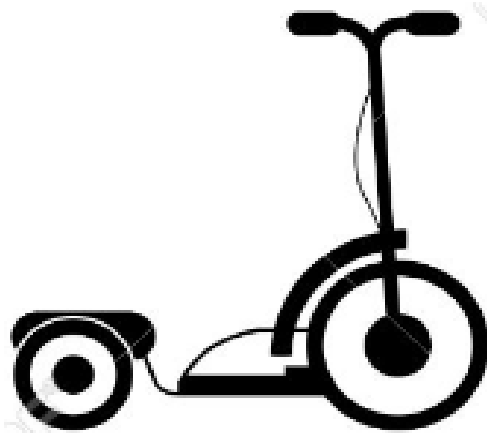
5. The PMA's 3 Polyurethane (PU) solid tyres were observed to be in serviceable condition. The tread pattern of the 3 tyres was clearly visible. We did not observe any tear, burst mark(s) and/or punctured hole(s) on the sidewalls as well as across the tread of the 3 tyres. However we found the left sidewall of the left rear tyre to be grazed. The tyre size and remaining tread depth of the 3 tyres were recorded as follows:-

200 X 50 (3mm) (RLT)  
(Grazed)

200 X 50 (3mm)
