Your Ref: TP/IP/53185/2021  
Our Ref : CI/TPD22002090/N

**Fatal Accident Investigation Team**

**INSPECTION REPORT OF MOTORCYCLE FBH 956B**

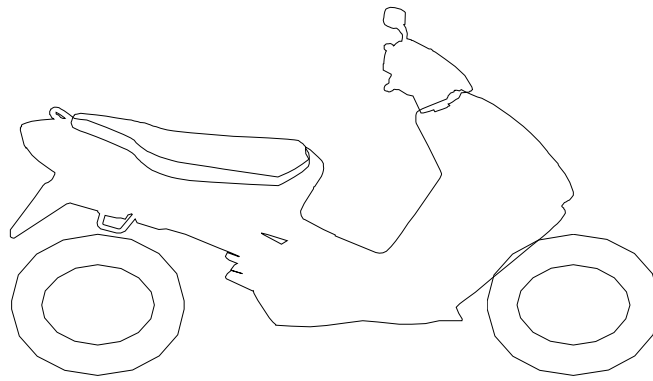
6. The condition of the Motorcycle's 2 tyres was observed to be in serviceable condition. The tread pattern of the 2 tyres was clearly visible. We did not observe any tear, burst mark(s) and/or punctured hole(s) on the sidewalls as well as across the tread of the 2 tyres. The 2 tyres were both observed to be sufficiently inflated for vehicular operation. The tyre brand, tyre size and remaining tread depth of the 2 tyres were recorded as follows:-

IRC 130/70 - 12 (5mm)

IRC 110/90 - 13 (6mm)
