**Memorandum for Billing for Accident Recoveries**

**Facilities Management Fault Report Form**

LOYANG AVENUE, Pole No: 82, Pole Slanting, calling from tp. report sl damage due to accident. uprooted. - slanting against the tree. lp 82. posing danger. location; Loyang ave towards telok paku road. vehicle; saf vehicle vehicle , 34699MID. report; G/20211111/0047

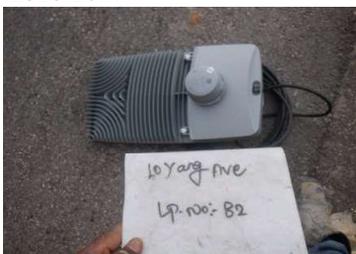
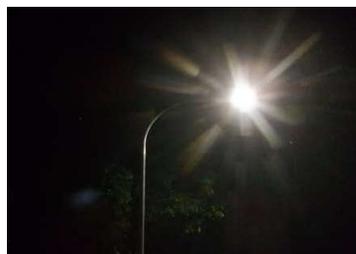
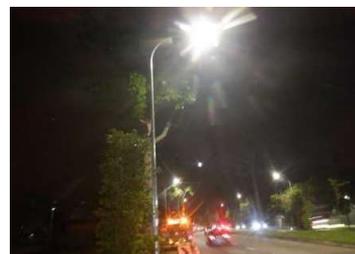
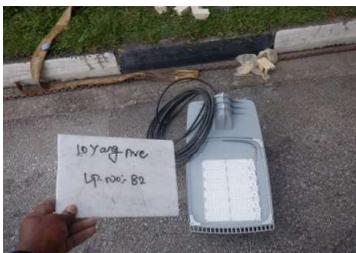
Checked and found 10m pole, 2m single arm, 1 no 139W LED lantern, control node and cut out damaged at LP82 (Loyang Avenue) due to hit by vehicle no - 34699MID. Replacement of 10m pole, 2m single arm, 1 no 139W LED lantern with control node and cut out at LP82 (Loyang Avenue) due to accident pole.
