Your Ref: TP/IP/04040/2022
Our Ref : CI/TPD22003616/P

Fatal Accident Investigation Team

MECHANICAL INSPECTION REPORT OF MOTOR BUS SG 5442M

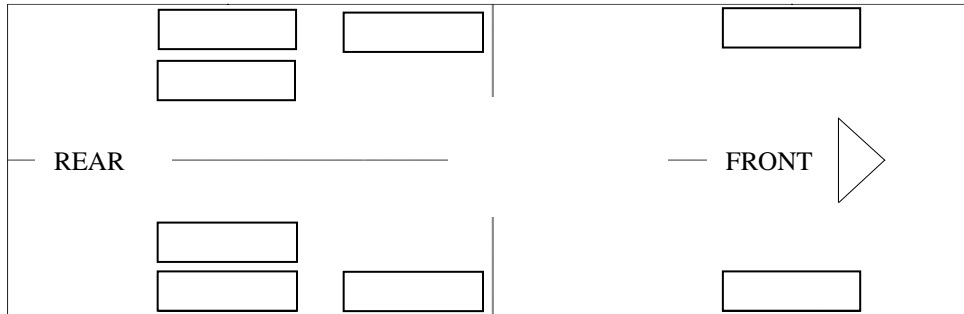
6. The 2 front tyres and 6 rear tyres of the Motor Bus were observed to be in serviceable condition and sufficiently inflated for vehicular operation. I did not find any tear, cut or burst mark(s) on the outer and the inner sidewalls as well as across the tread of the 8 tyres. The tyre brand, tyre size and remaining tread depth of the 8 tyres of the Motor Bus were recorded as follows:-

Bridgestone 275/70R22.5 (13.8mm)

Bridgestone 275/70R22.5 (13.4mm)

Bridgestone 275/70R22.5 (9.8mm)

Bridgestone 275/70R22.5 (8.9mm)
