Your Ref: Porsche Macan
(chassis number WP1ZZZ95ZKLB05467)
Our Ref : CI/TP22004080/D

INSPECTION REPORT OF AN UNREGISTERED PORSCHE MACAN MOTOR CAR WITH CHASSIS NUMBER WP1ZZZ95ZKLB05467

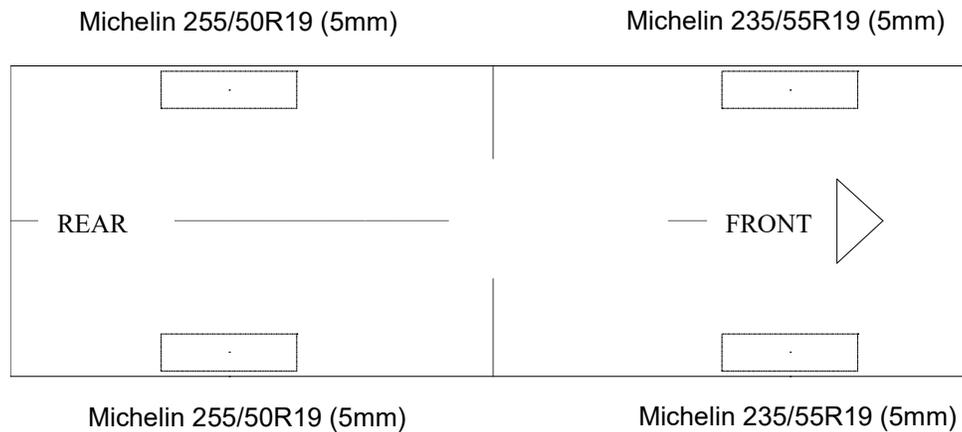
9. The Motor Car was fitted with 19inch sport wheel rims that were wrapped with tyres that were observed to be of serviceable condition. The tyres were also sufficiently inflated for vehicular operation. The tyre brand, tyre size and approximate remaining tread depth of the 4 tyres of the Motor Car were recorded as follows: -
