Your Ref : 266146
Our Ref : CI/MSG22004574/D

19 May 2022

**AUTOMOBILE TECHNICAL INVESTIGATION REPORT OF ACCIDENT
INVOLVING YP 6099X AND XD 5502E ON 27 NOVEMBER 2021**

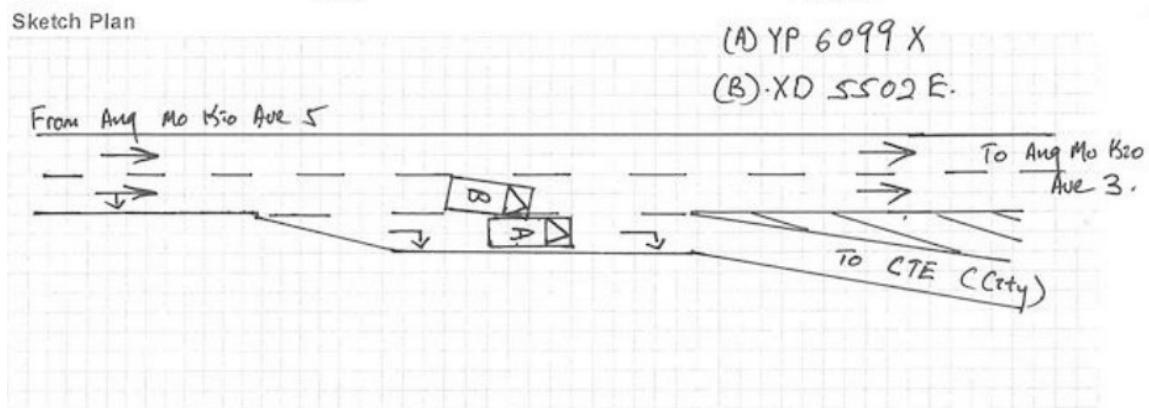
6. The Singapore Accident Statement lodged by the driver of the Insured Vehicle had amongst other information contained a description of the circumstance of accident.
7. On 27 November 2021 at about 1130hrs, the Insured Vehicle was travelling along the right lane of Ang Mo Kio Avenue 5, near the entrance to CTE (City). Suddenly, the Third Party Vehicle, on the left, cut into the path of the Insured Vehicle and collided onto the left side of the Insured Vehicle. The impact pushed the Insured Vehicle to the right, resulting in the right wheels of the Insured Vehicle to hit onto the road kerb on the right of the roadway.
8. Sketch plan of the accident, extracted from the Singapore Accident Statement lodged by the driver of the Insured Vehicle, is shown below.

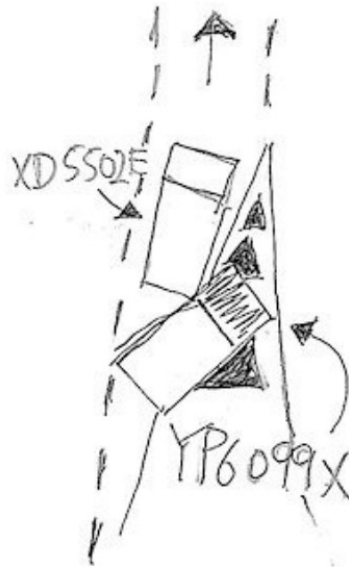
Sketch Plan

9. The Singapore Accident Statement lodged by the driver of the Third Party Vehicle had amongst other information contained a description of the circumstance of accident.
10. The driver of the Third Party Vehicle had reported that the Third Party Vehicle was travelling along Ang Mo Kio Avenue 5, filter lane exit CTE towards City. The Insured Vehicle, travelling on the right side, suddenly cut through the road divider and hit onto the rear right side of the Third Party Vehicle.
11. Sketch plan of the accident, extracted from the Singapore Accident Statement lodged by the driver of the Third Party Vehicle, is shown below.

24. First contact would be at left side front portion of the Insured Vehicle before stretching towards the left side centre and left side rear of the Insured Vehicle due to the higher travelling speed of the Insured Vehicle. The sketch plan (refer to page 3 above and shown again below) does not match the damage pattern of the Insured Vehicle.
