Your Ref: TP/IP/55291/2021
Our Ref : CI/TPD22004867/N

7 July 2022

**INSPECTION REPORT OF BICYCLE (BLUE) - TRAFFIC POLICE POUND
REPORT NO. 3923/21**

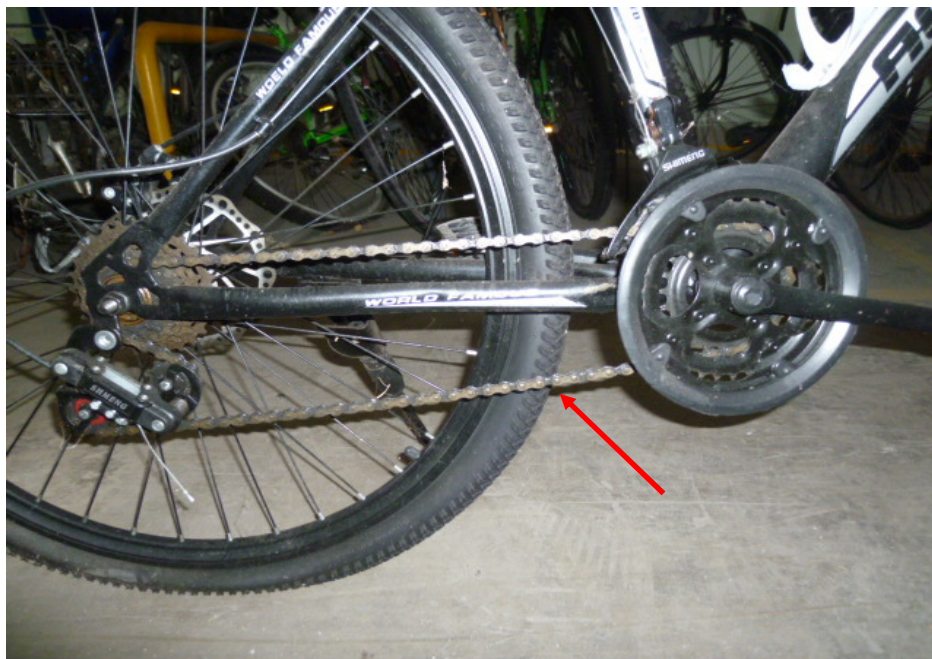
7. The gear train of the Bicycle was found to be intact without any misalignment. It was also adequately lubricated for operating purposes. See photos 15 & 16 below.

Photo 15 shows the general view of the gear train of the Bicycle, which was observed to be intact with no misalignment (arrowed). It was also adequately lubricated for operating purposes.

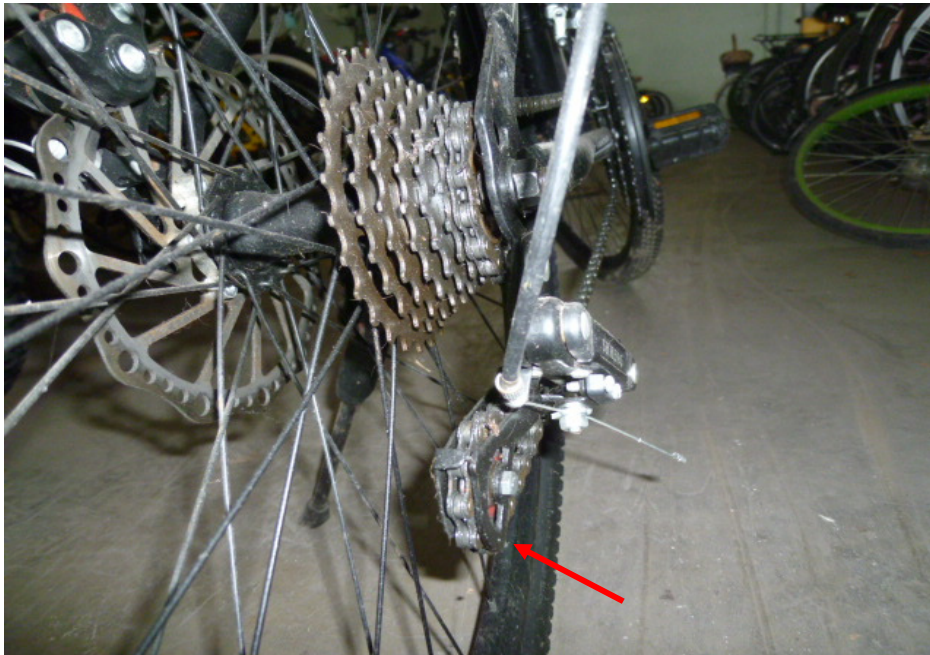
Photo 16 shows a closer view of the gear train of the Bicycle, which was observed to be intact with no misalignment (arrowed). It was also adequately lubricated for operating purposes.

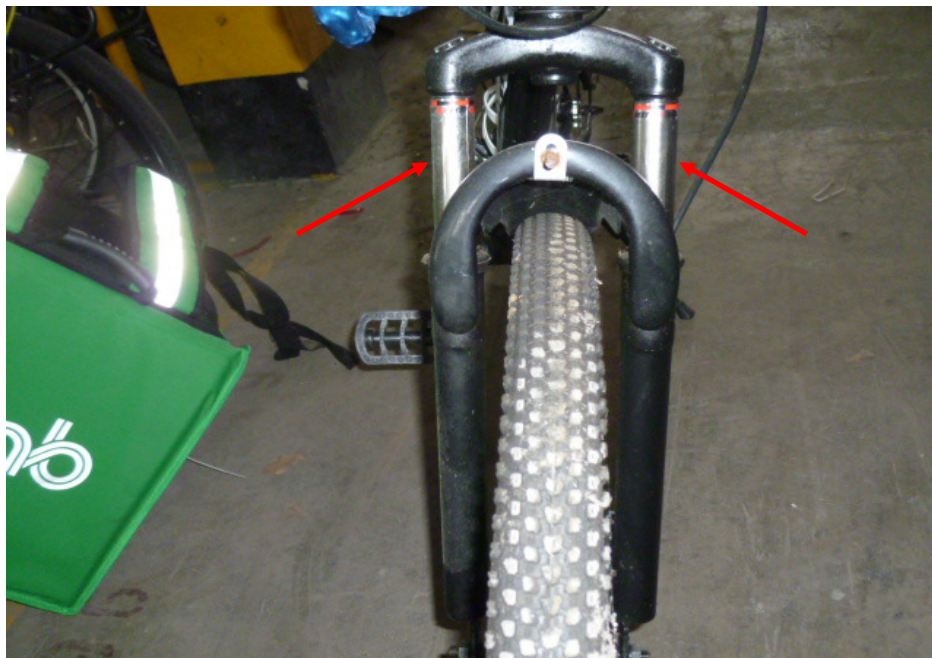
8. Our checks on the various steering components of the Bicycle revealed that its steering system was in serviceable condition. Its front fork assembly was found to be intact and undamaged. Turning the handle bar towards the left and right did not produce any abnormal free play and/or resistance.

Photo 17 shows the front fork assembly (arrowed) of the Bicycle. The front forks and fork bracket of the Bicycle were both found to be intact and undamaged. Turning the Bicycle's handle bar towards the left and right did not produce any abnormal free play. The steering system of the Bicycle was in serviceable condition at the time of our inspection.

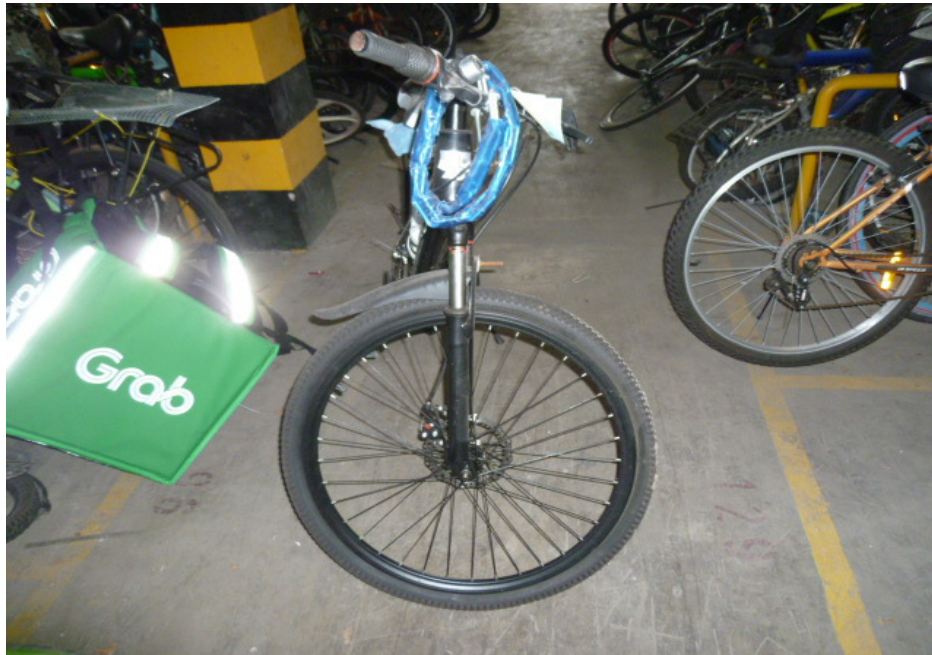
Photo 18 shows the front wheel of the Bicycle turned towards its full left. Turning the Bicycle's handle bar towards the left did not produce any abnormal free play and/or resistance. This would indicate that the steering system of the Bicycle was in serviceable condition at the time of our inspection.

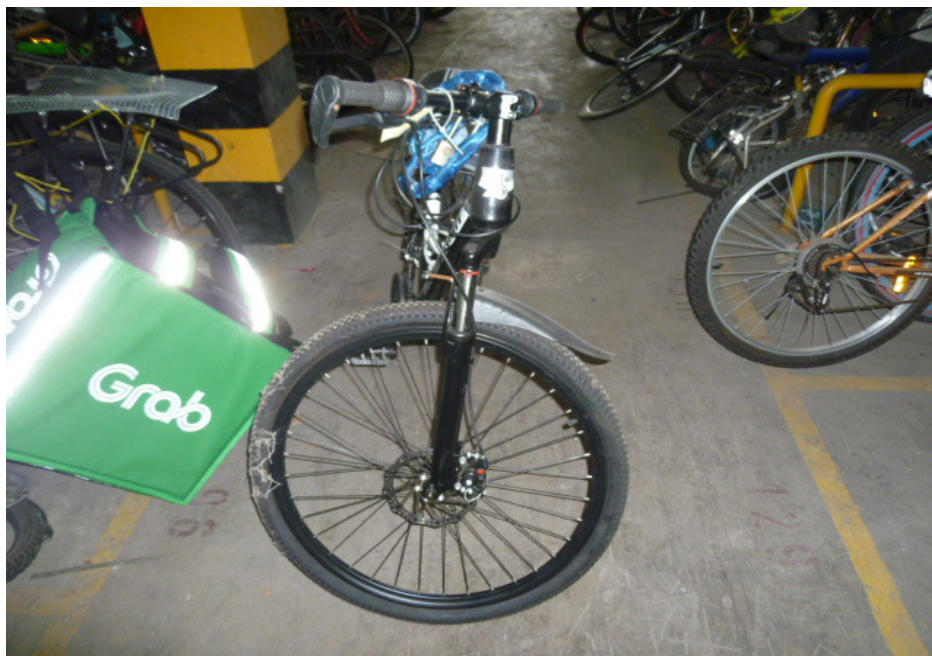
Photo 19 shows the front wheel of the Bicycle turned towards its full right. Turning the Bicycle's handle bar towards the right did not produce any abnormal free play and/or resistance. This would indicate that the steering system of the Bicycle was in serviceable condition at the time of our inspection.

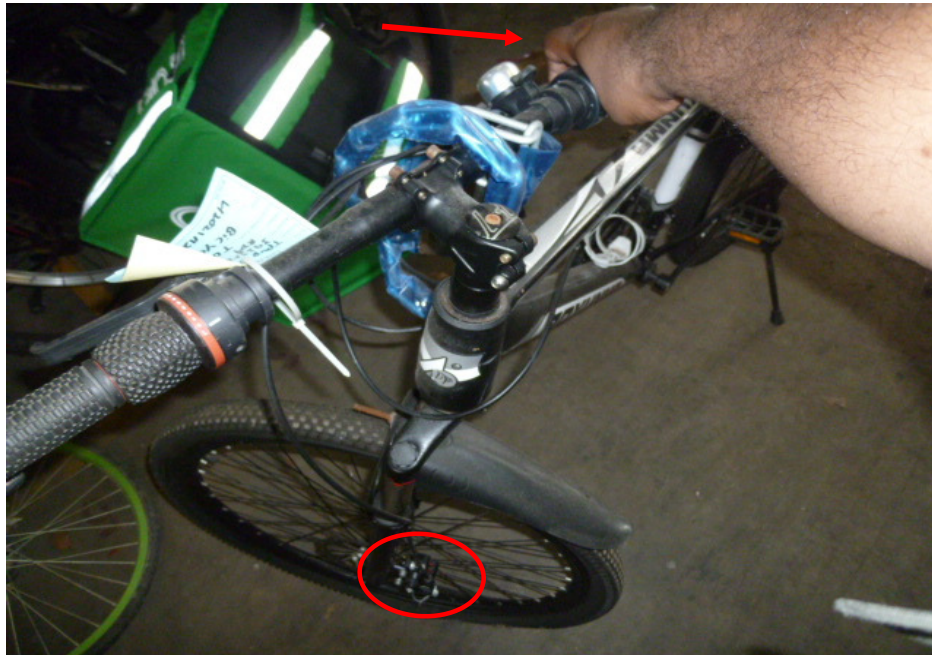
10. A static brake test was conducted on the front brake of the Bicycle. There was some resistance felt upon pressing the right hand brake lever. This was further confirmed by looking at the front brake pads while we pressed the right hand brake lever. It shows that the front brake pads responded to the gripping action. The front brake pads pressed against the front brake disc. This had appeared to indicate that the front brake of the Bicycle was in serviceable condition.

Photo 20 shows a static brake test conducted on the Bicycle's front brake. There was some resistance felt upon pressing the right hand brake lever (arrowed). It also shows that the front brake pads responded to the gripping action (circled) after depressing the right hand brake lever.

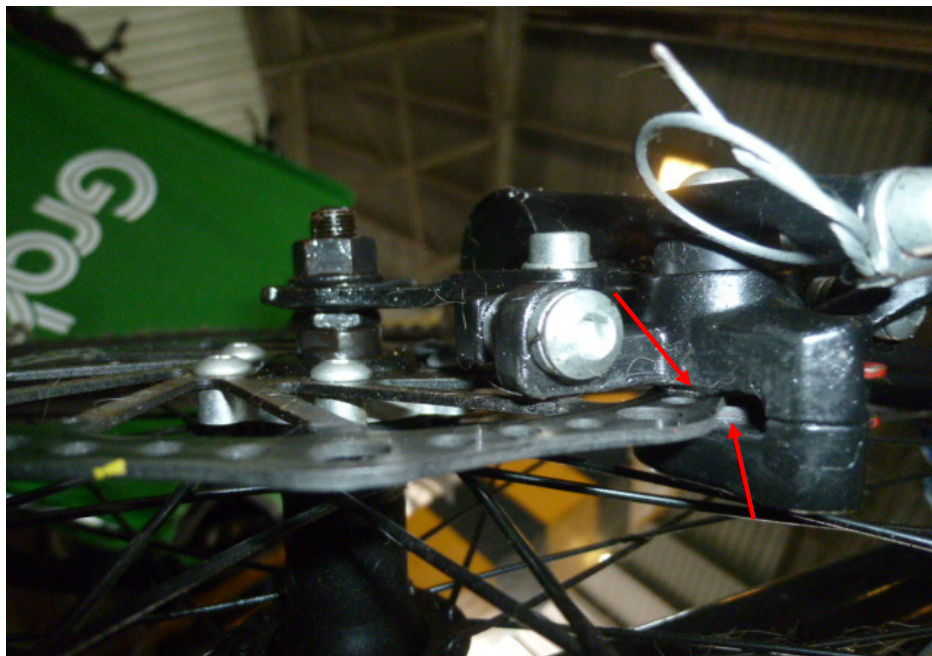
Photo 21 shows a close up view of the front brake pads responding to the gripping action. The front brake pads pressed against the front brake disc (arrowed) upon depressing the right hand brake lever. This had appeared to indicate that the front brake of the Bicycle was in serviceable condition.

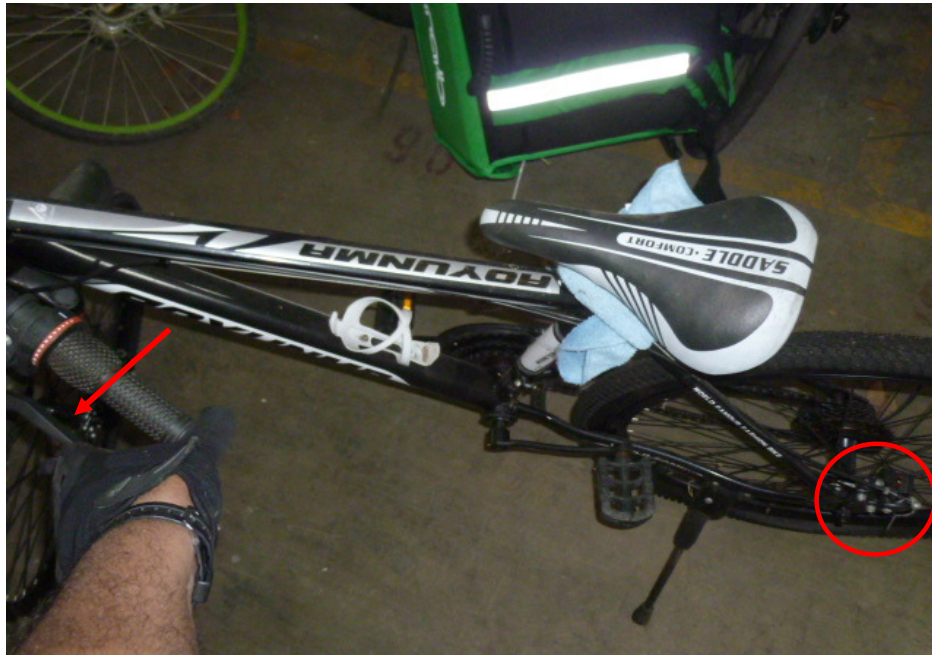
11. A static brake test was conducted on the rear brake of the Bicycle. There was some resistance felt upon pressing the left hand brake lever. This was further confirmed by looking at the rear brake pads while we pressed the left hand brake lever. It shows that the rear brake pads responded to the gripping action. The rear brake pads pressed against the rear brake disc. This had appeared to indicate that the rear brake of the Bicycle was in serviceable condition.

Photo 22 shows a static brake test conducted on the Bicycle's rear brake. There was some resistance felt upon pressing the left hand brake lever (arrowed). It also shows that the rear brake pads responded to the gripping action (circled) after depressing the left hand brake lever.

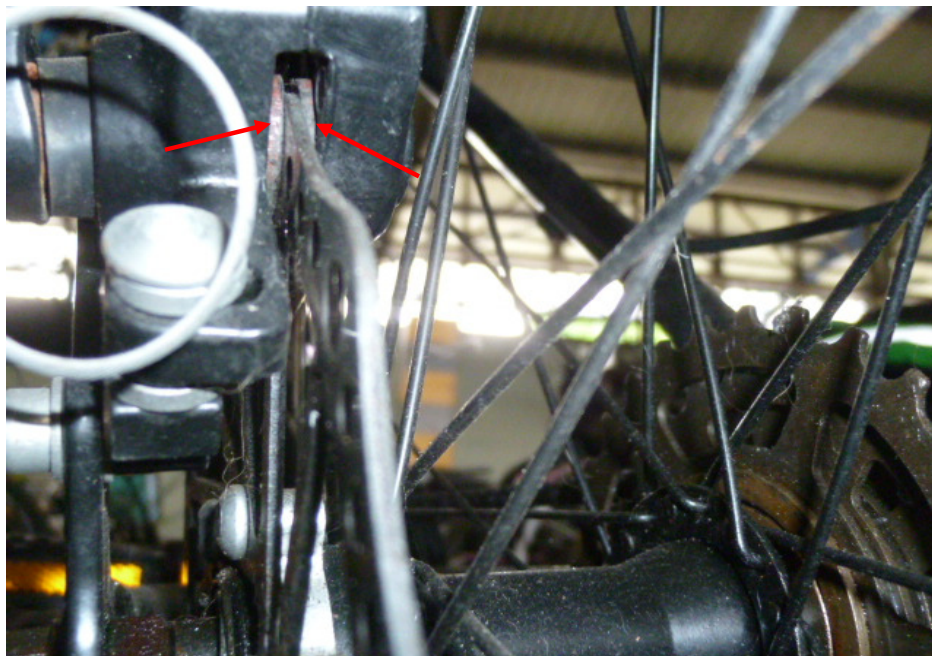
Photo 23 shows a close up view of the rear brake pads responding to the gripping action. The rear brake pads pressed against the rear brake disc (arrowed) upon depressing the left hand brake lever. This had appeared to indicate that the rear brake of the Bicycle was in serviceable condition.
