Your Ref: TP/IP/04581/2022
Our Ref : CI/TPD22004870/N

Fatal Accident Investigation Team

**INSPECTION REPORT OF BICYCLE (ORANGE) - TRAFFIC POLICE POUND
REPORT NO. 0720/22**

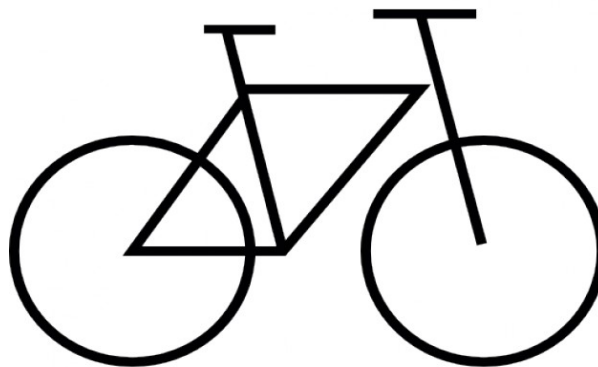
5. The condition of the Bicycle's front & rear tyres was observed to be in serviceable condition. The tread pattern of the 2 tyres was clearly visible. We did not observe any tear, burst mark(s) and/or punctured hole(s) on the sidewalls as well as across the tread of the 2 tyres. The front tyre was observed to be sufficiently inflated for vehicular operation. However the rear tyre was observed to be deflated as a result of the accident. The tyre brand, tyre size and remaining tread depth of the 2 tyres were recorded as follows:-

Cheng Shin Tyre (26 x 1.95 / 50 - 559)
(Deflated)

Cheng Shin Tyre (26 x 1.75)
(Deflated)
