Your Ref: TP/IP/10567/2022
Our Ref : CI/TPD22005080/P

Fatal Accident Investigation Team

MECHANICAL INSPECTION REPORT OF MOTOR BUS SG 6122E

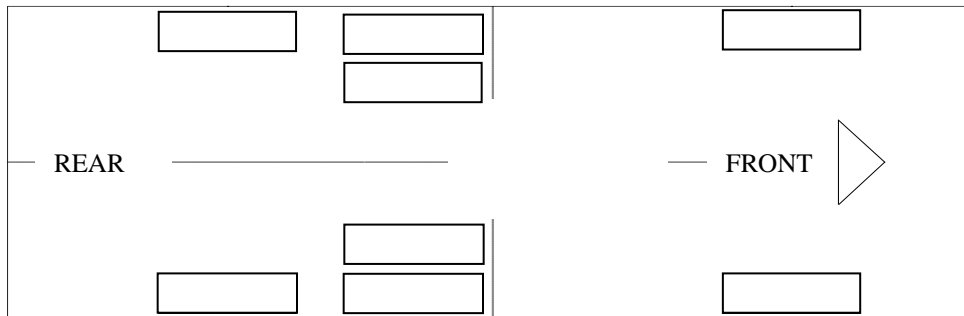
6. The 2 front tyres and 6 rear tyres of the Motor Bus were observed to be in serviceable condition and sufficiently inflated for vehicular operation. I did not find any tear, cut or burst mark(s) on the outer and the inner sidewalls as well as across the tread of the 8 tyres. The tyre brand, tyre size and remaining tread depth of the 8 tyres of the Motor Bus were recorded as follows:-

Goodyear 275/70R22.5 (14.4mm)

Firenza 275/70R22.5 (14.7mm)

Falken 275/70R22.5 (14mm)

Firenza 275/70R22.5 (14mm)
