Your Ref: TP/IP/05078/2022  
Our Ref : CI/TPD22005083/P

### **Fatal Accident Investigation Team**

### **MECHANICAL INSPECTION REPORT OF MOTOR CAR SFF 319D**

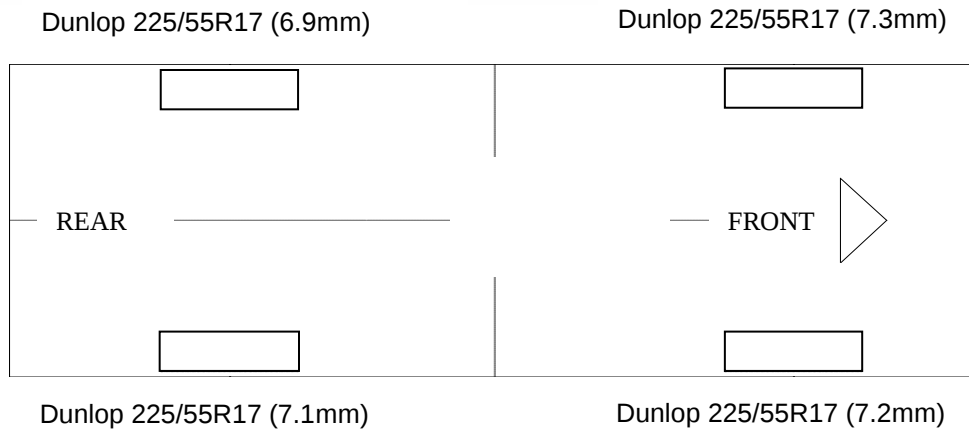
6. The 4 tyres of the Motor Car were observed to be in serviceable condition and sufficiently inflated for vehicular operation. I did not find any tear, cut or burst mark(s) on the outer and the inner sidewalls as well as across the tread of the 4 tyres. The tyre brand, tyre size and remaining tread depth of the 4 tyres of the Motor Car were recorded as follows:-
