Your Ref: TP/IP/07067/2021  
Our Ref : CI/TPD22005250/N

**Fatal Accident Investigation Team**

**INSPECTION REPORT OF MOTORCYCLE FBQ 4093J**

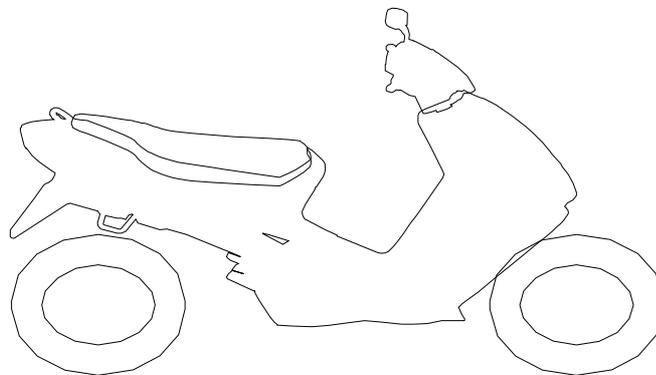
6. The condition of the Motorcycle's 2 tyres was observed to be in serviceable condition. The tread pattern of the 2 tyres was clearly visible. We did not observe any tear, burst mark(s) and/or punctured hole(s) on the sidewalls as well as across the tread of the 2 tyres. The 2 tyres were both observed to be sufficiently inflated for vehicular operation. The tyre brand, tyre size and remaining tread depth of the 2 tyres were recorded as follows:-

Cheng Shin Tire 140/70 - 14 (5mm)

Cheng Shin Tire 110/80 - 14 (5mm)
