## LKK Auto Consultants Pte Ltd

| Affiliated to Federation Internationale Des Experts En Automobile | | | | |
|---|---|---|---|--|
| <b>1. Policy Particulars :- THIRD PARTY CLAIM</b> | | | | |

## ADJUSTMENT ON REPAIR COST FOR VEHICLE NO. SHC 4500L

PHOTOGRAPHS FOR VEHICLE NO. SHC 4500L

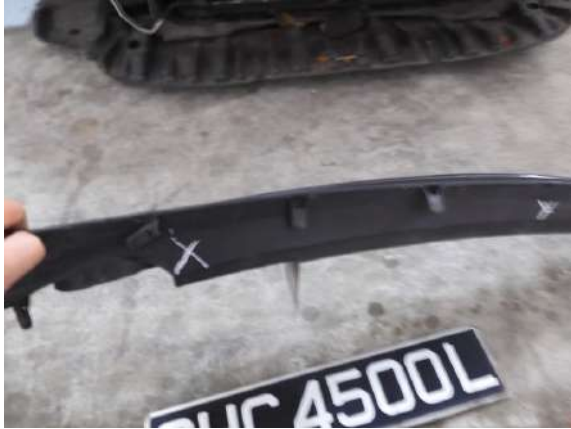
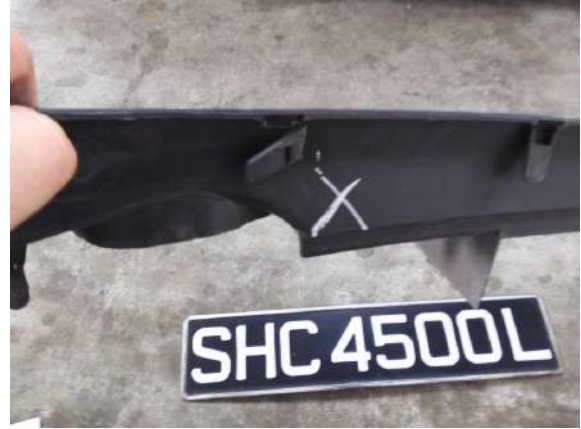
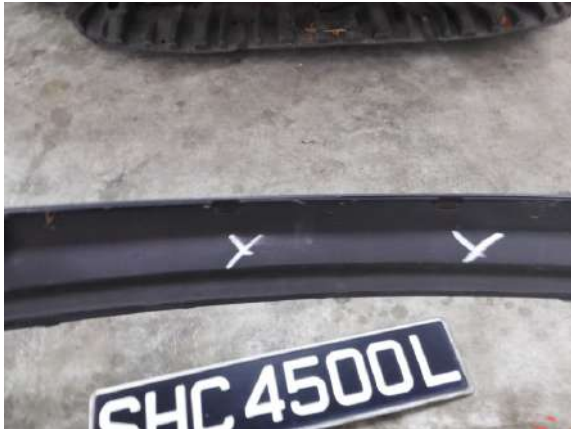
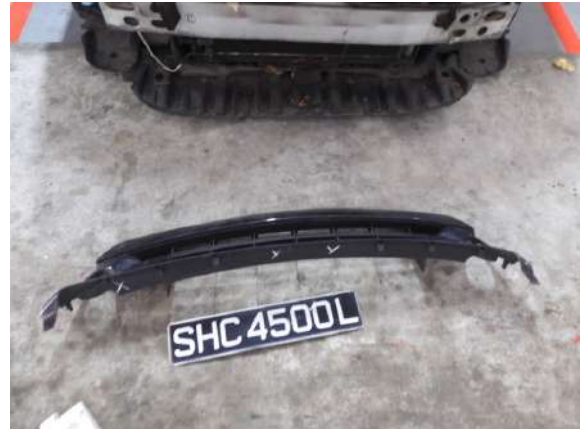
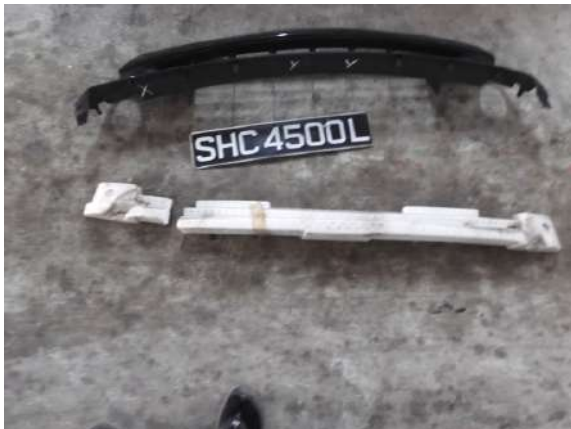
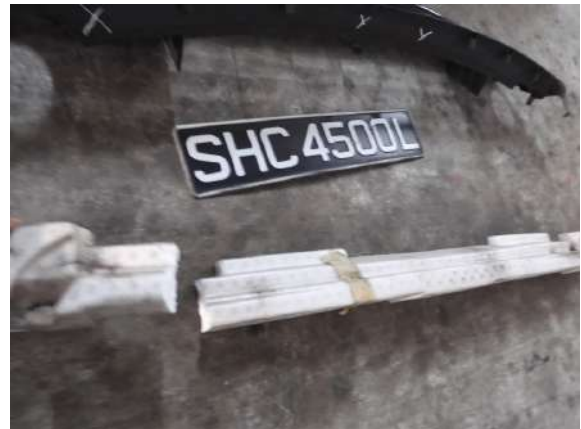
PHOTOGRAPHS FOR VEHICLE NO. SHC 4500L

| Affiliated to Federation Internationale Des Experts En Automobile | | | | |
|---|---|---|---|--|
| THE VEHICLE SUSTAINED DAMAGES AT THE FRONT PORTION.<br>DAMAGES SEE DETAILS. | | | | |
