Our Reference : KAAS/TA/6035/8480/TP/07.20
Date : 08 August 2020

VEHICLE APPRAISAL REPORT

Name of Workshop : Apex Motoring
Place of inspection : 25 Kaki Bukit Road 4 #01-55, Synergy @ Kaki Bukit, Singapore 417800
Date of Assignment : 30 July 2020
Date of Accident : 27 July 2020
Date of Inspection : 30 July 2020

Registration No.	: SMH 8480Z	Chassis Frame No.	: GB7-1086395
Make / Model	: Honda Freed Hybrid 1.5G (A)	Engine No. (Logcard)	: LEB5624179
Year of Manufacture/Reg	: 2019	Odometer Reading	: 138,026 KM
Colour	: Silver		
Class / Type	: MPV

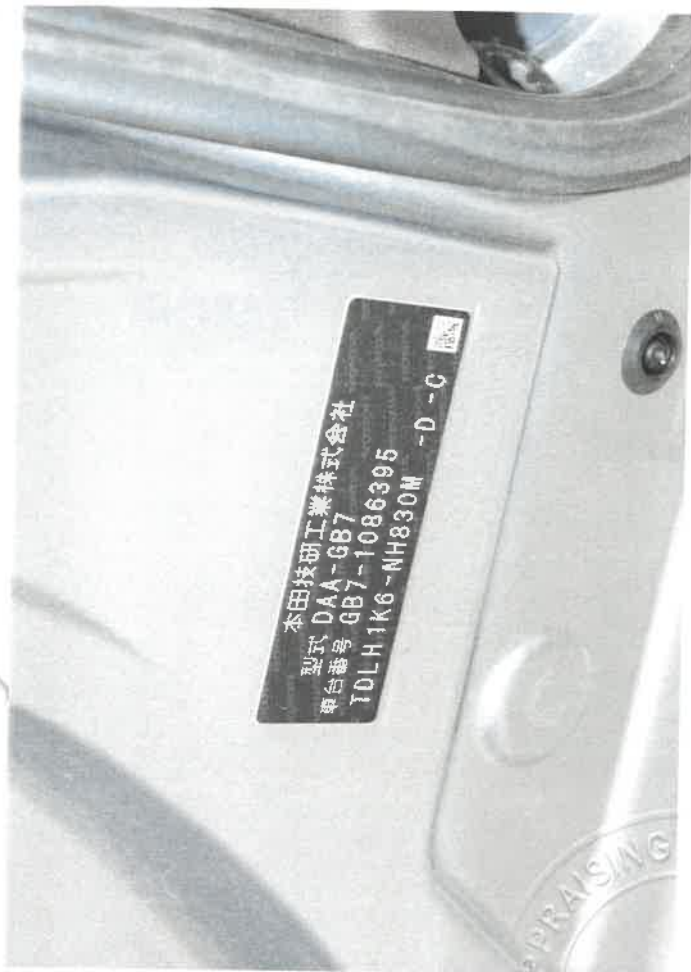
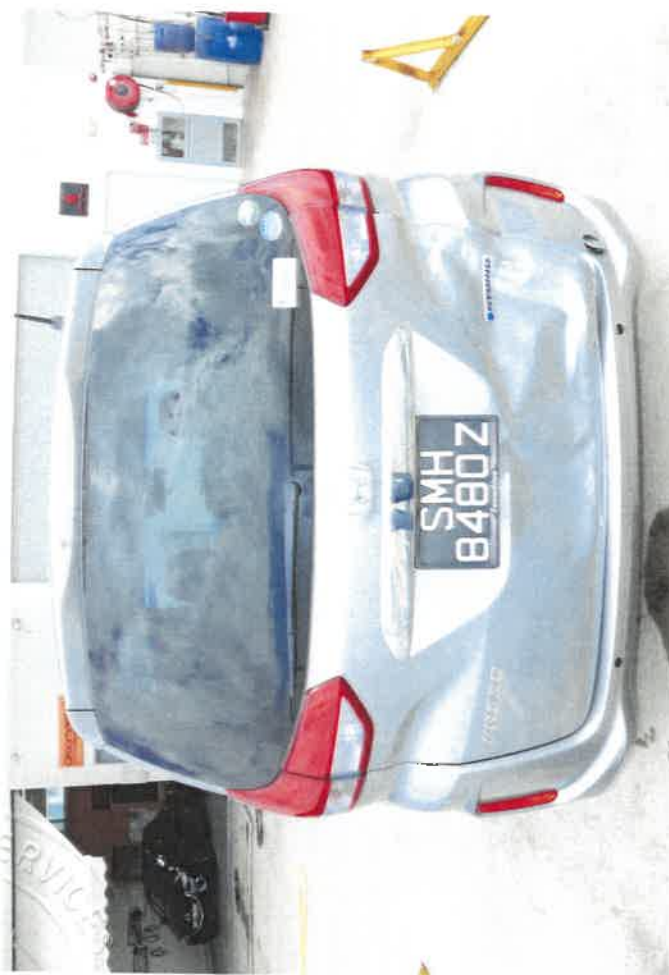
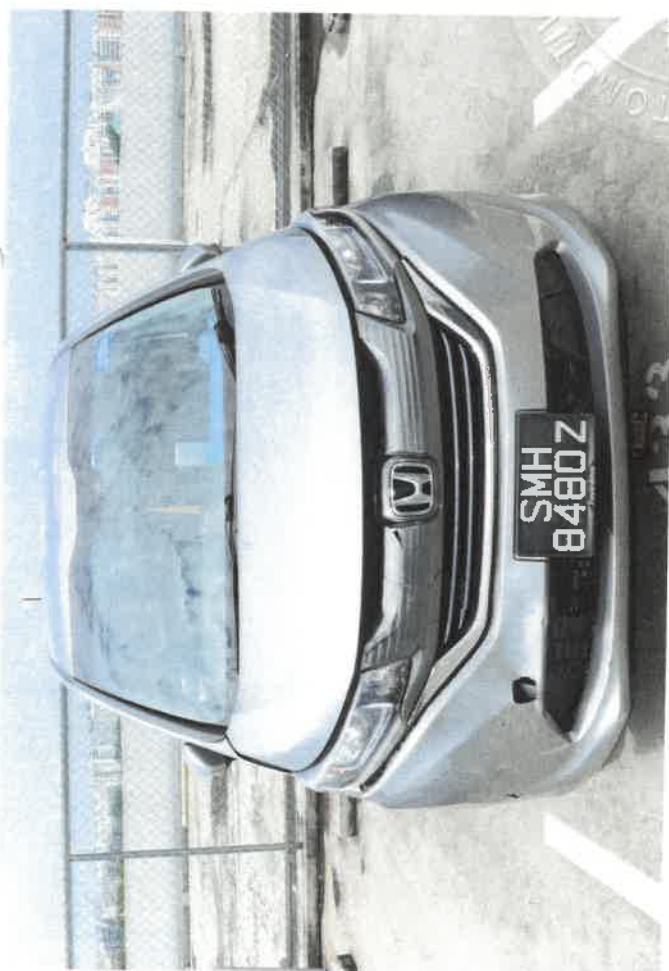
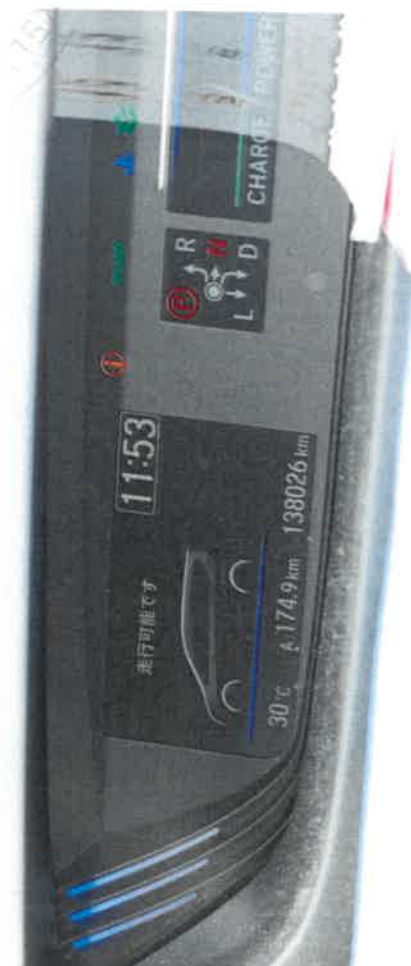
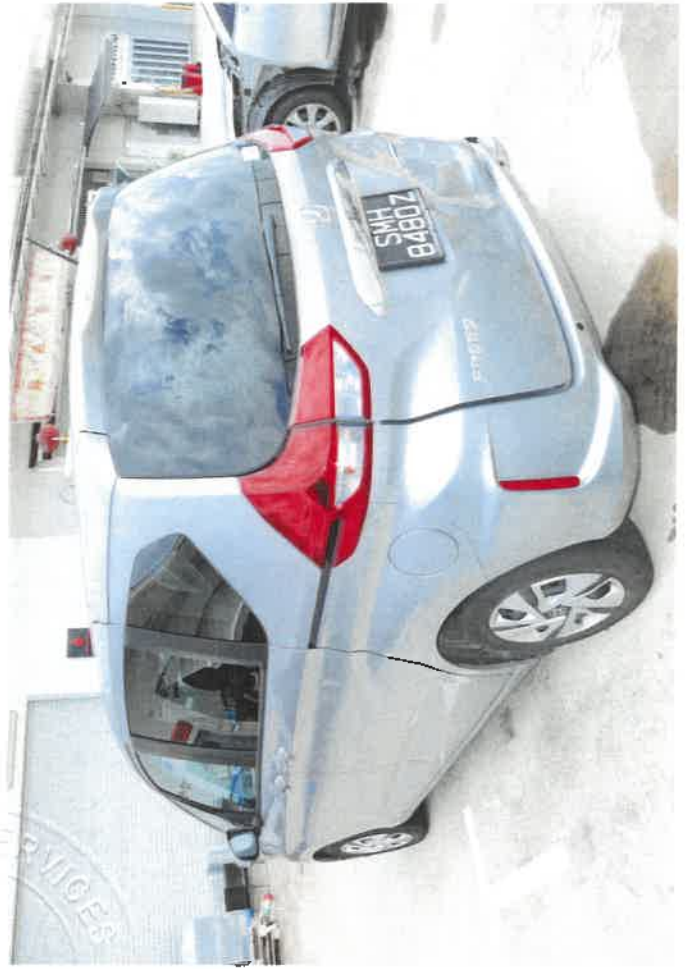
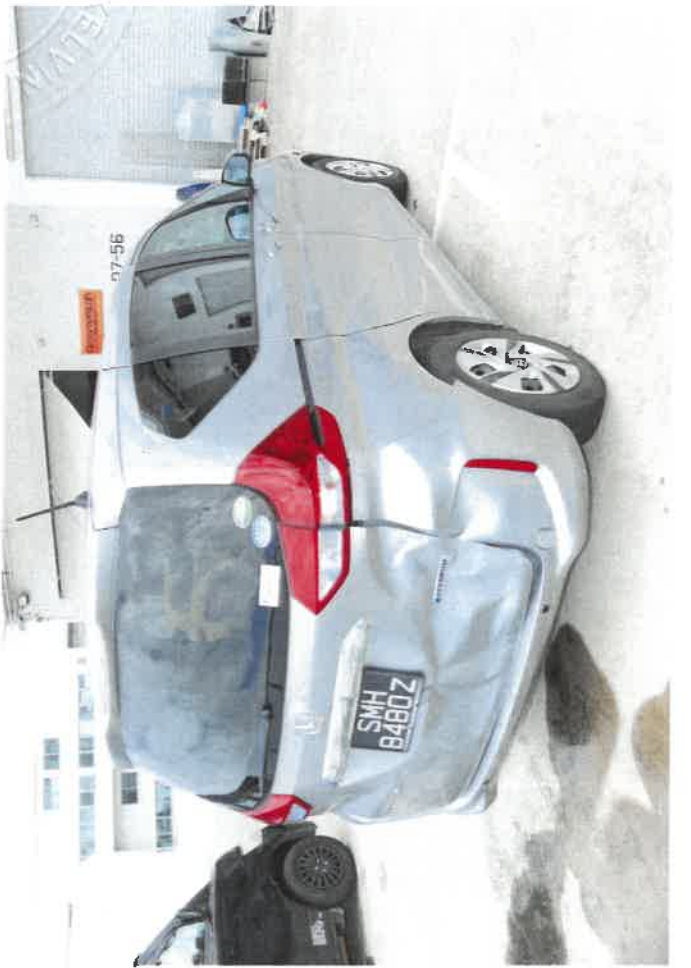
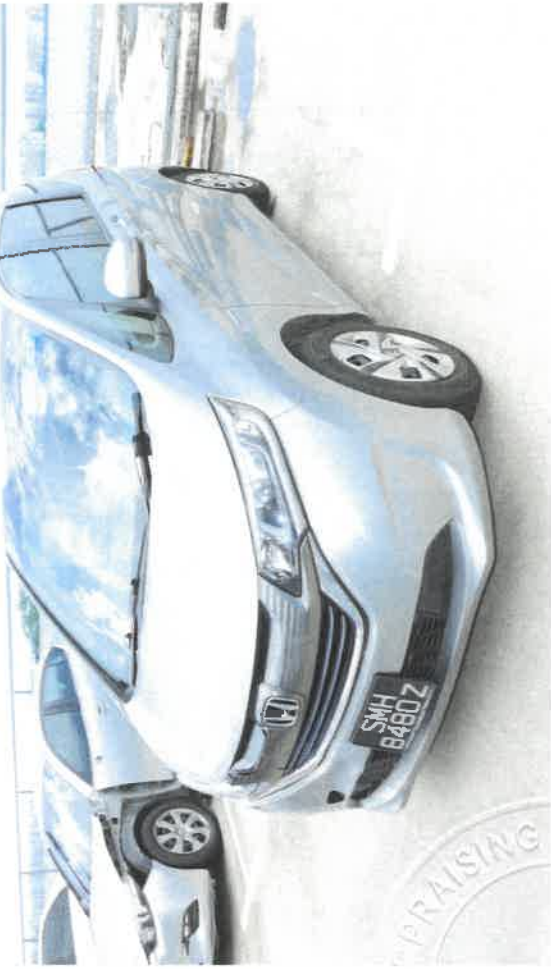
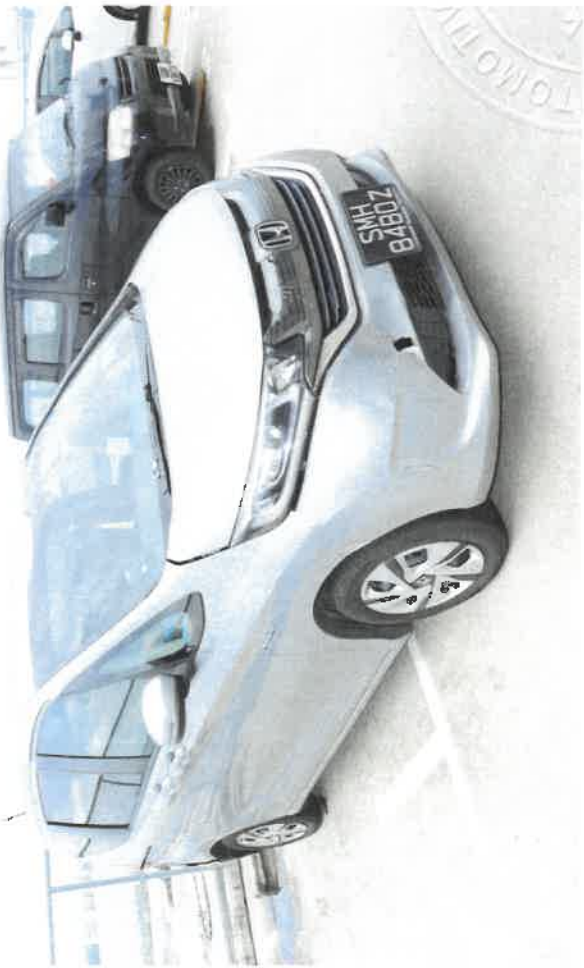
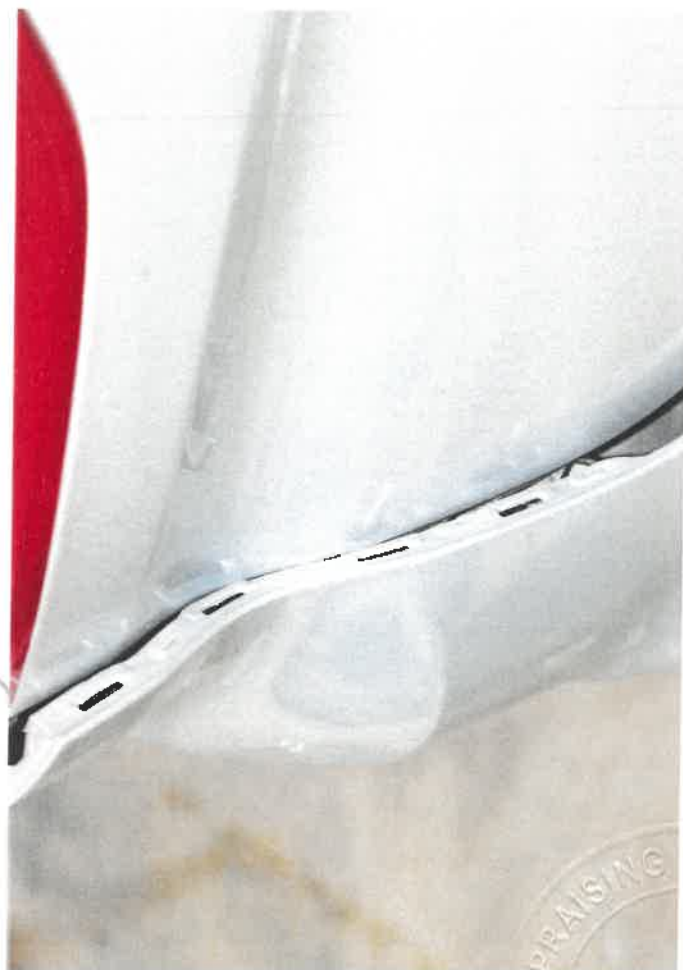
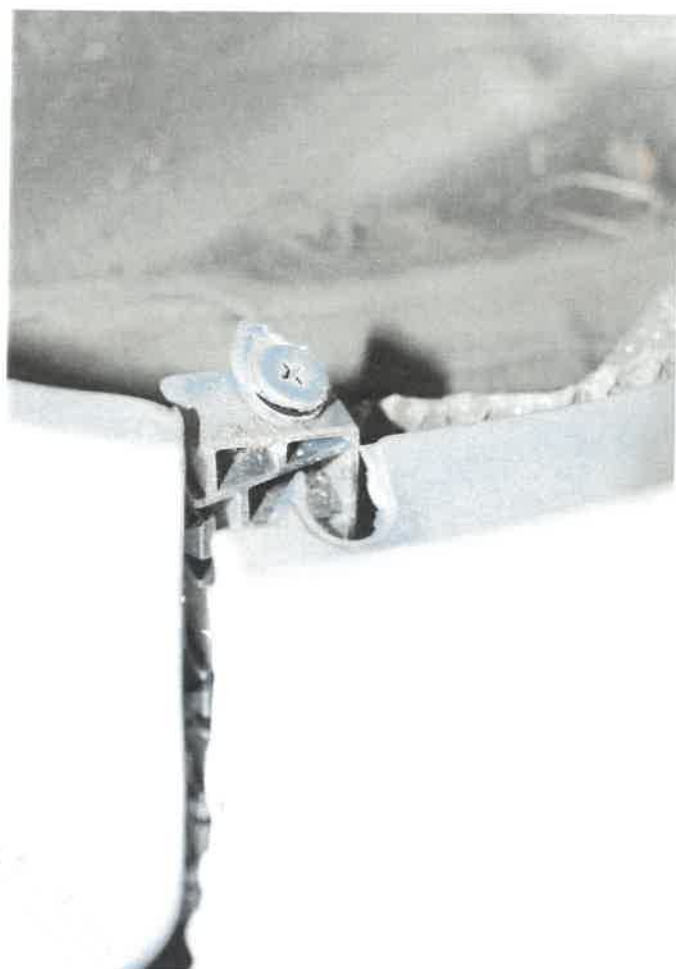
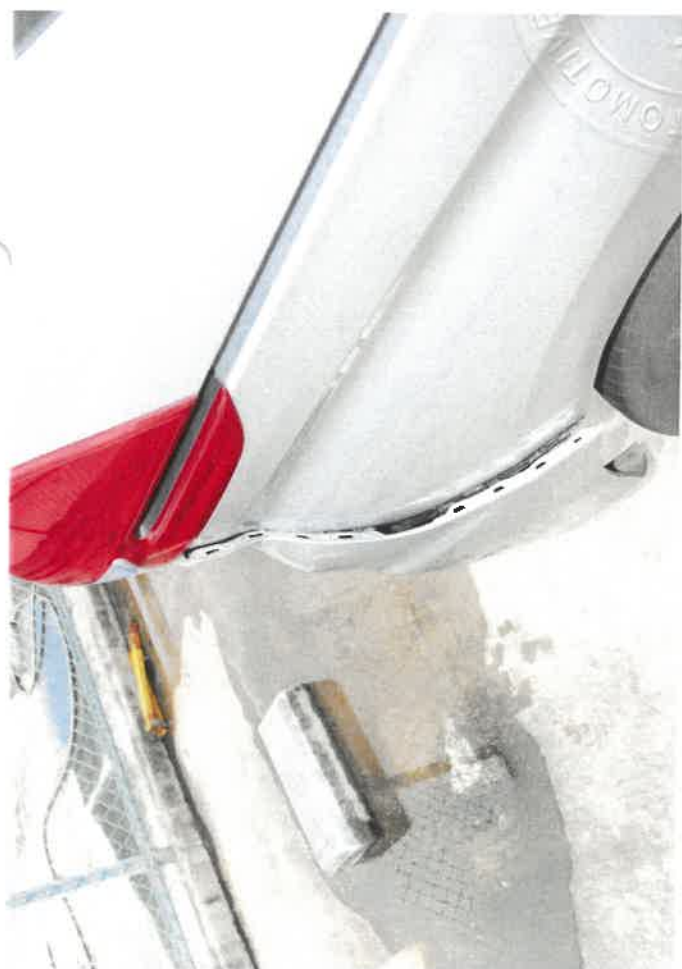
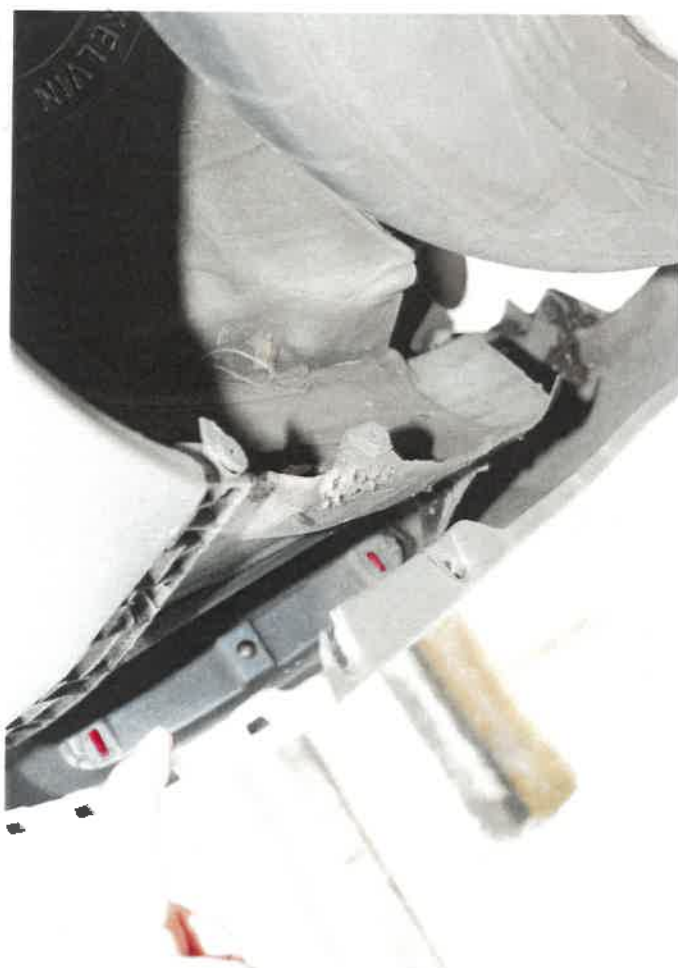
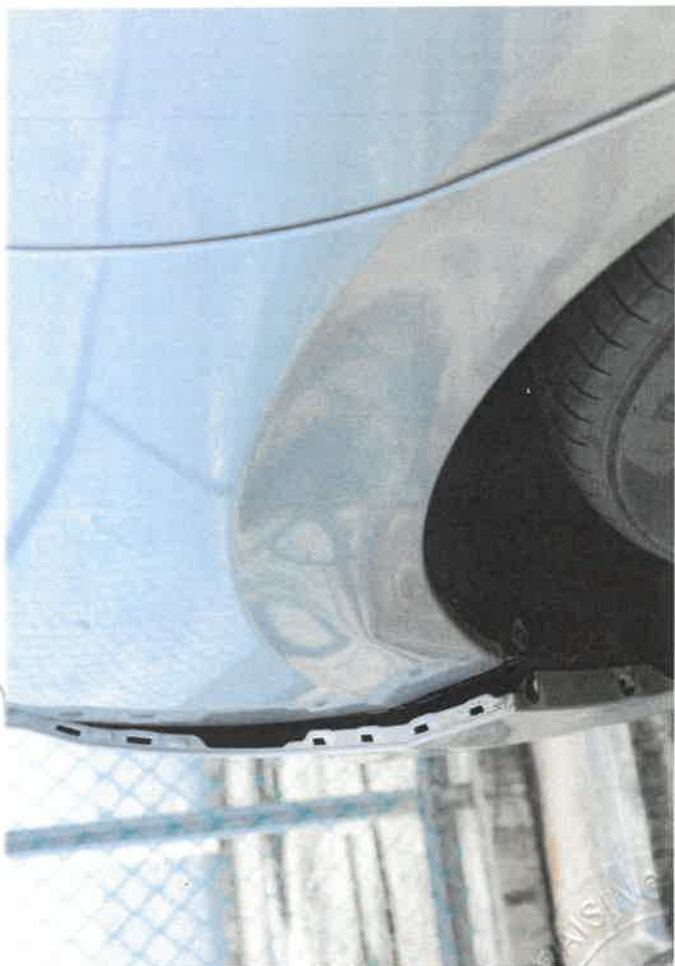
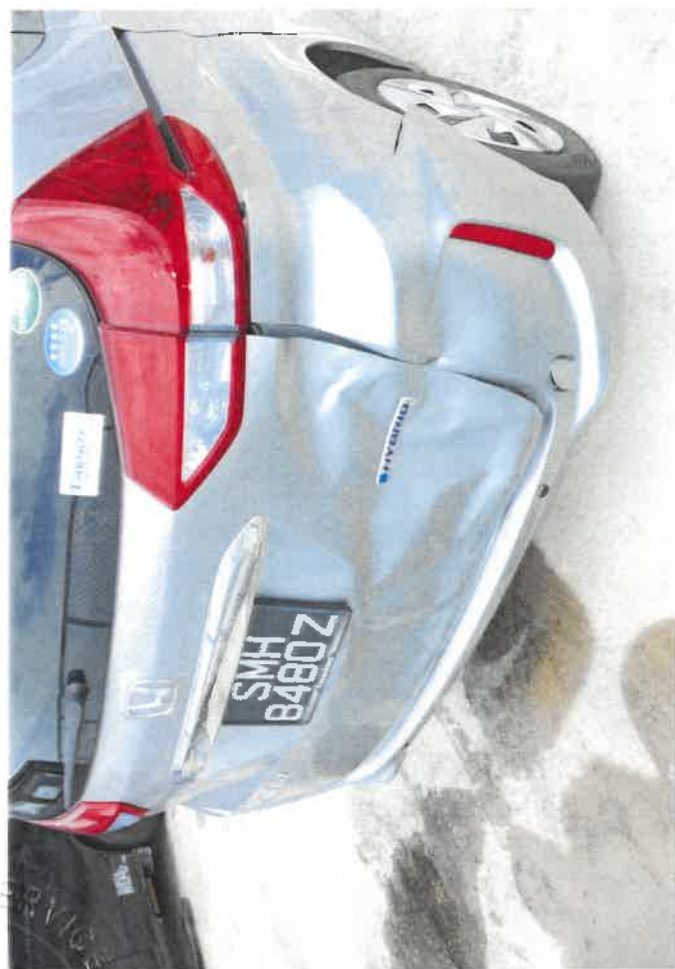
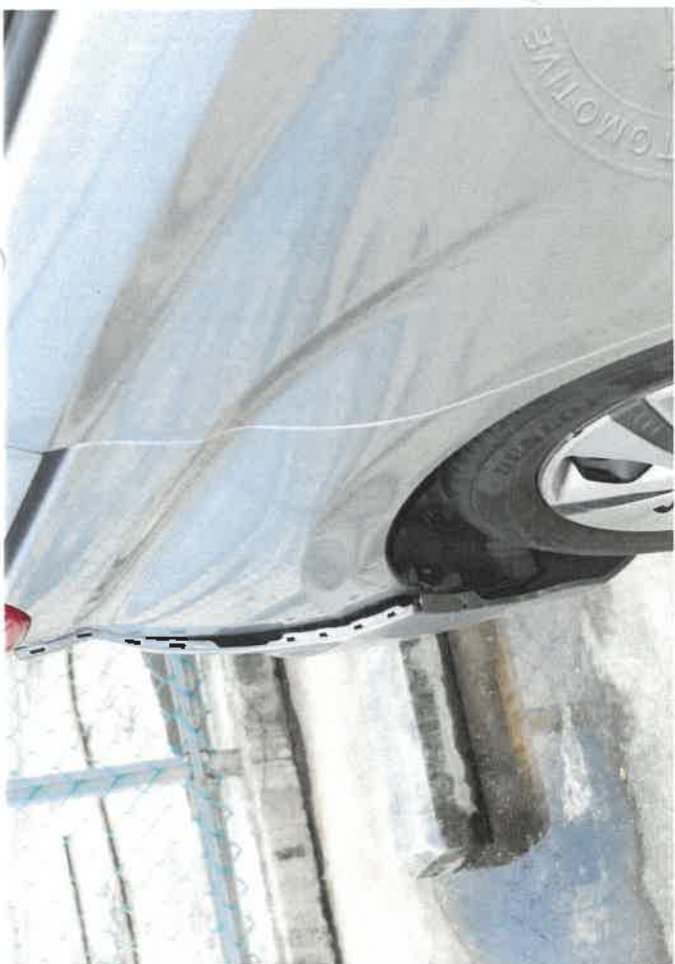
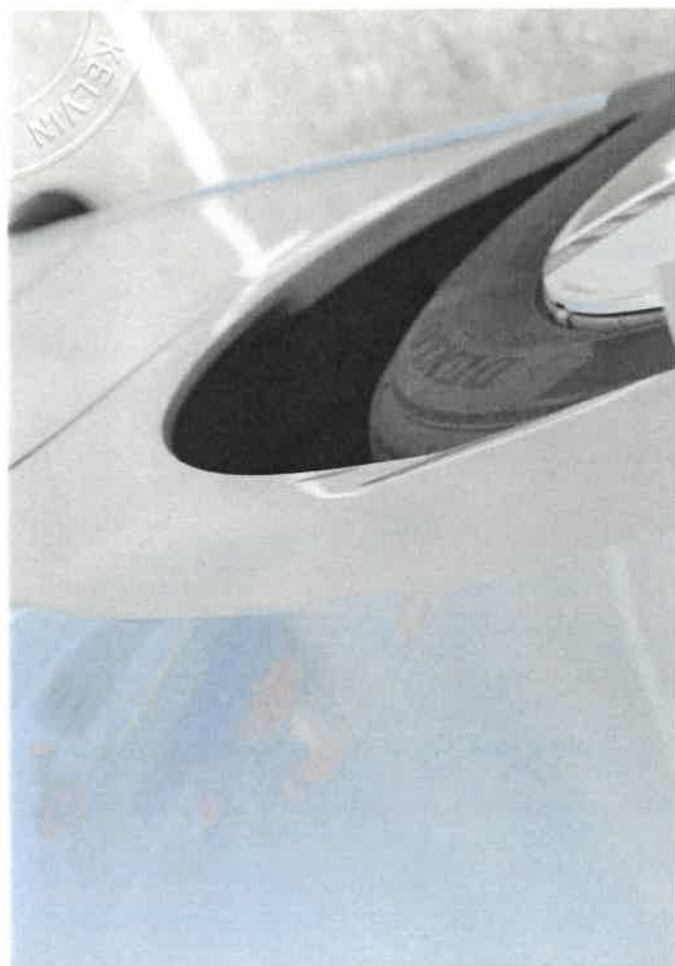
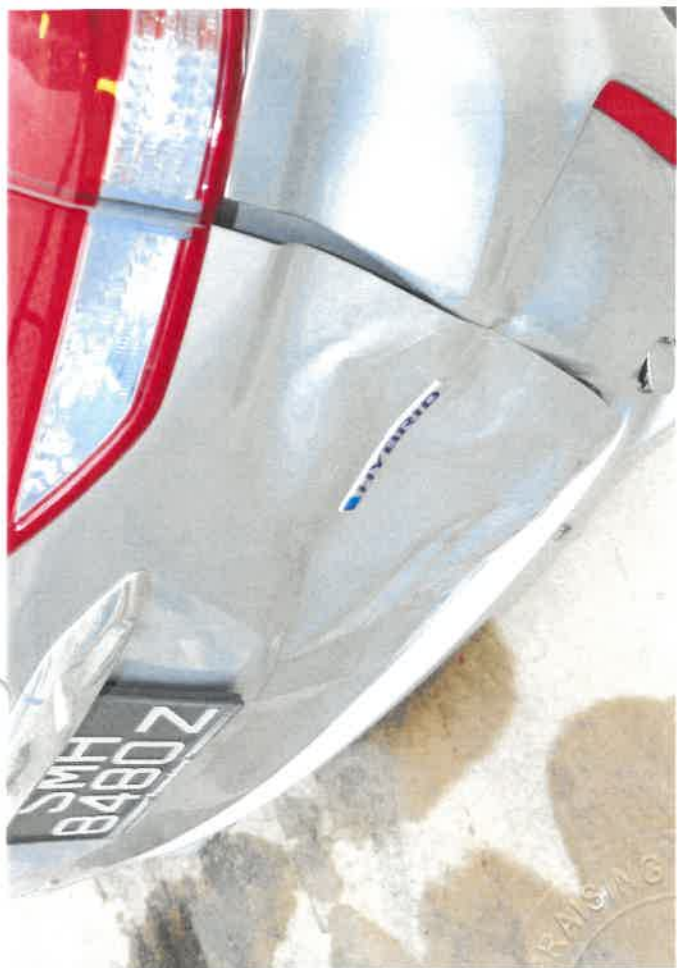
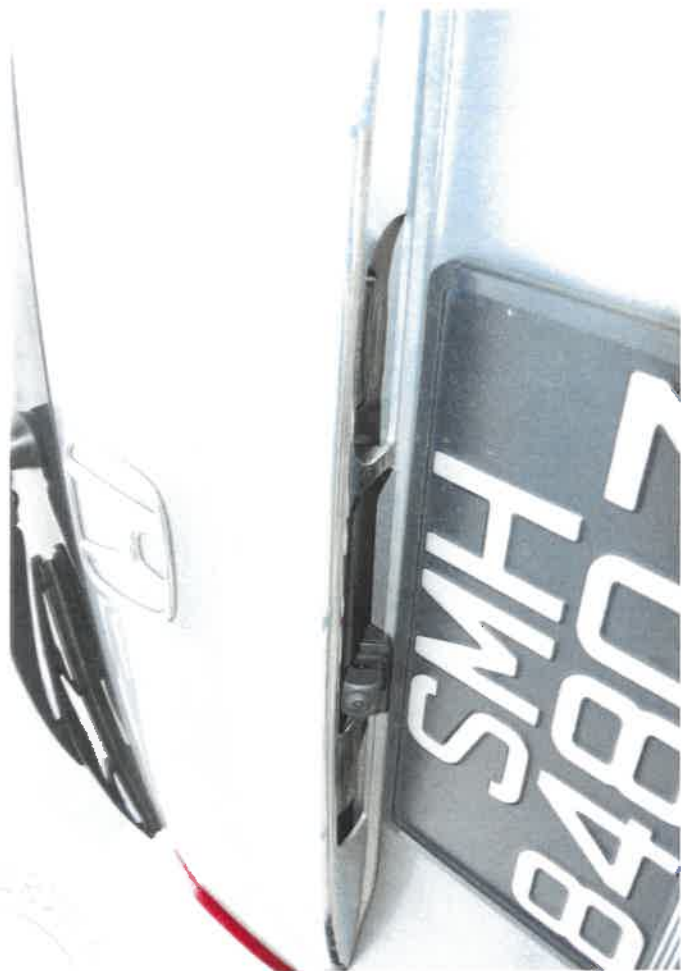
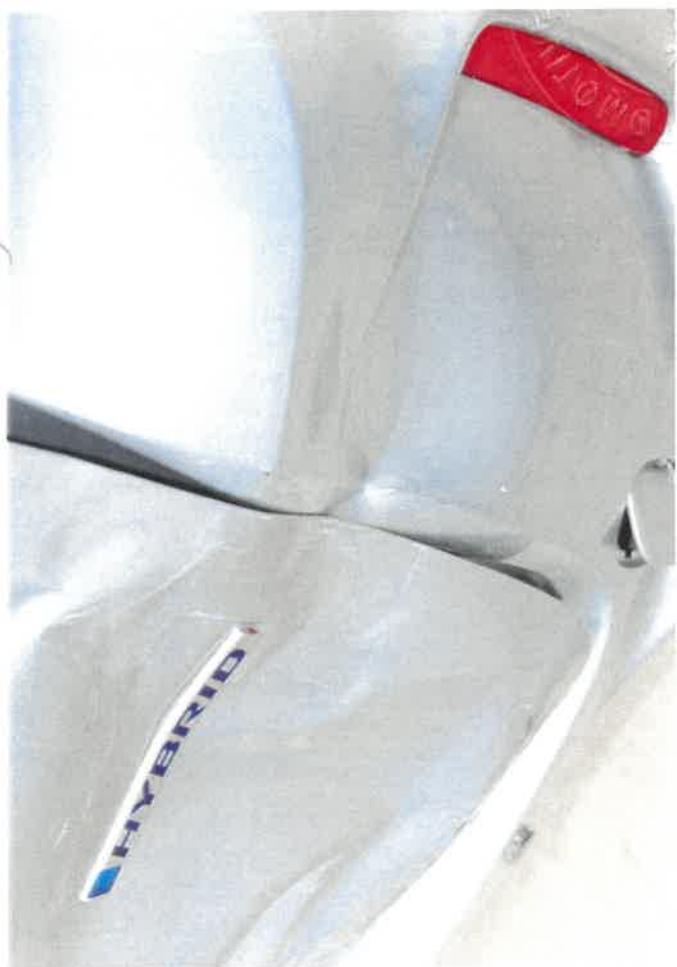
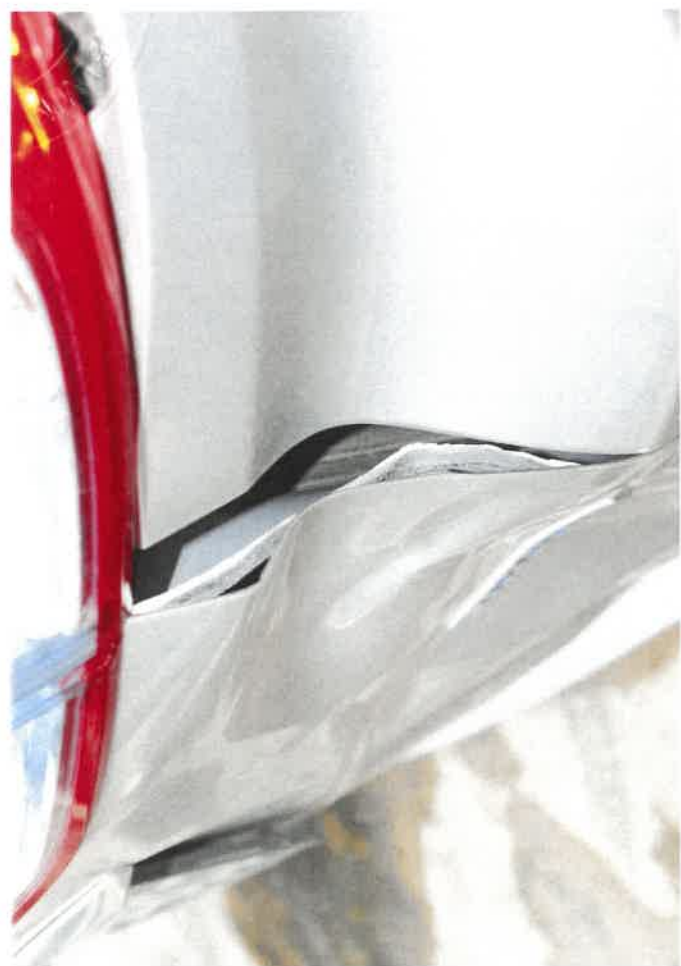
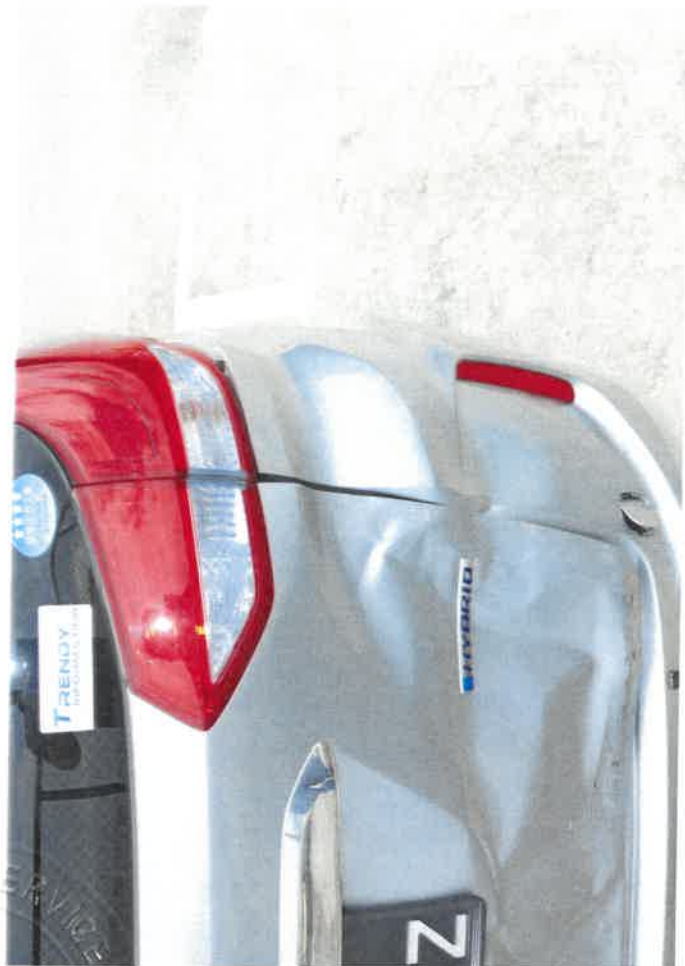
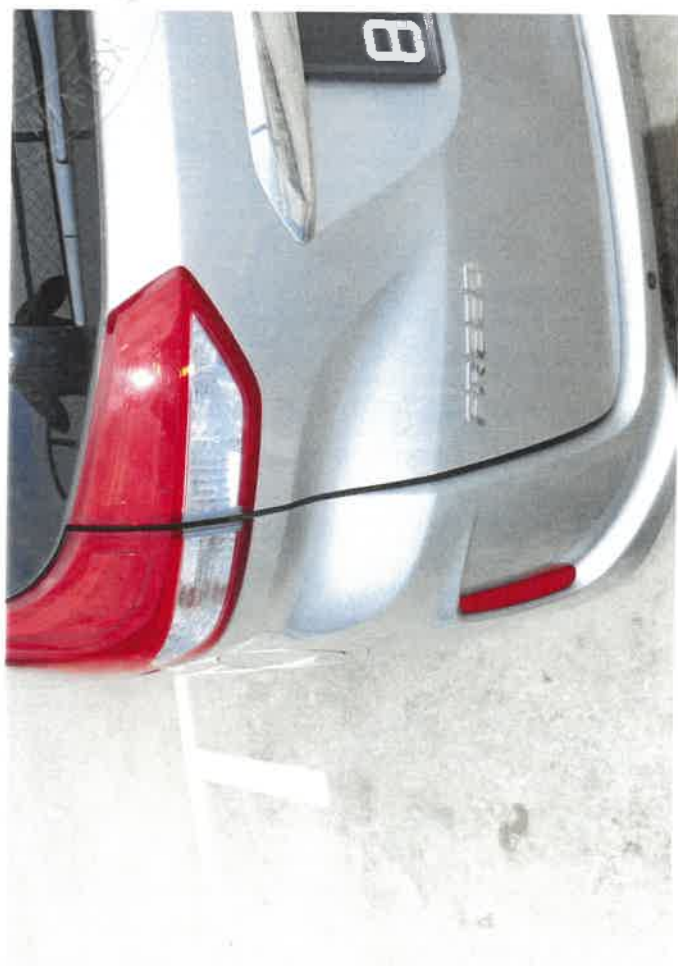
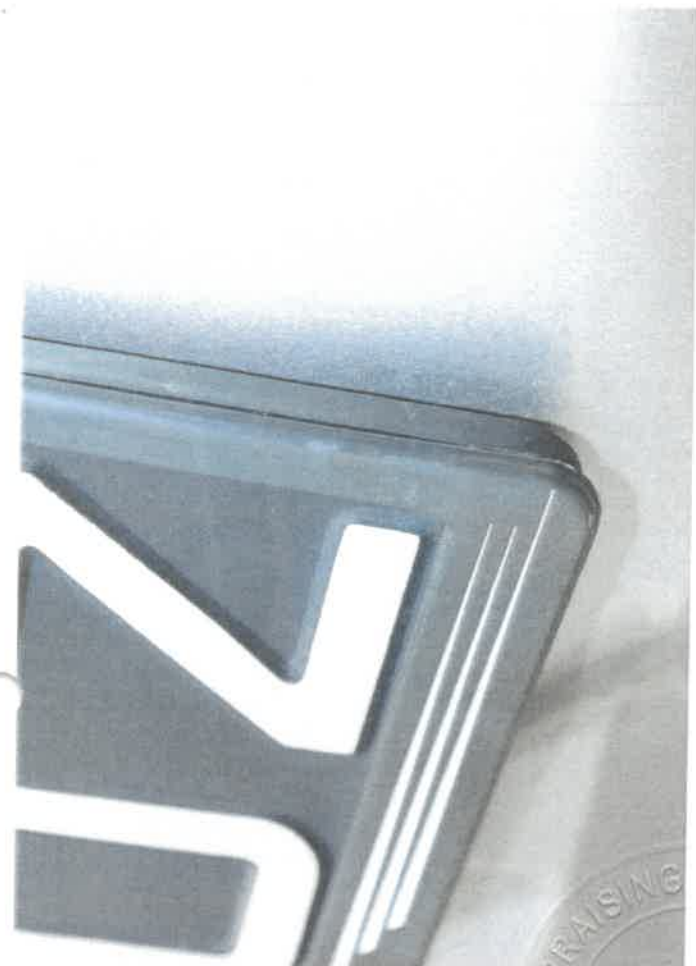
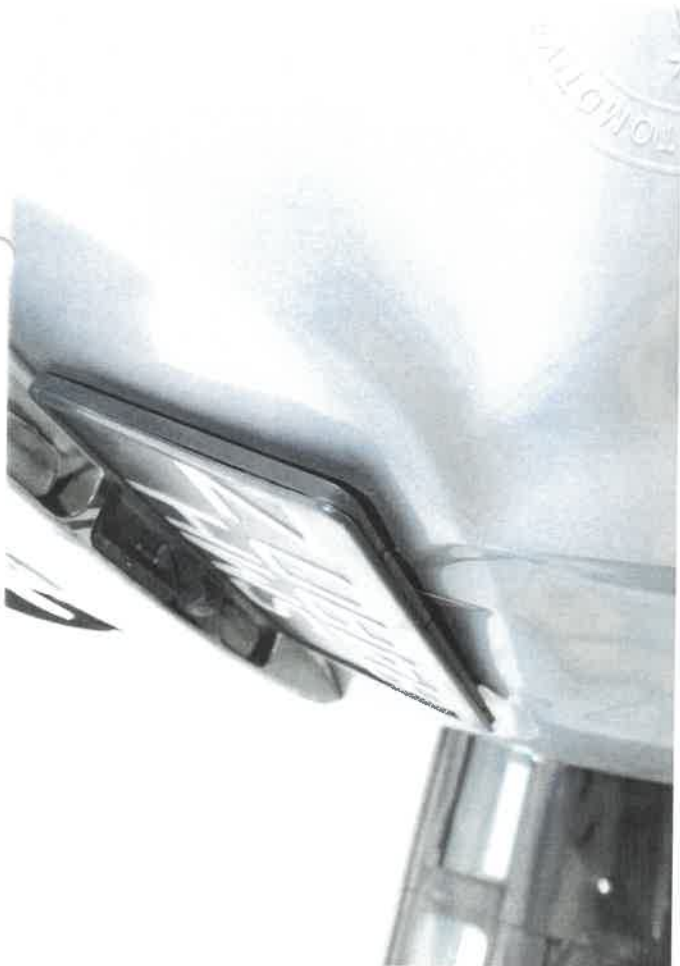
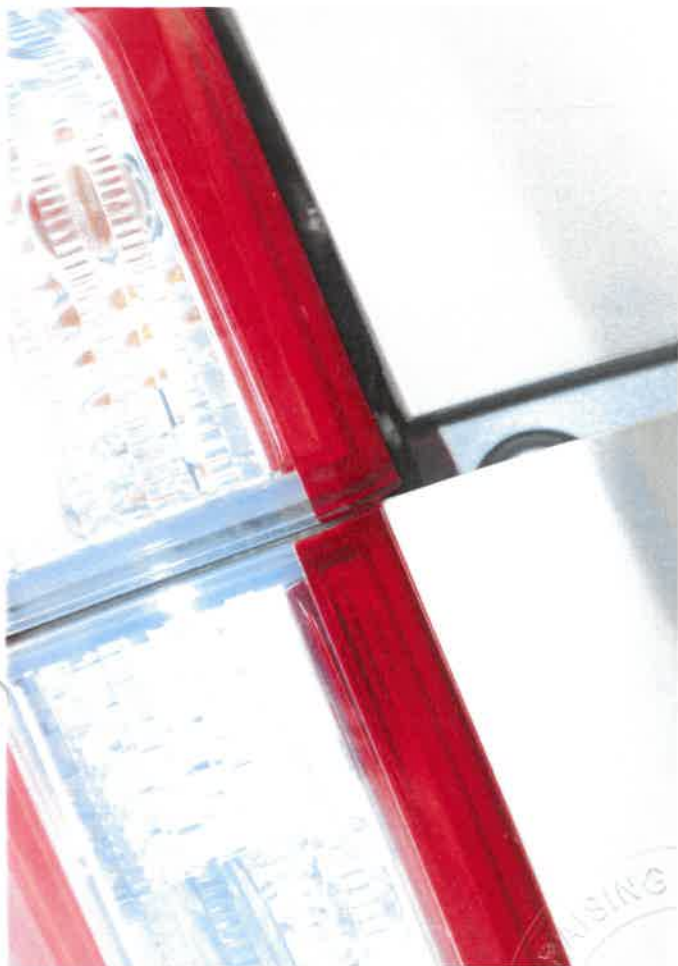
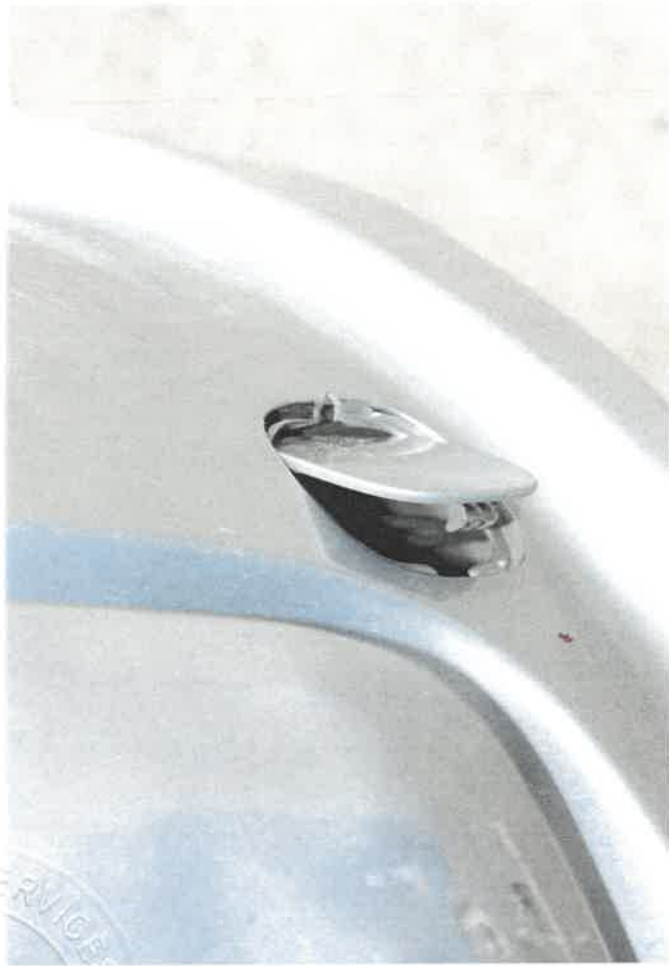
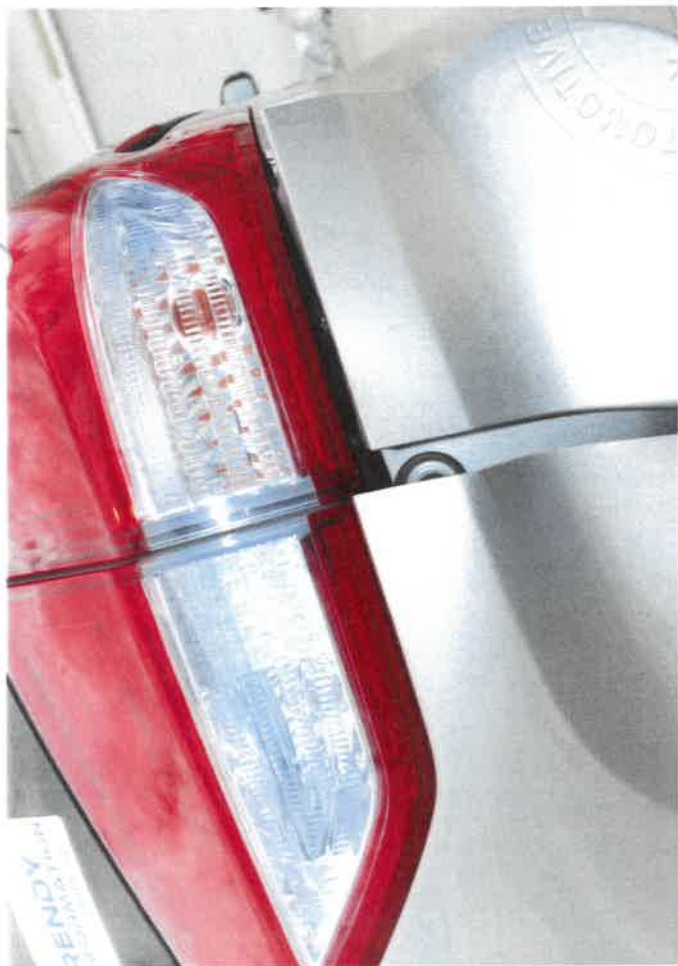
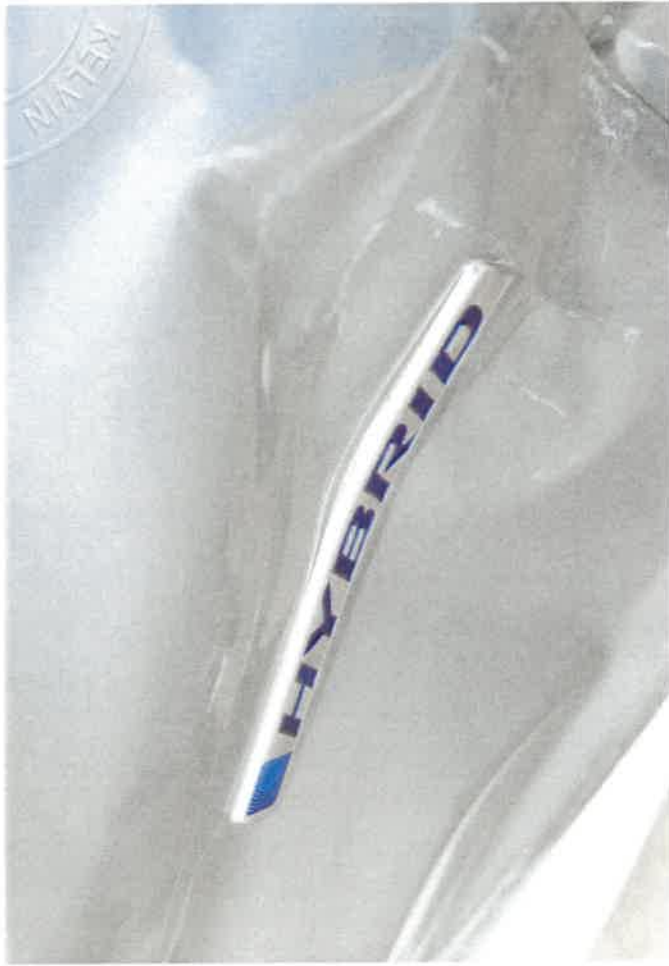
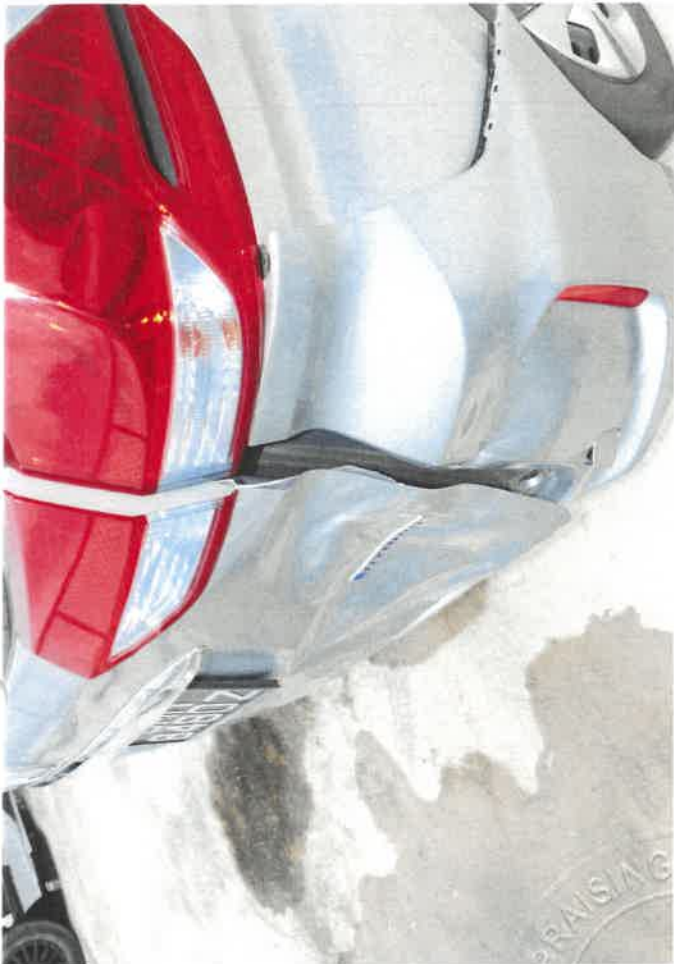
Damages sustained were consistent with the subject vehicle being involved in a collision with another vehicle and the impact was delivered

The general area of damages is at the **Front and Rear portion**
(Please refer to the parts list and photographs as attached for more information)

The estimated repair costs submitted by Messrs **Apex Motoring** is \$ 20,167.50 .
We have adjusted the cost to \$ 15,103.88 and the repairer has agreed to undertake the repairs at a
Contract Lump Sum of \$ 12,050.00 to a acceptable quality and standards.
However, we have not given authorization and instruction to the repairer to proceed with the repairs.
