Our Reference : KAAS/TA/6035/8480/TP/07.20
Date : 08 August 2020

VEHICLE APPRAISAL REPORT

Name of Workshop : Apex Motoring
Place of inspection : 25 Kaki Bukit Road 4 #01-55, Synergy @ Kaki Bukit, Singapore 417800
Date of Assignment : 30 July 2020
Date of Accident : 27 July 2020
Date of Inspection : 30 July 2020

Registration No.	: SMH 8480Z	Chassis Frame No.	: GB7-1086395
Make / Model	: Honda Freed Hybrid 1.5G (A)	Engine No. (Logcard)	: LEB5624179
Year of Manufacture/Reg	: 2019	Odometer Reading	: 138,026 KM
Colour	: Silver		
Class / Type	: MPV

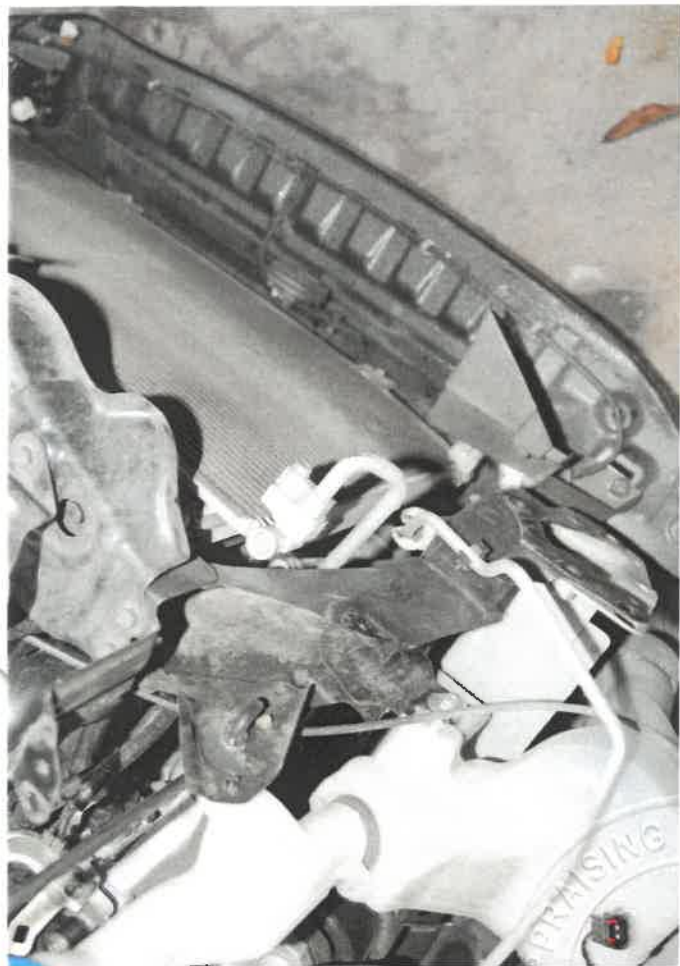
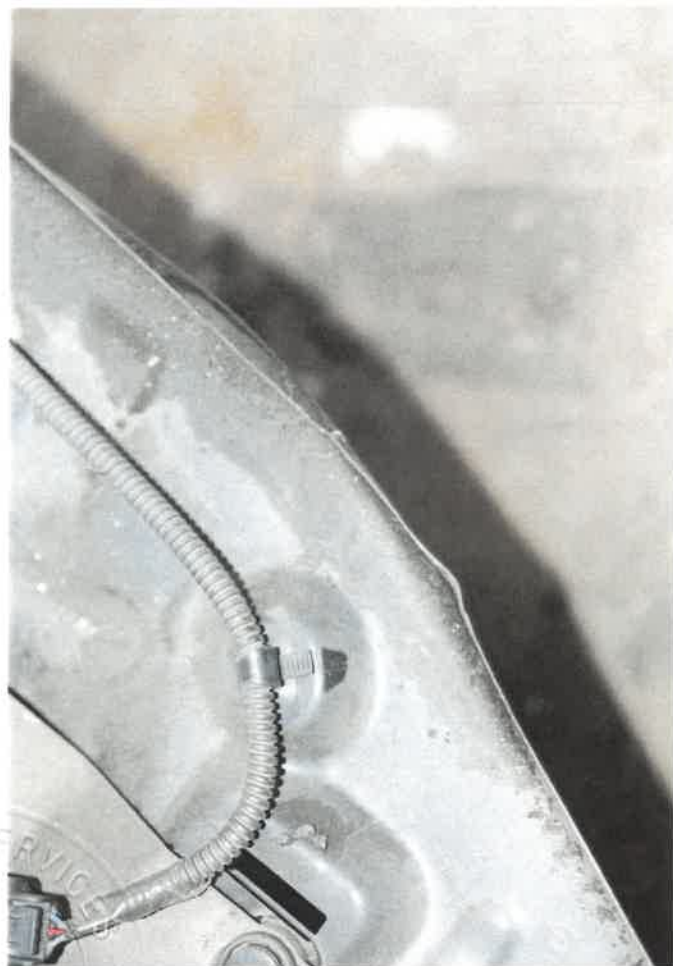
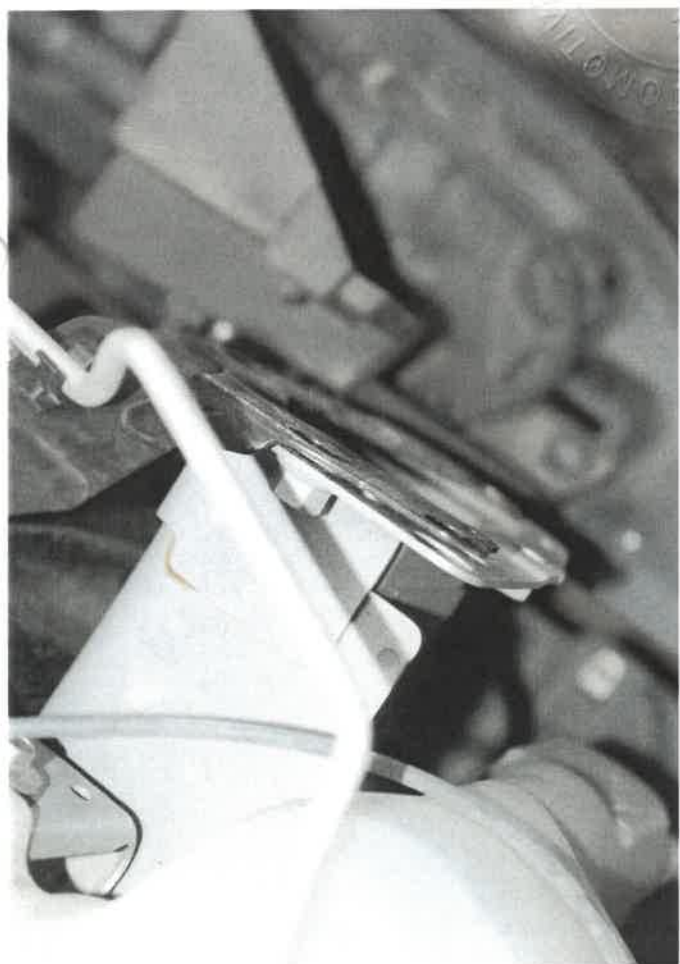
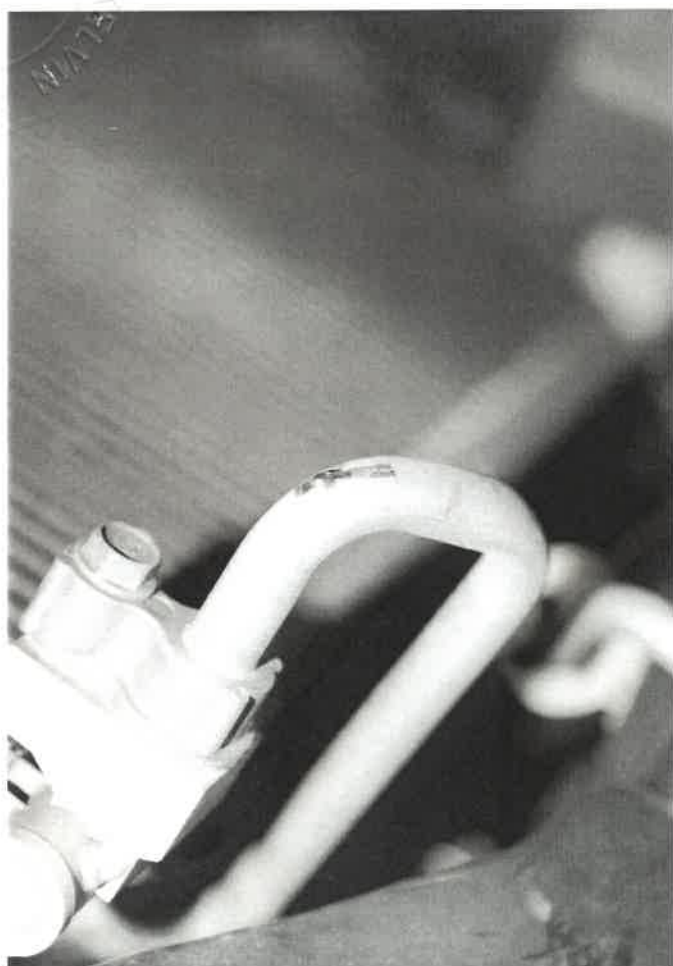
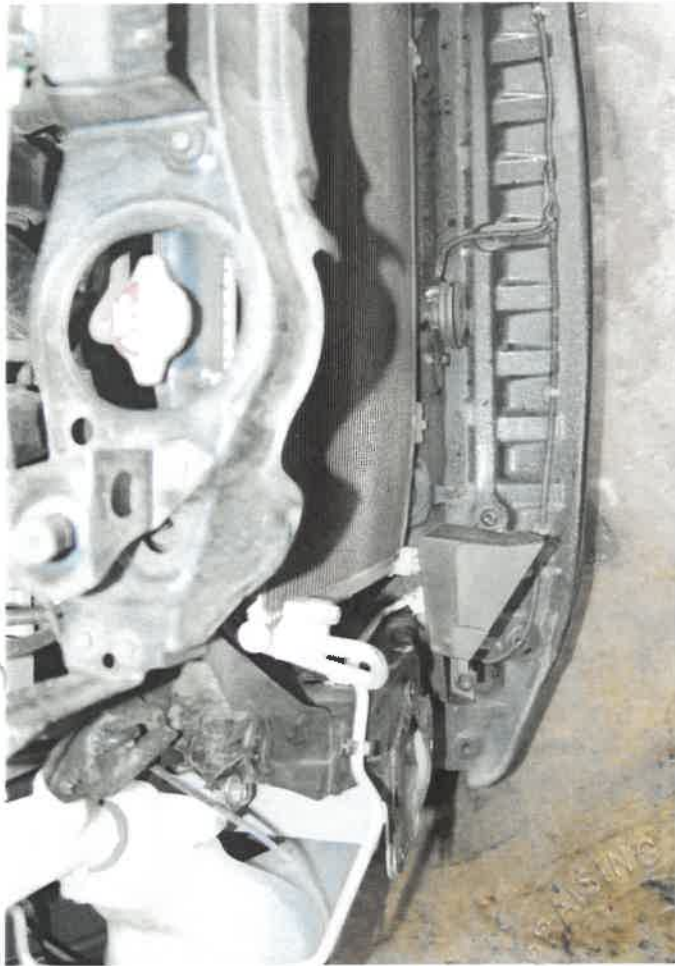
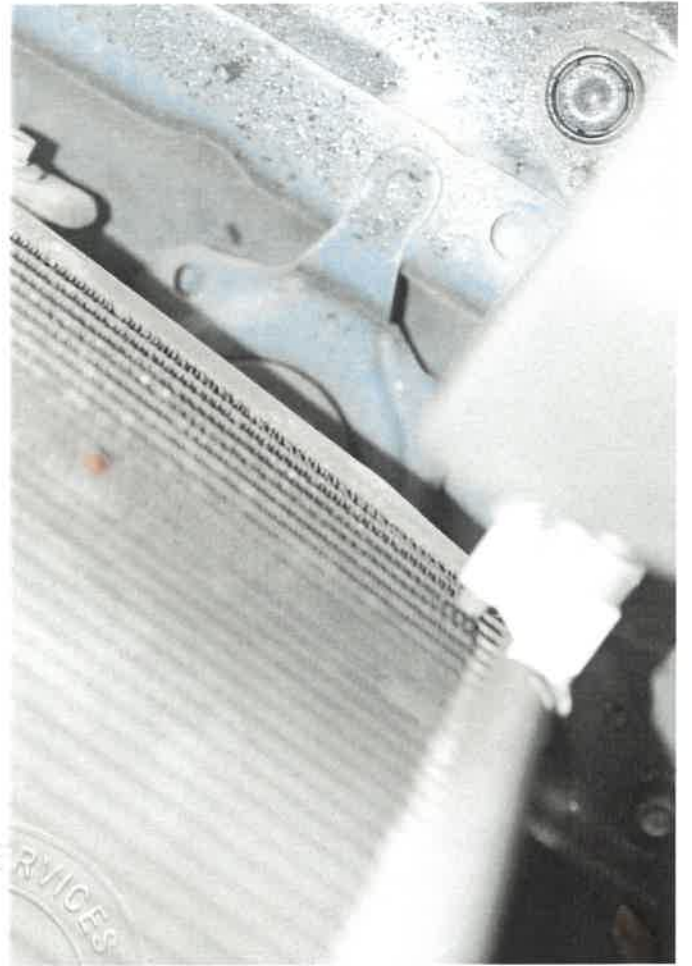
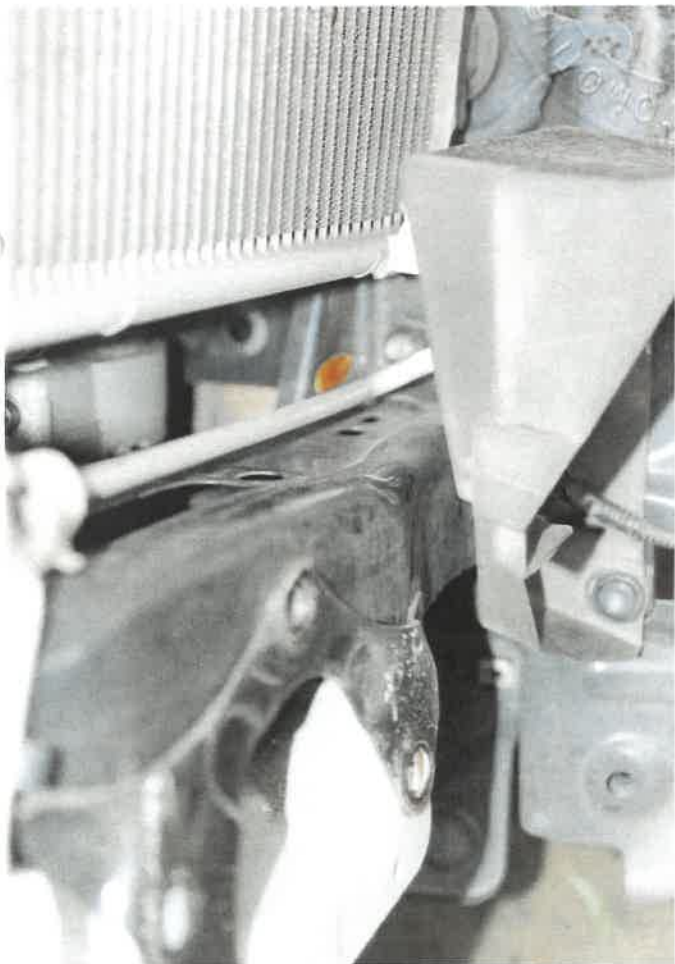
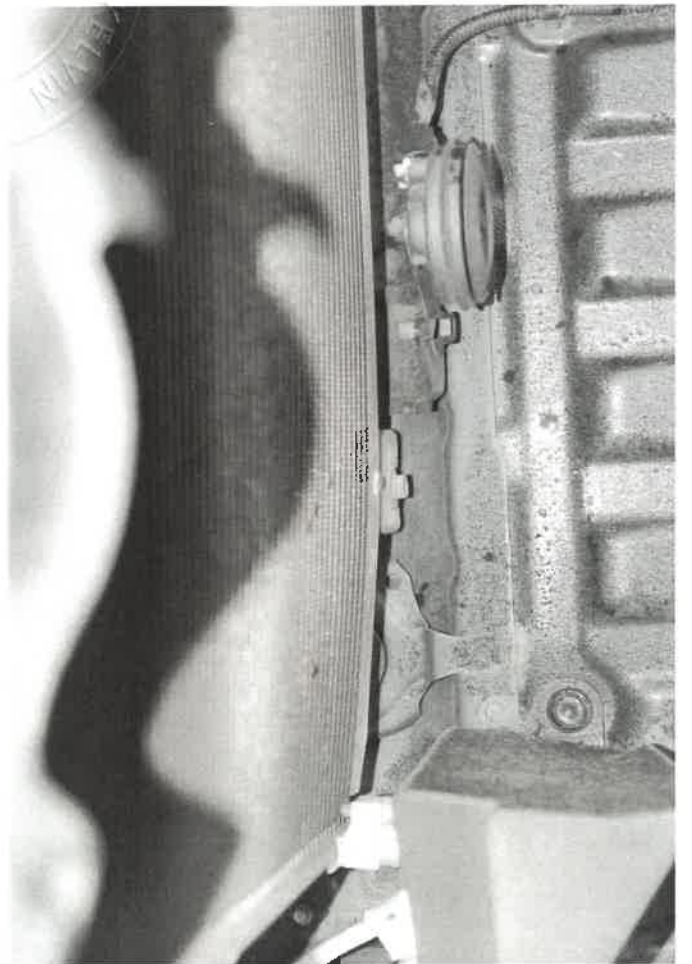
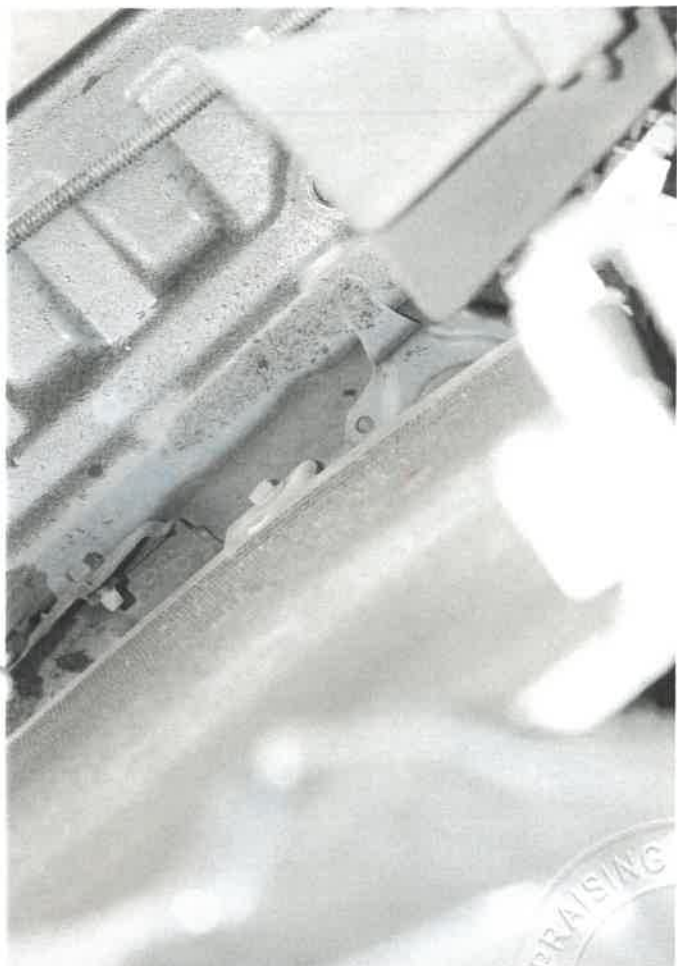
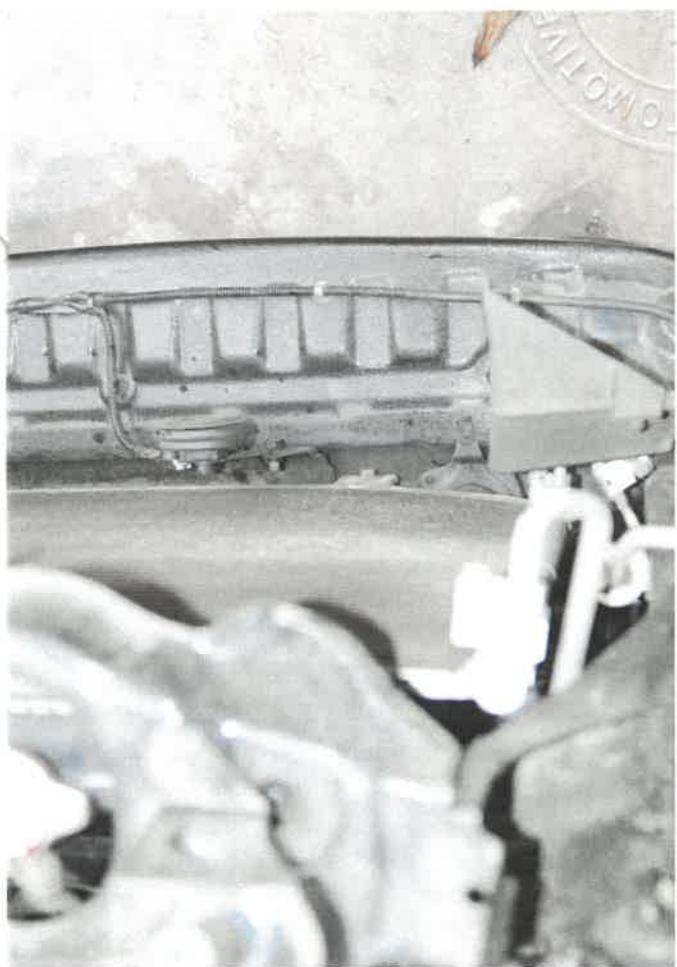
Damages sustained were consistent with the subject vehicle being involved in a collision with another vehicle and the impact was delivered

The general area of damages is at the **Front and Rear portion**
(Please refer to the parts list and photographs as attached for more information)

The estimated repair costs submitted by Messrs **Apex Motoring** is \$ 20,167.50 .
We have adjusted the cost to \$ 15,103.88 and the repairer has agreed to undertake the repairs at a
Contract Lump Sum of \$ 12,050.00 to a acceptable quality and standards.
However, we have not given authorization and instruction to the repairer to proceed with the repairs.
