Our Ref : TP / FMP SLC9229R/ 04.24/22

DAMAGED VEHICLE (SLC 9229 R) INSPECTION REPORT (WITHOUT PREJUDICE)

Registration No	: SLC 9229 R	Mileage	: 79718 Km
Make & Model	: KIA FORTE K3 1.6A EX	Engine No	: G4FGGH612127
Date of Registration	: 30 th May 2016	Chassis No.	: KNAFX411MG5596214
Colour	: Red	Engine Capacity.	: 1,591 c.c.

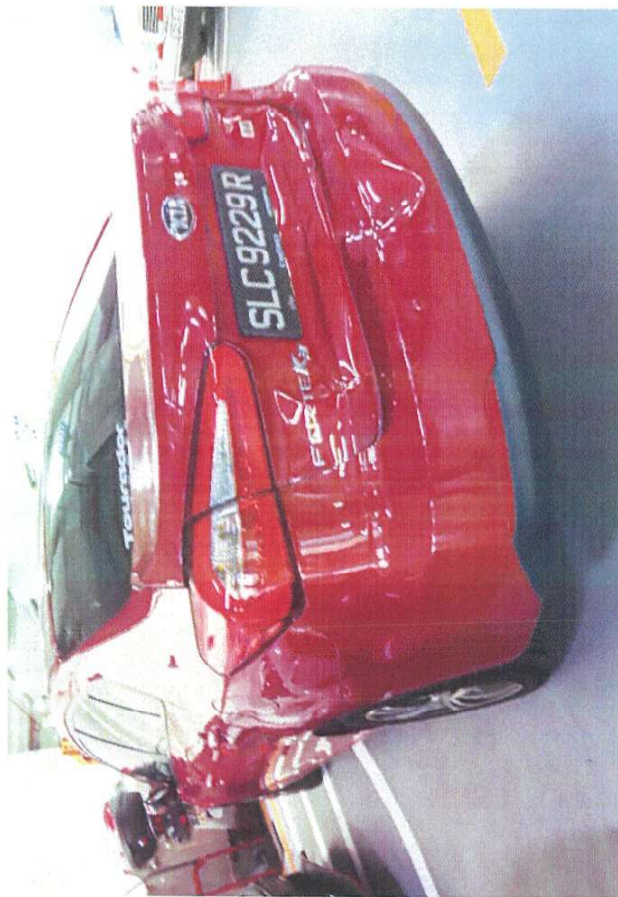
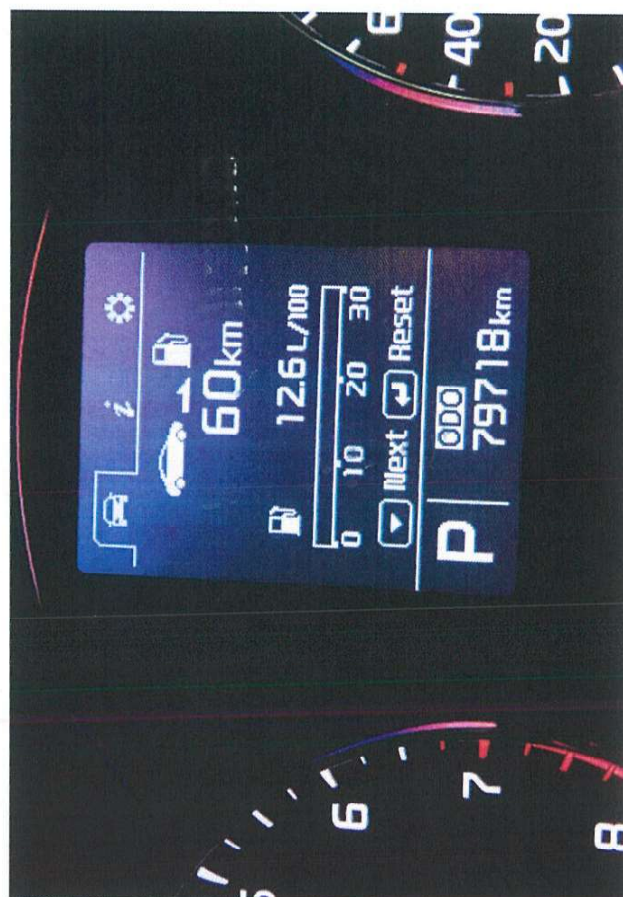
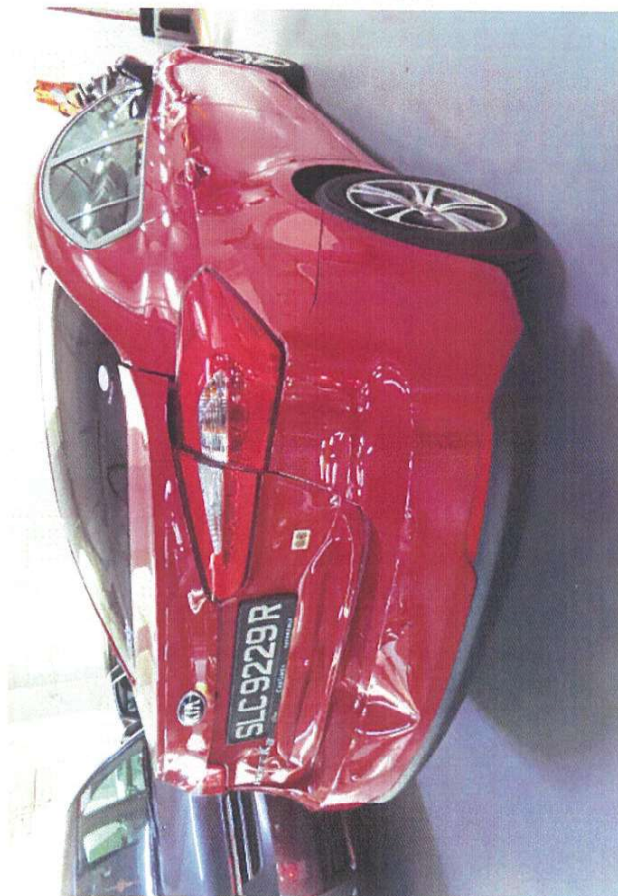
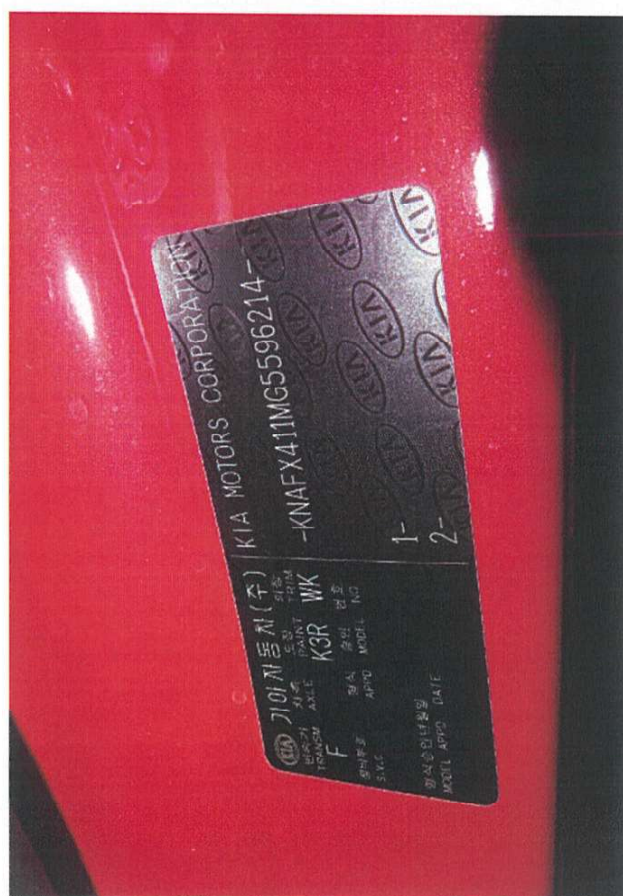
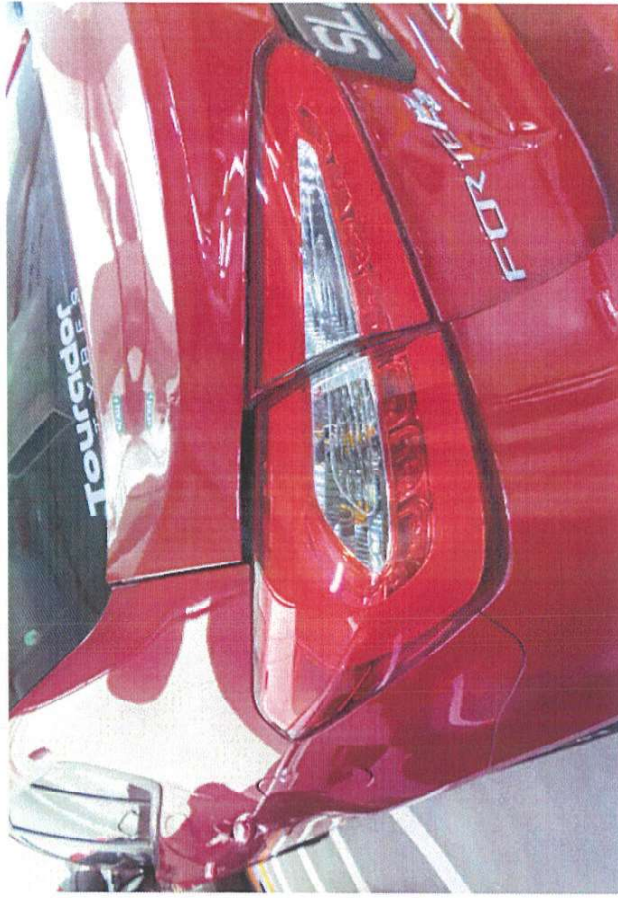
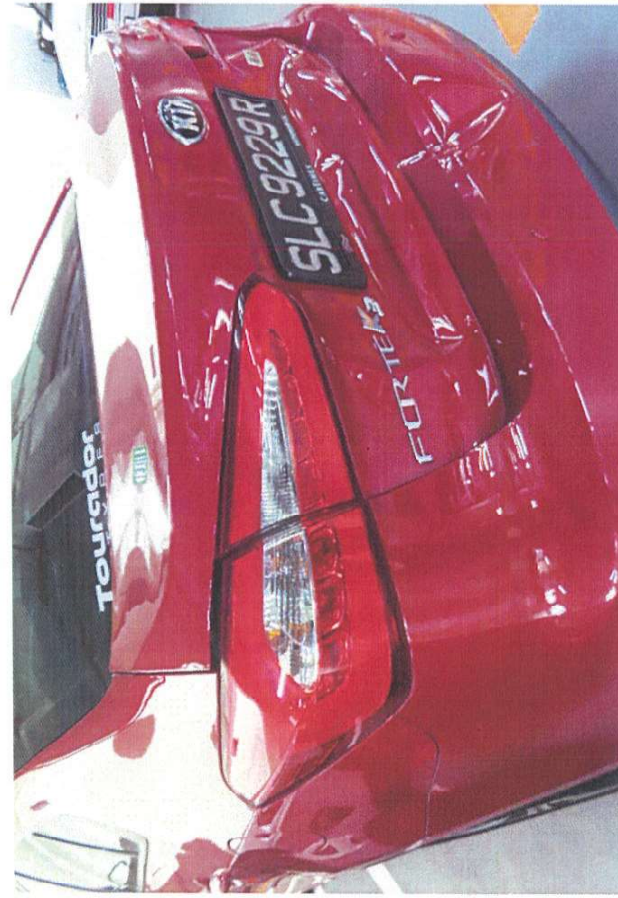
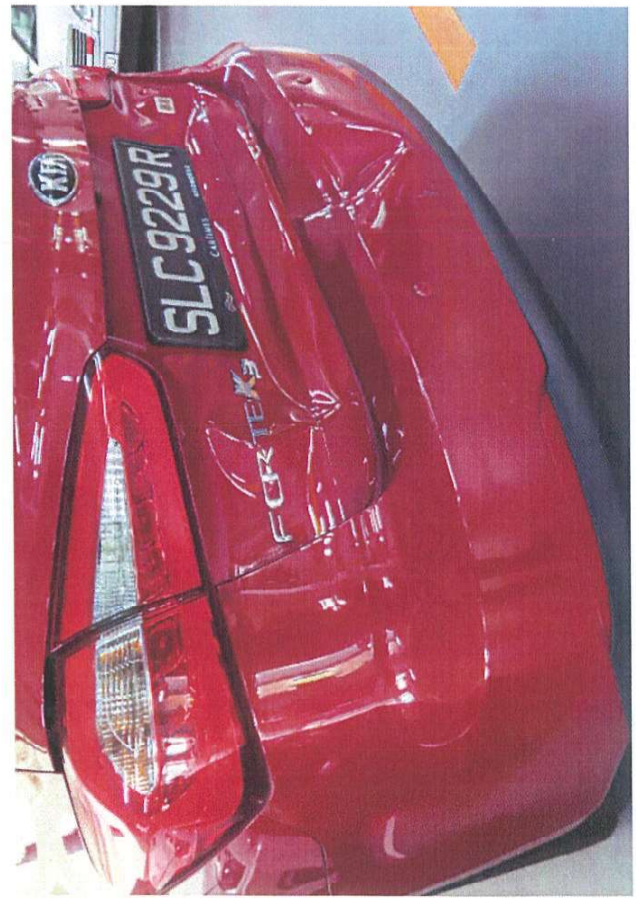
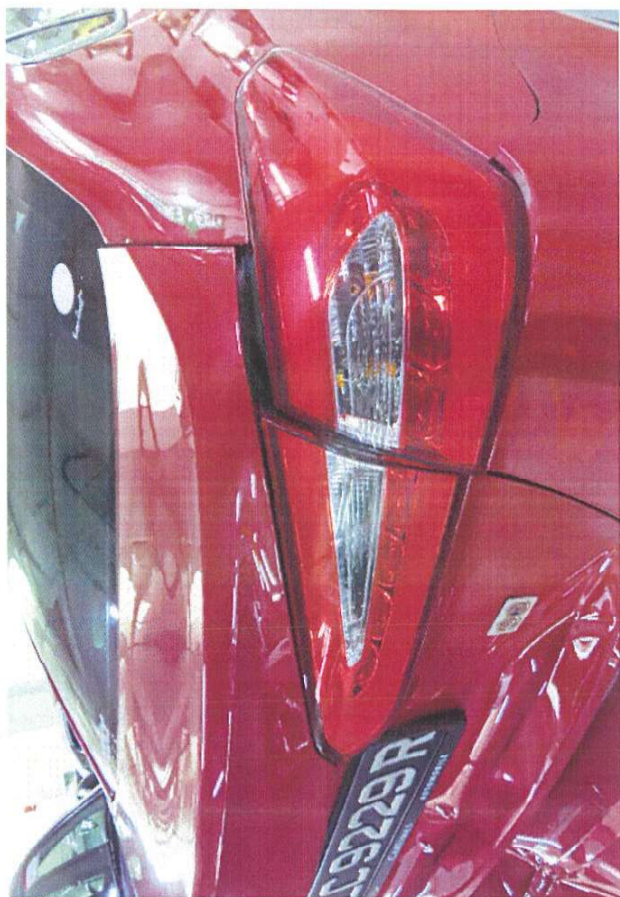
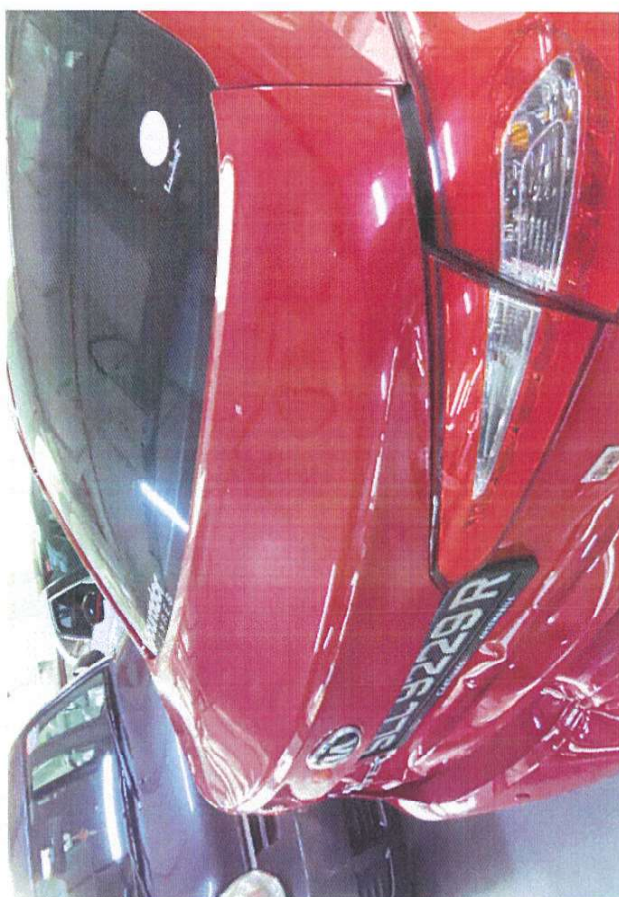
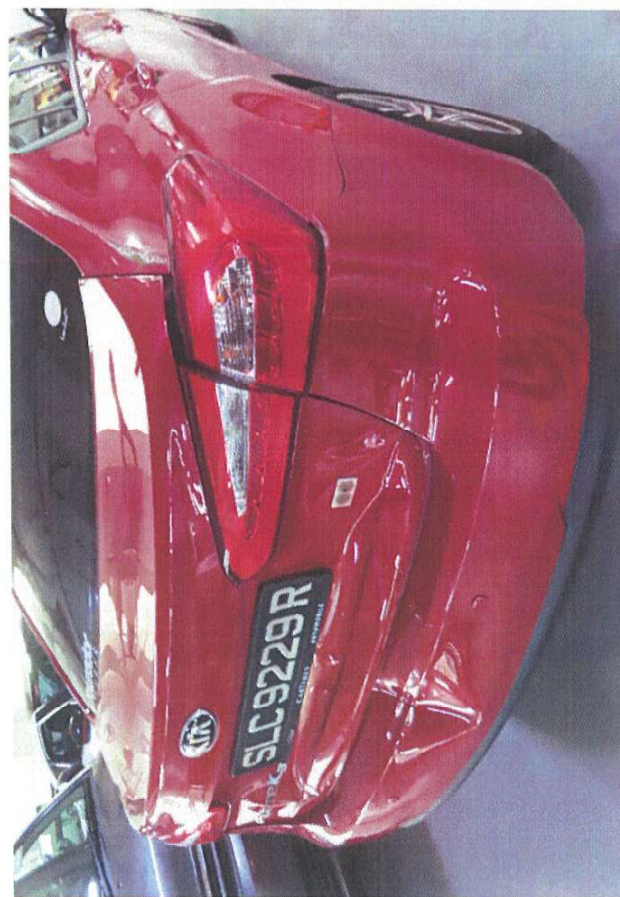
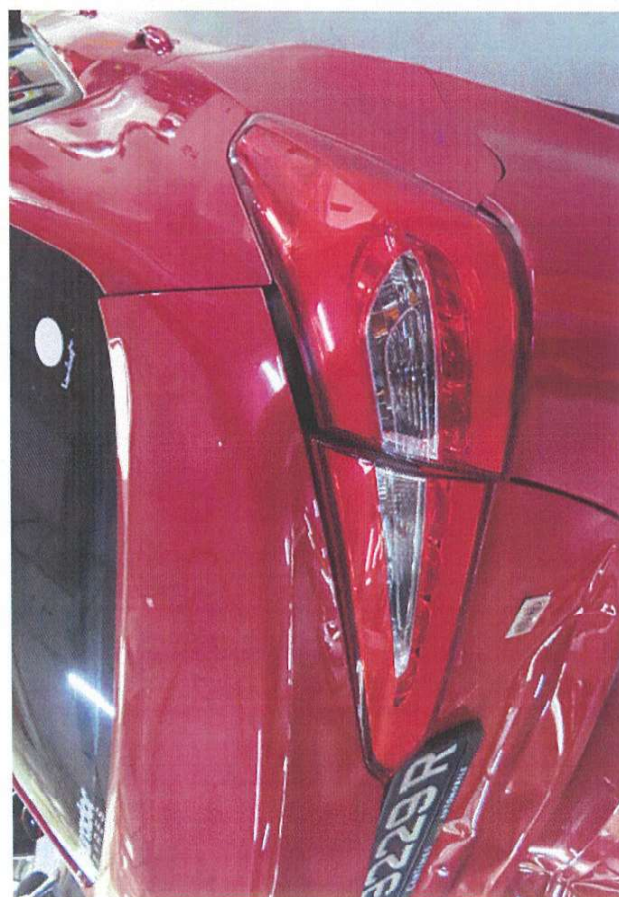
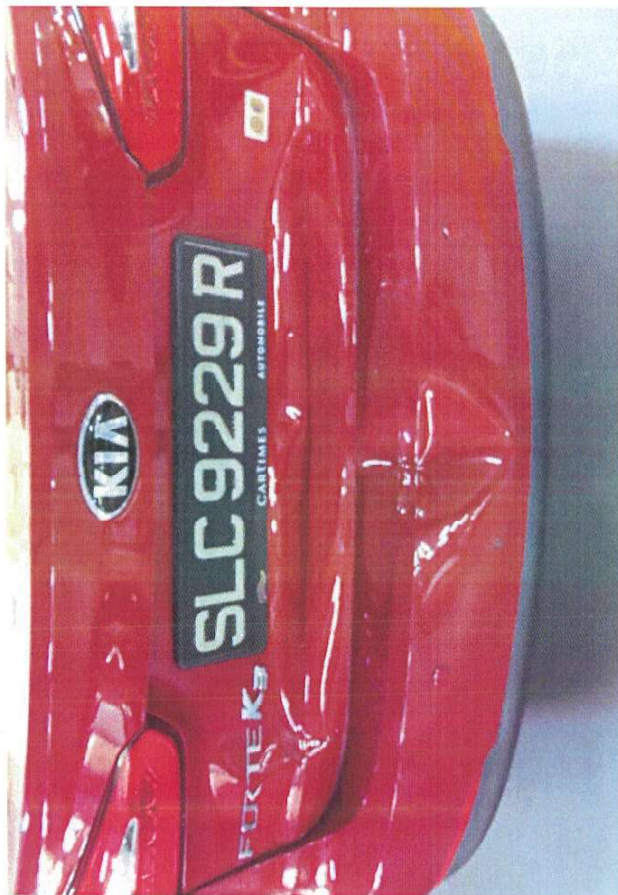
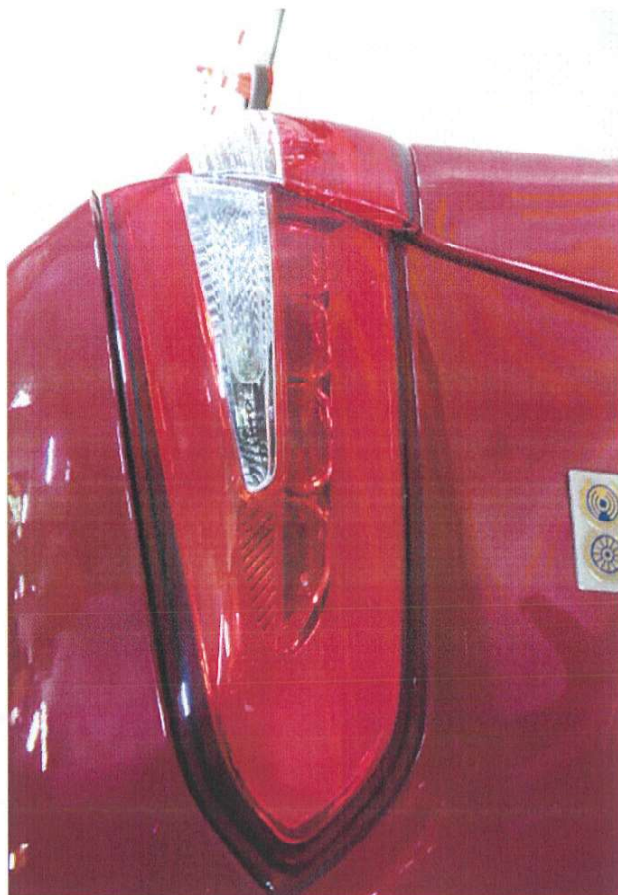
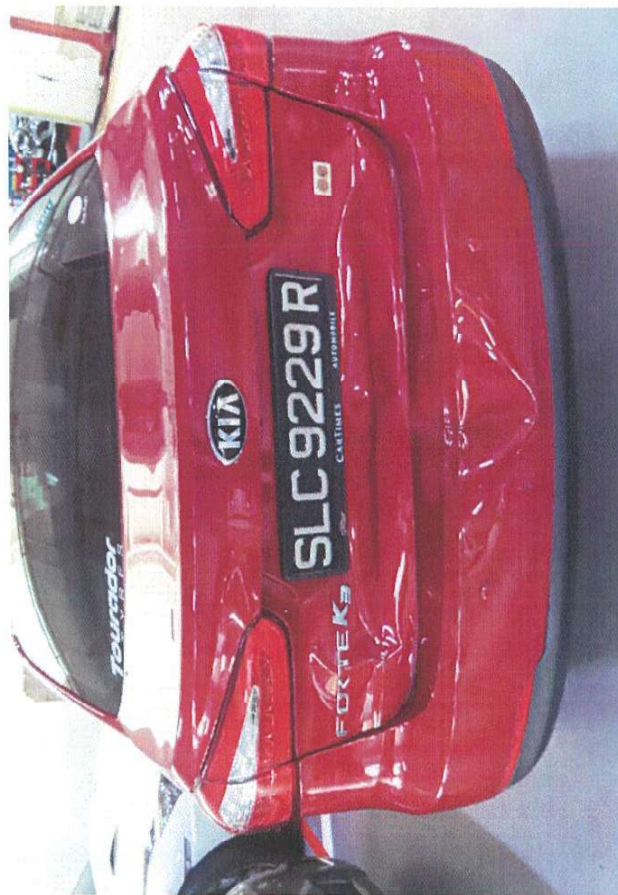
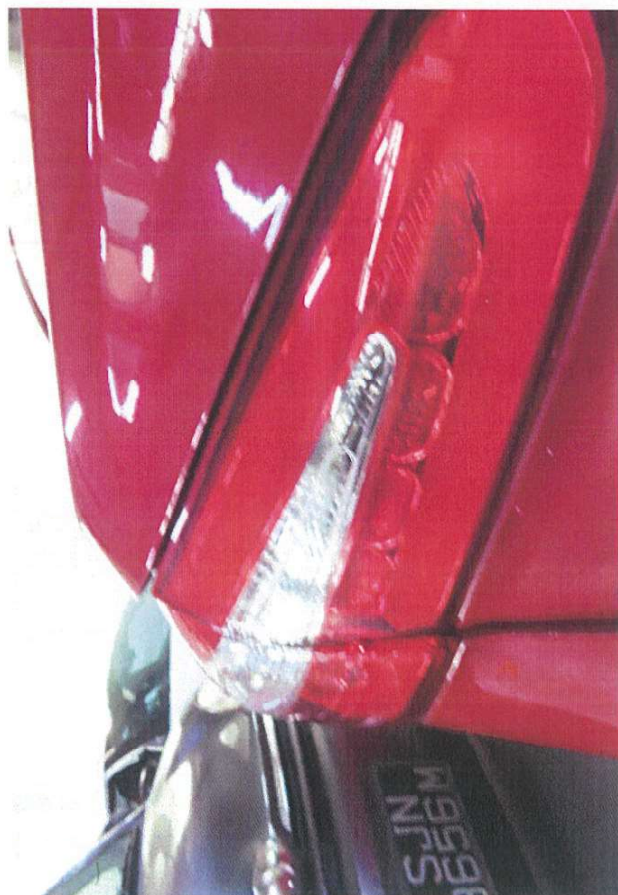
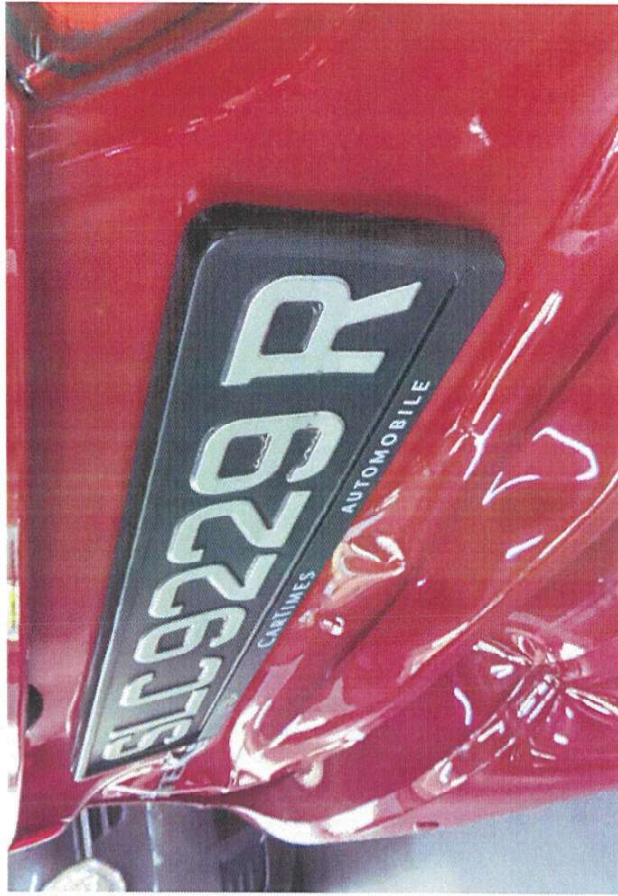
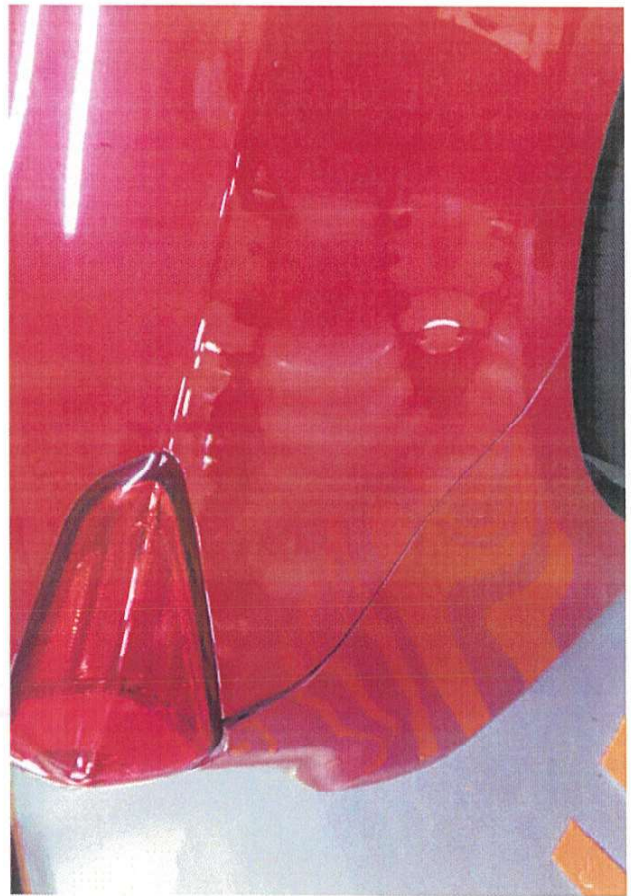
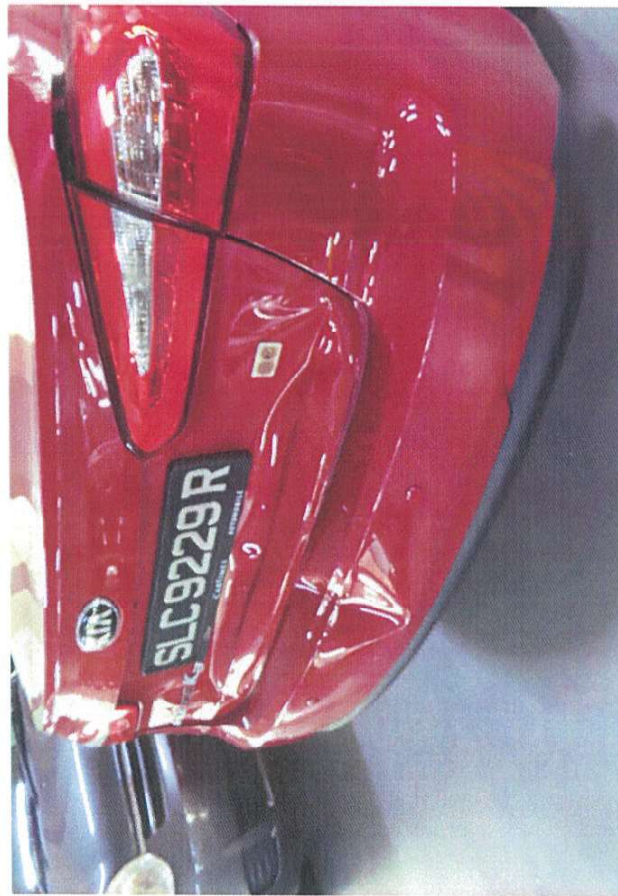
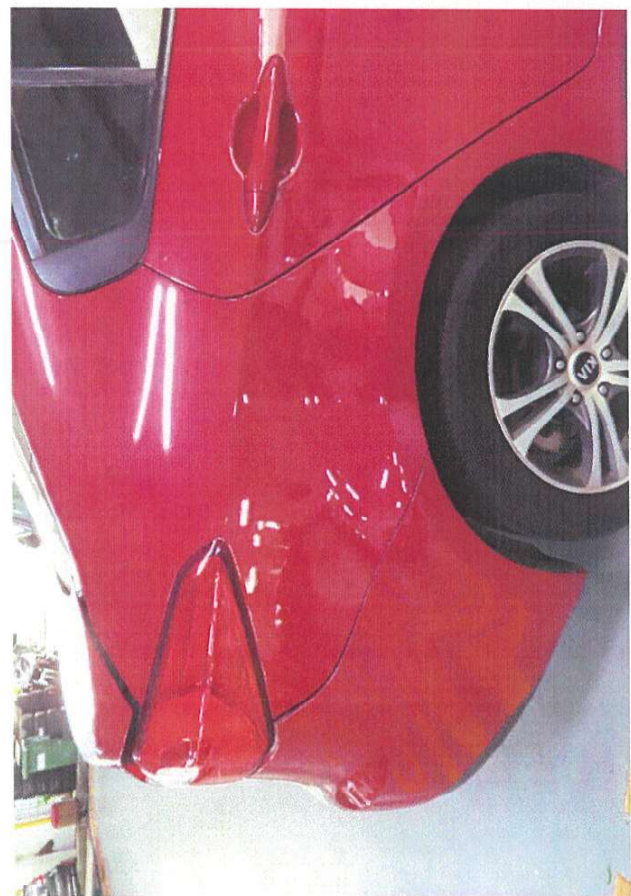
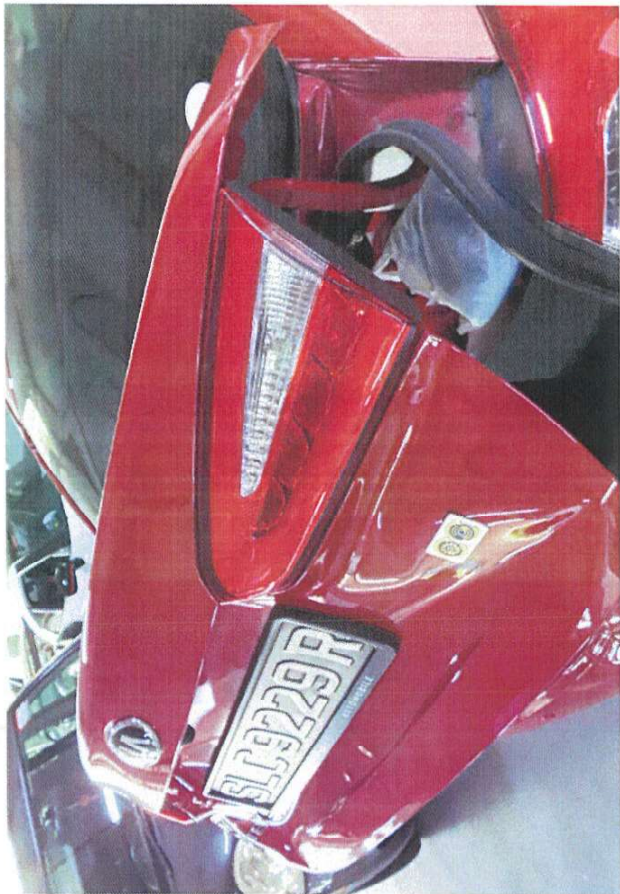
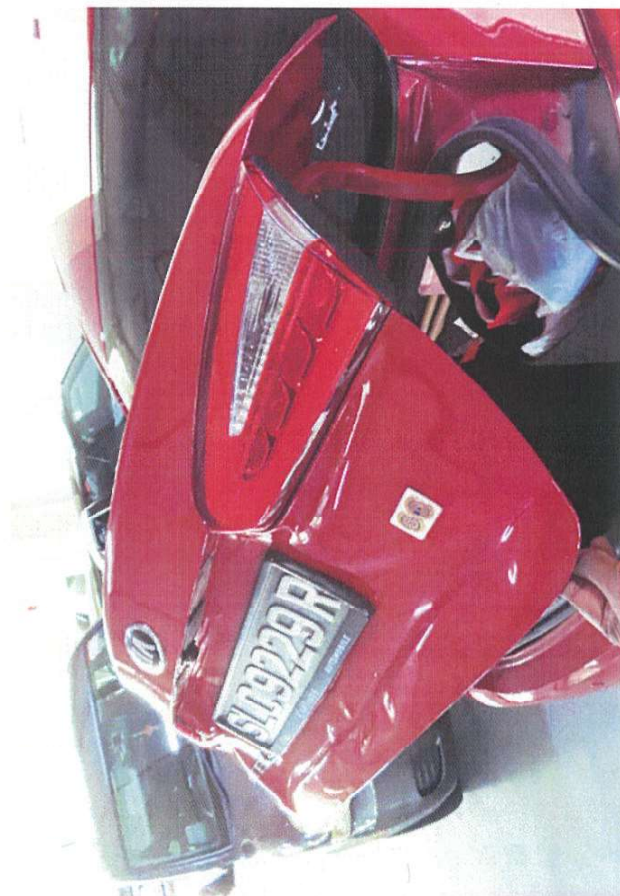
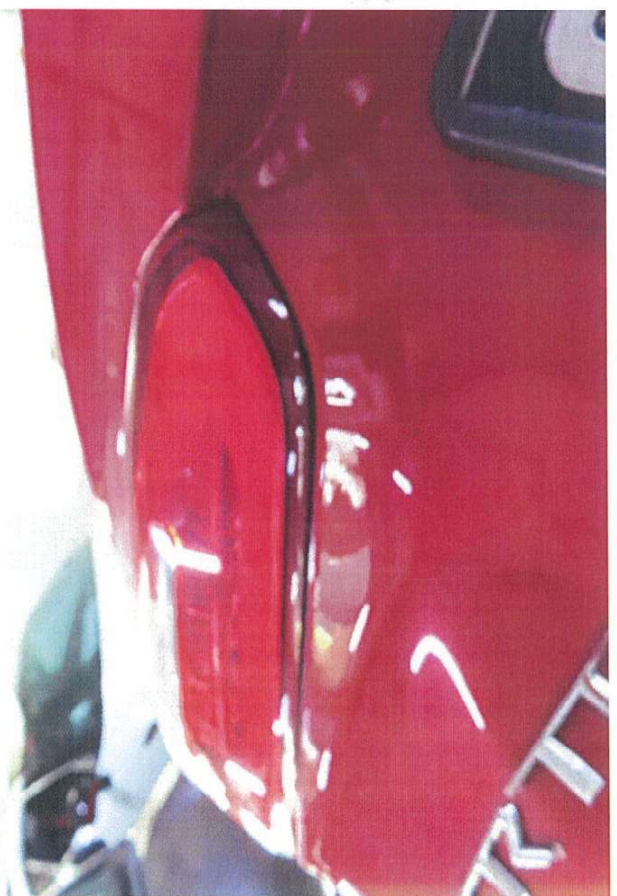
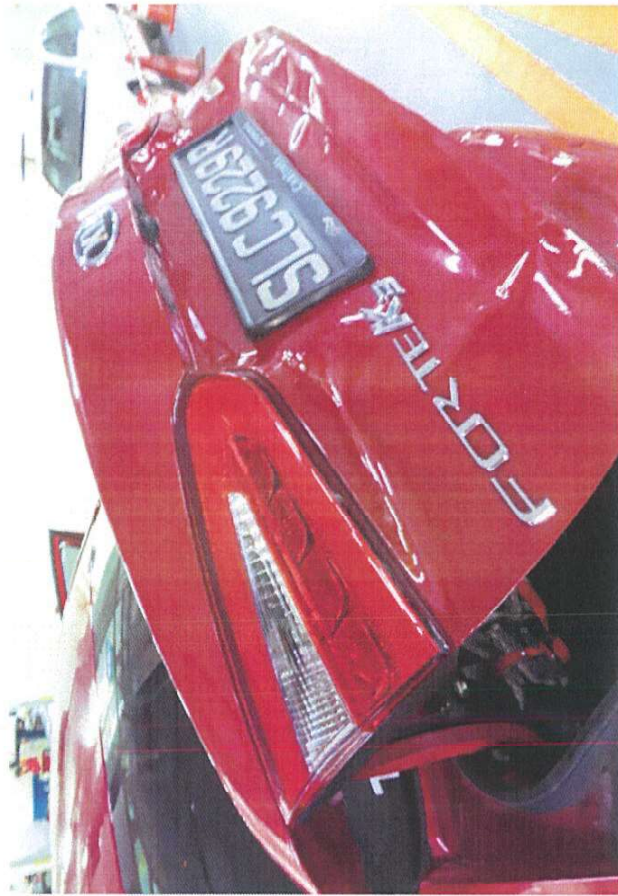
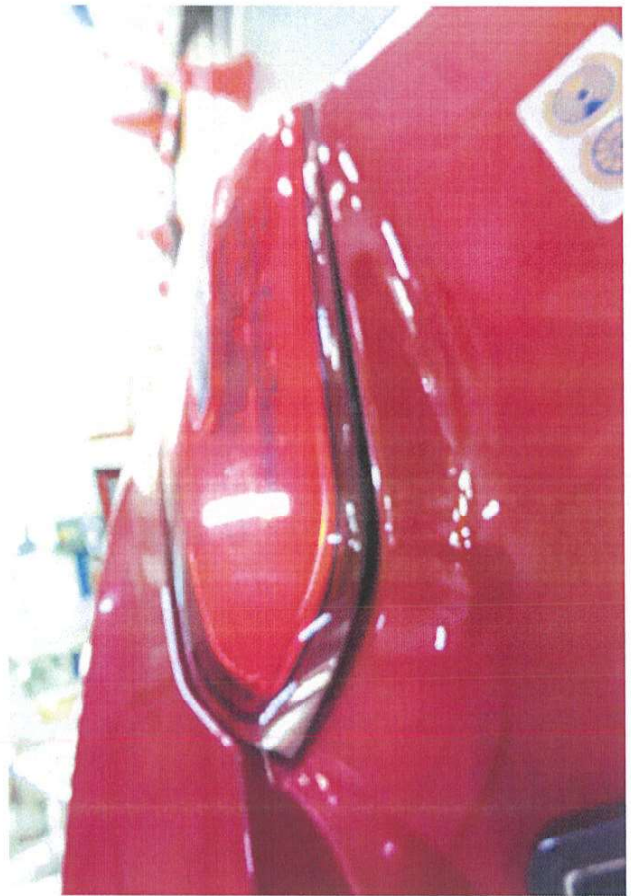
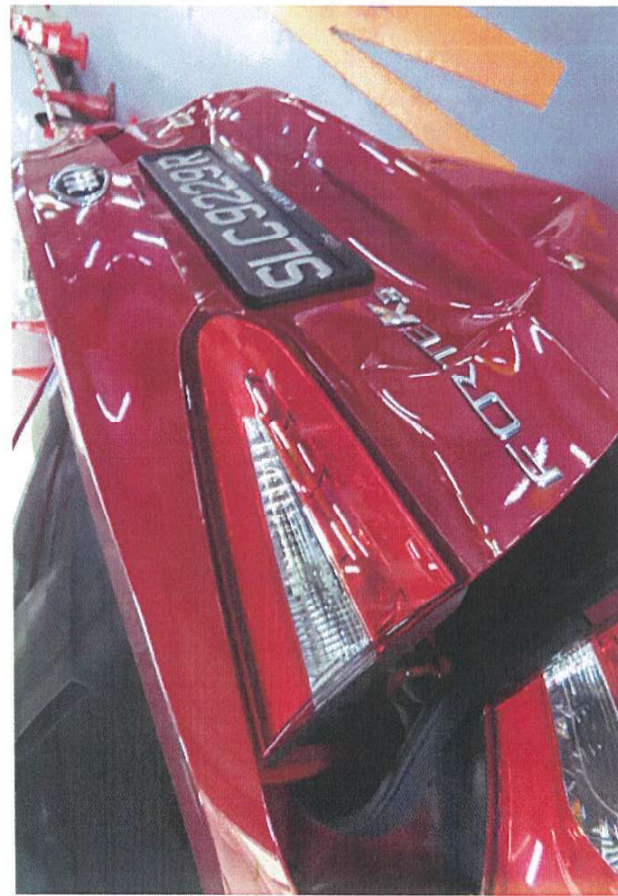
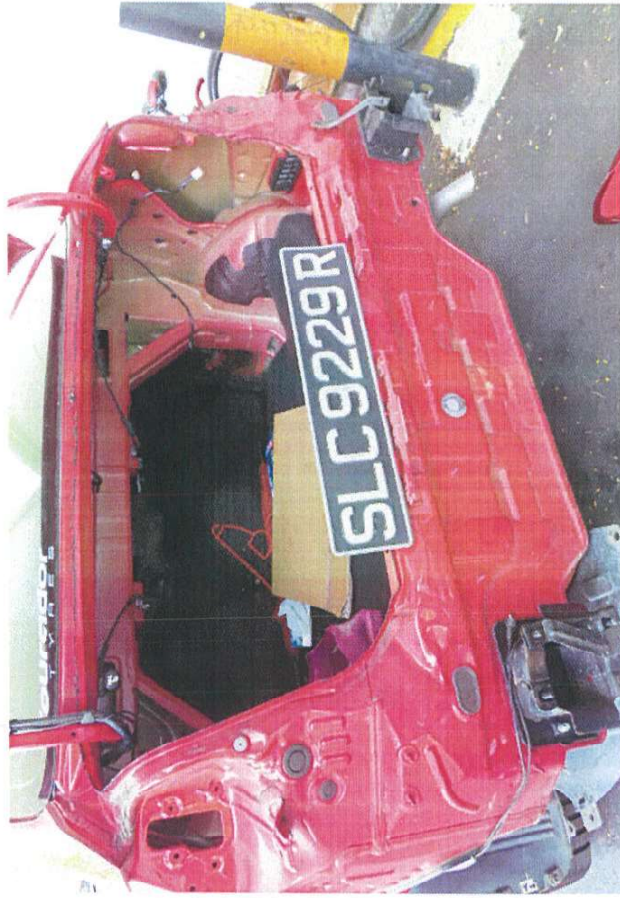
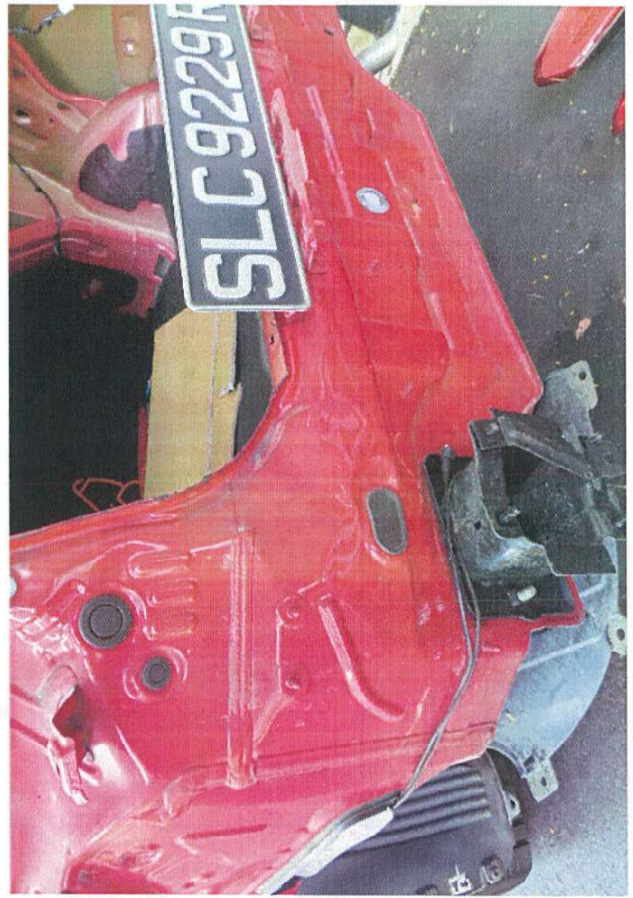
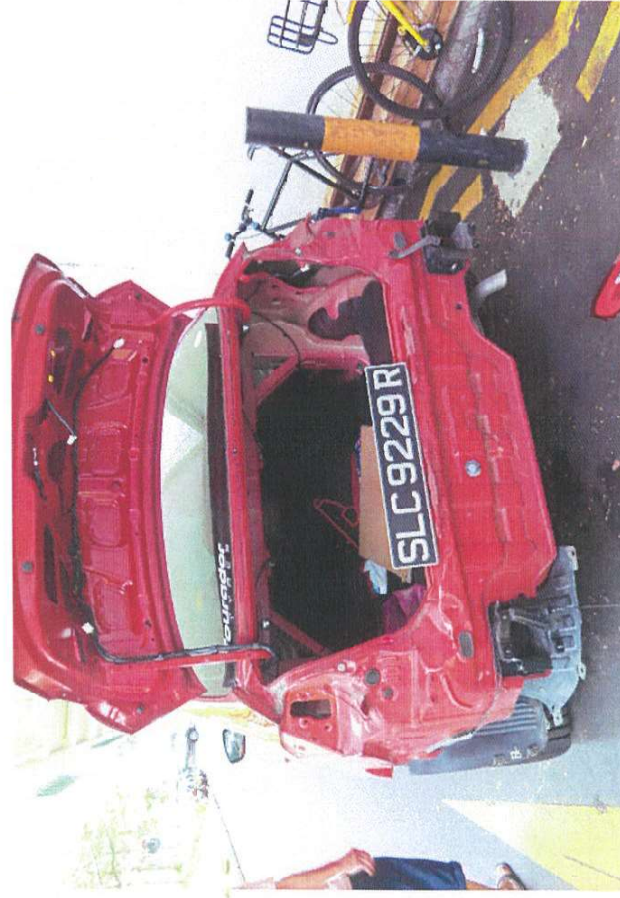
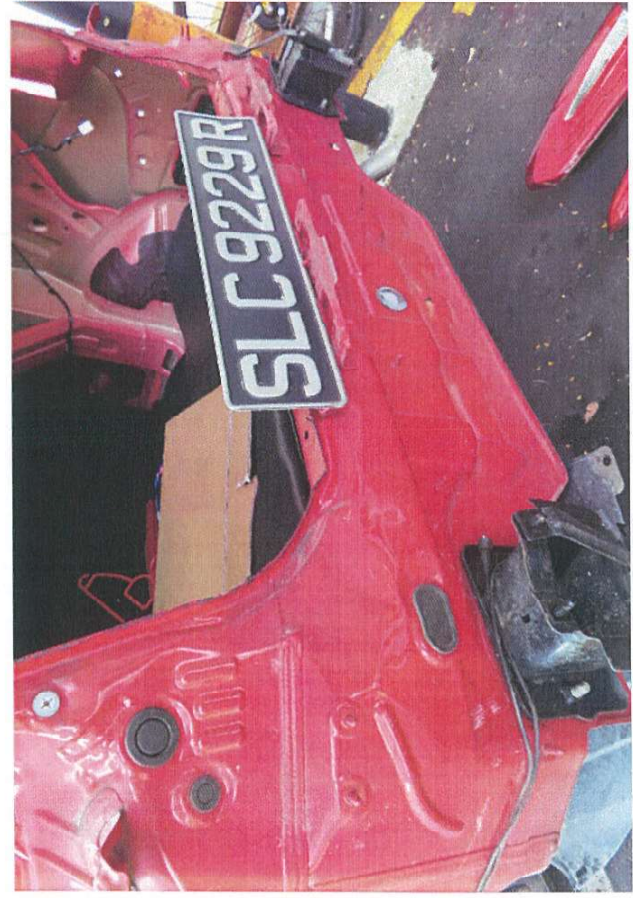
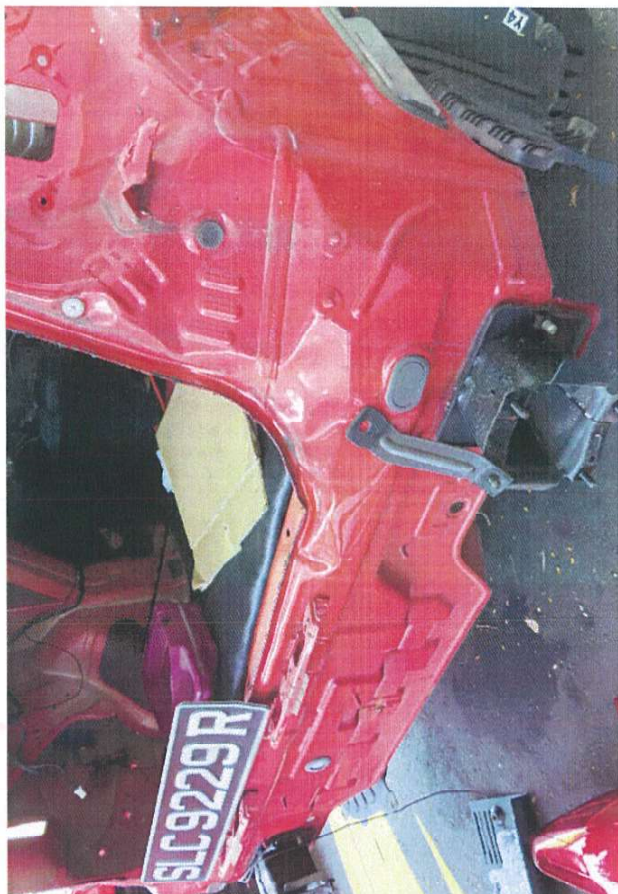
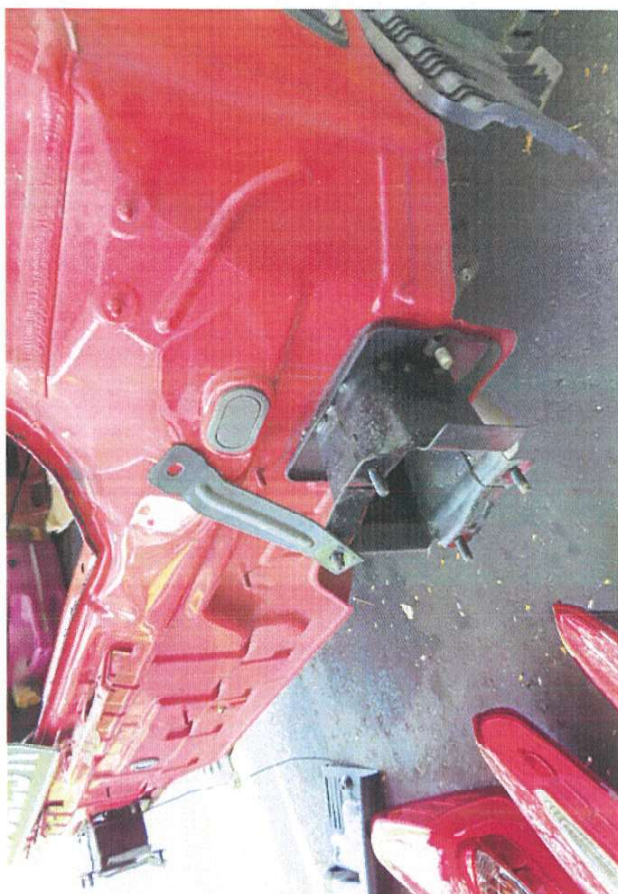
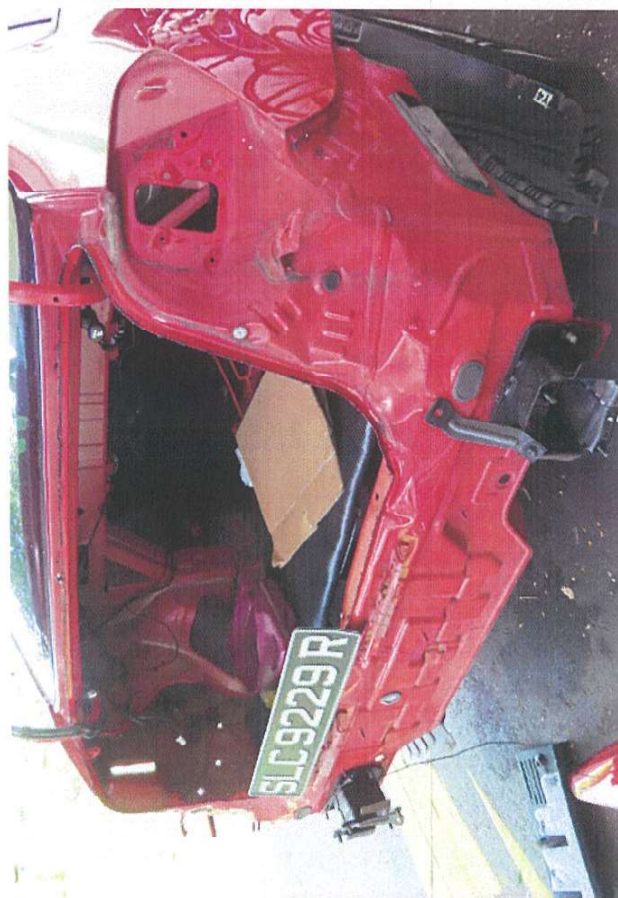
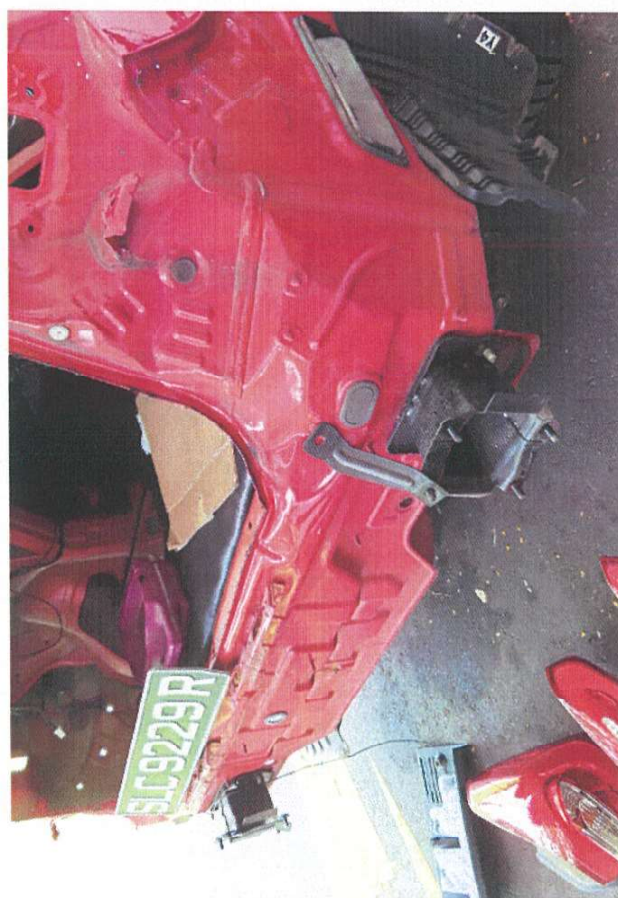
The impact of the collision has damaged/affected the boot lid, boot lid lamps, rear bumper, rear end panel, tail lamp and etc.

Our adjusted cost of lump sum repair is **\$7,100.00** and an estimated **6** days is required to repair the vehicle. Please refer to the Annex for a detailed account of the cost estimates
