Our Ref : TP / FMP SLC9229R/ 04.24/22

DAMAGED VEHICLE (SLC 9229 R) INSPECTION REPORT (WITHOUT PREJUDICE)

Registration No	: SLC 9229 R	Mileage	: 79718 Km
Make & Model	: KIA FORTE K3 1.6A EX	Engine No	: G4FGGH612127
Date of Registration	: 30 th May 2016	Chassis No.	: KNAFX411MG5596214
Colour	: Red	Engine Capacity.	: 1,591 c.c.

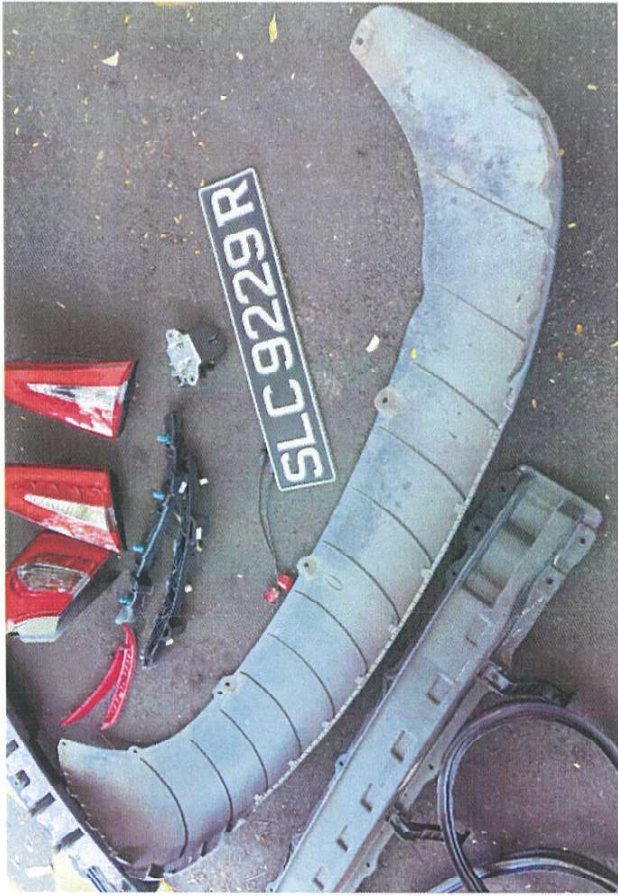
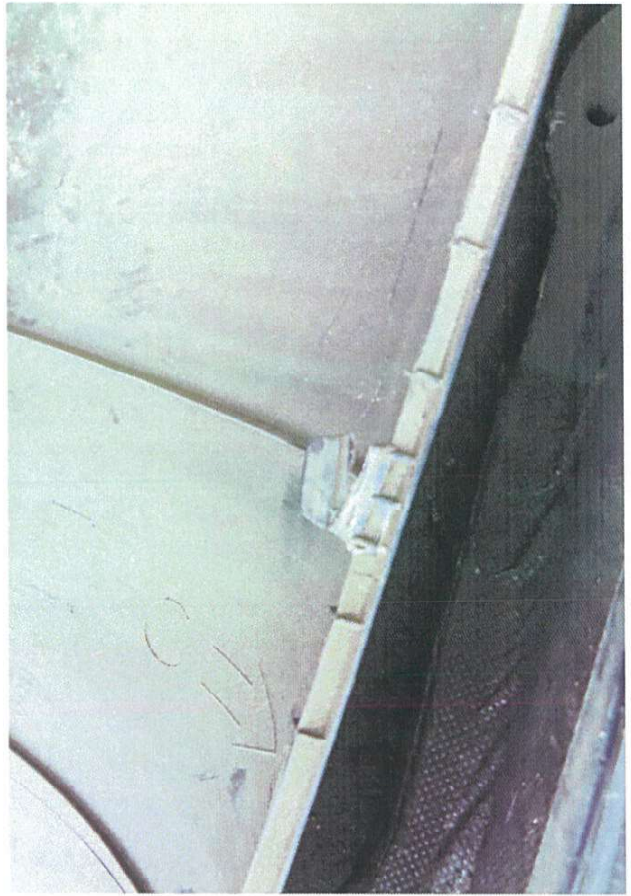
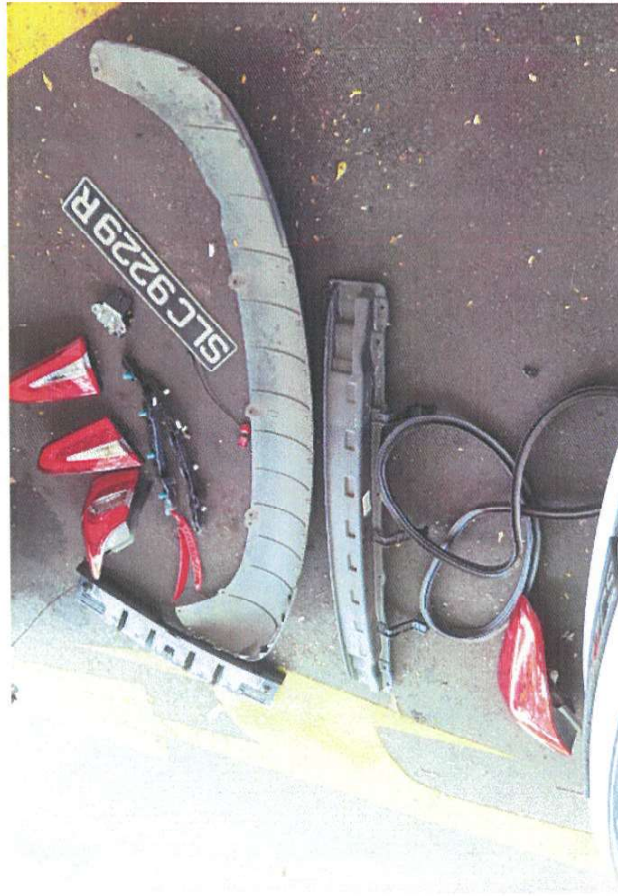
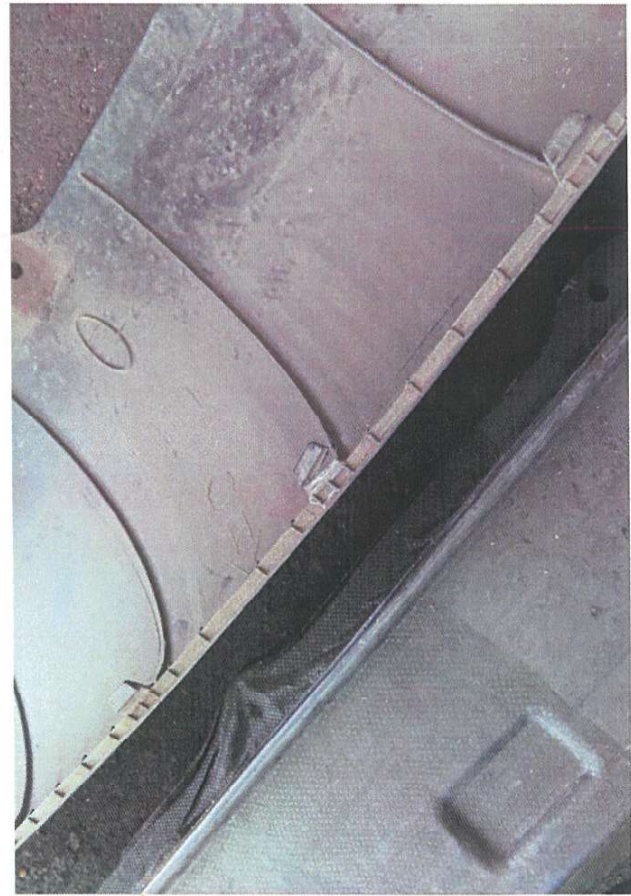
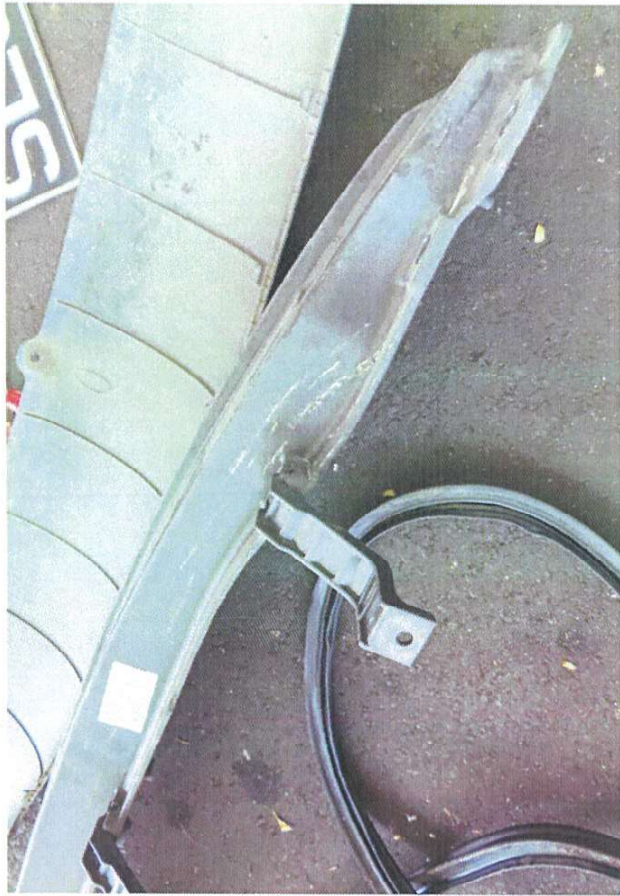
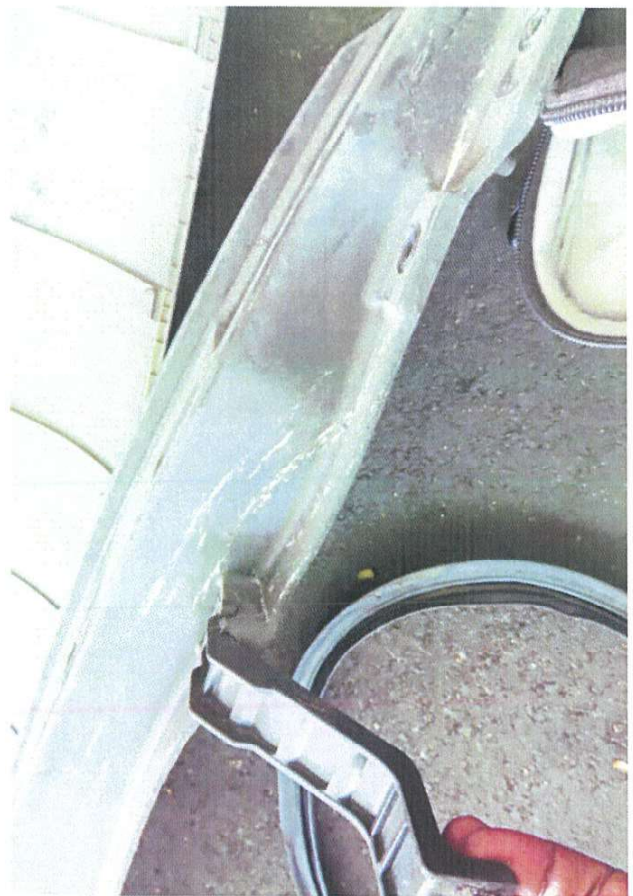
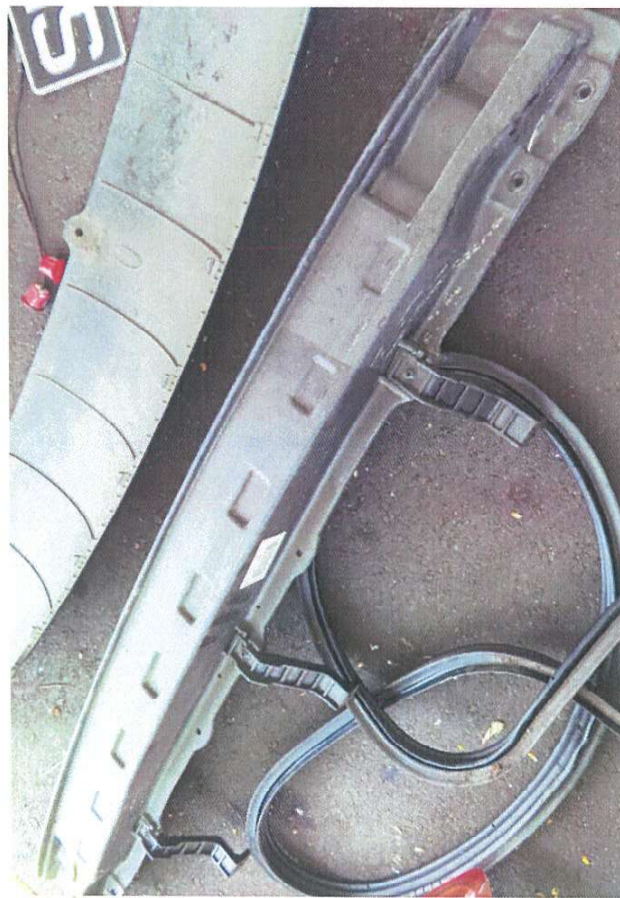
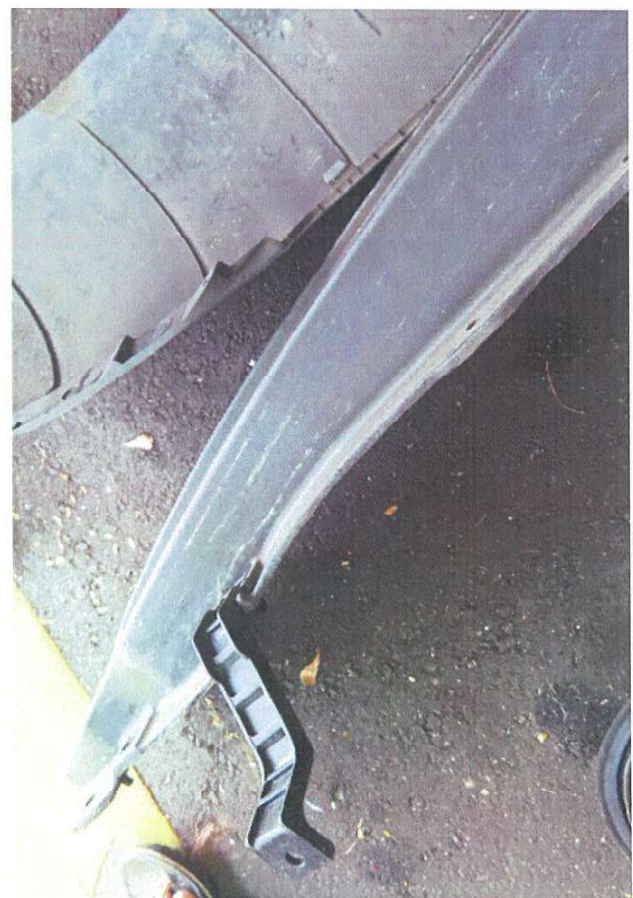
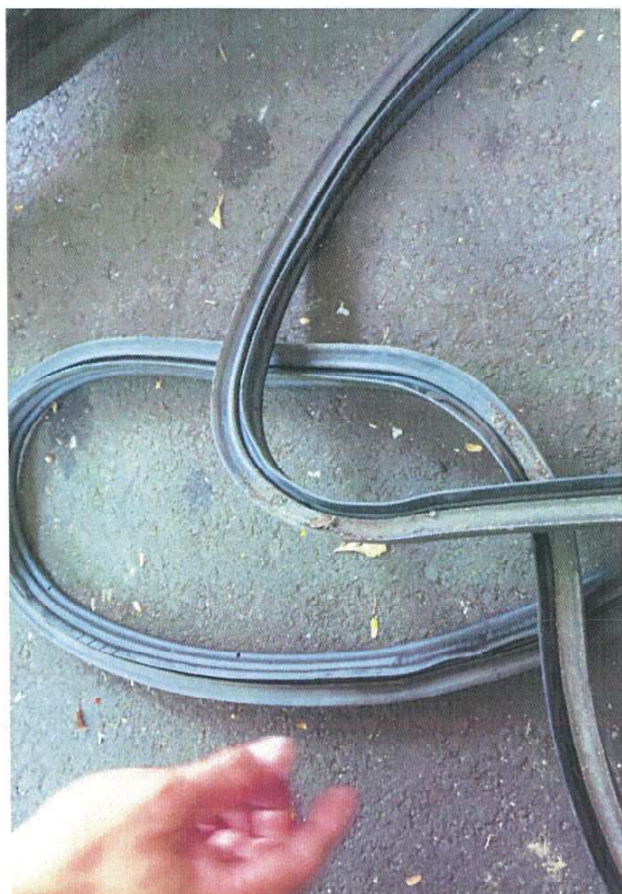
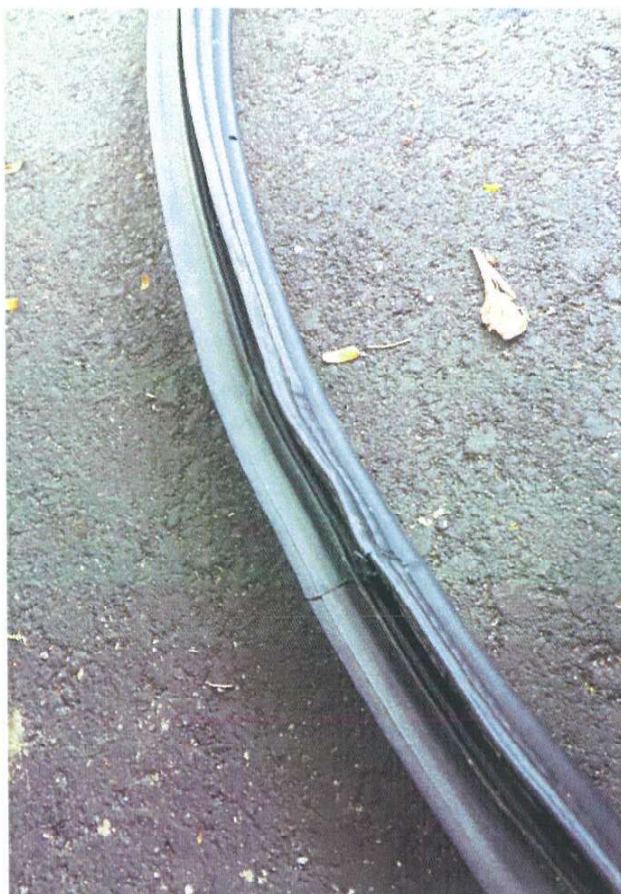
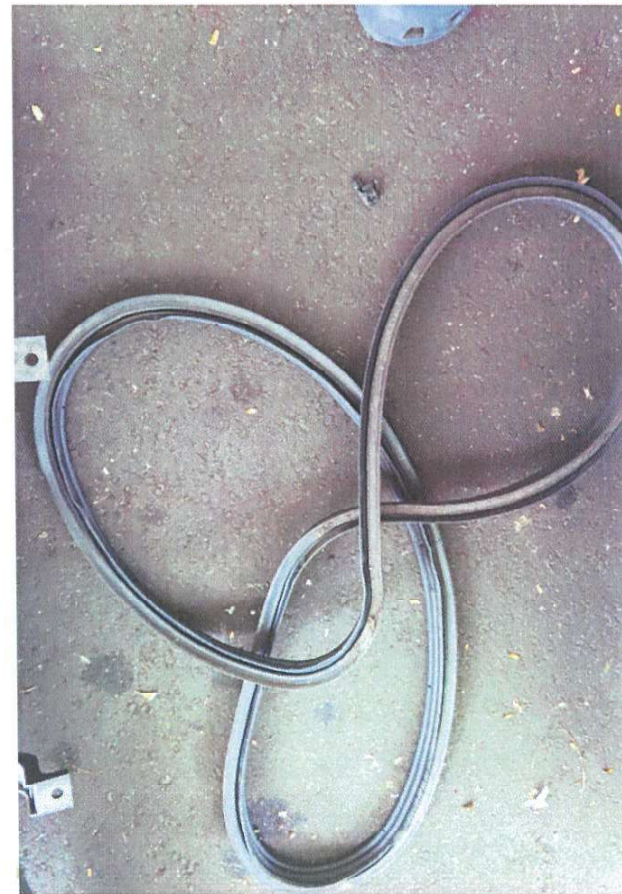
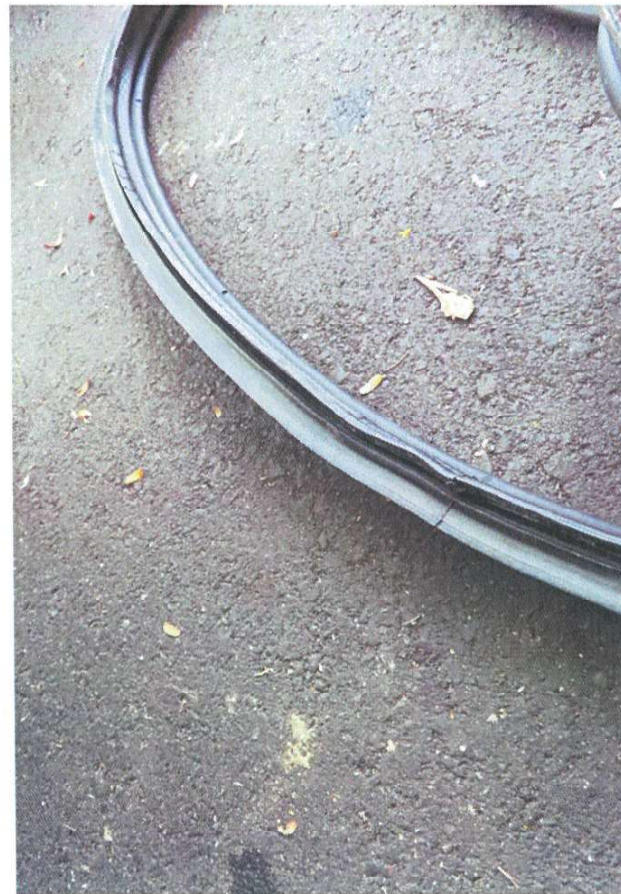
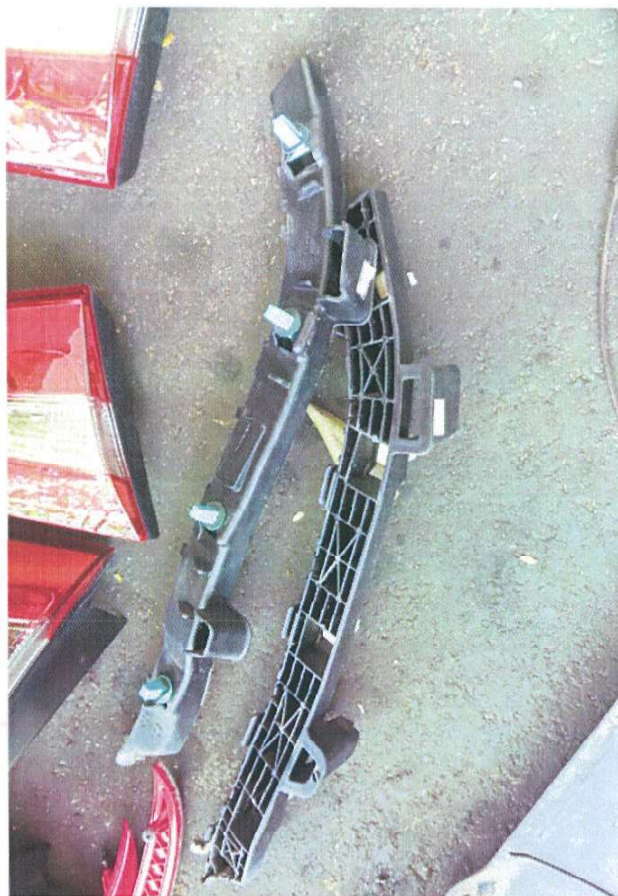
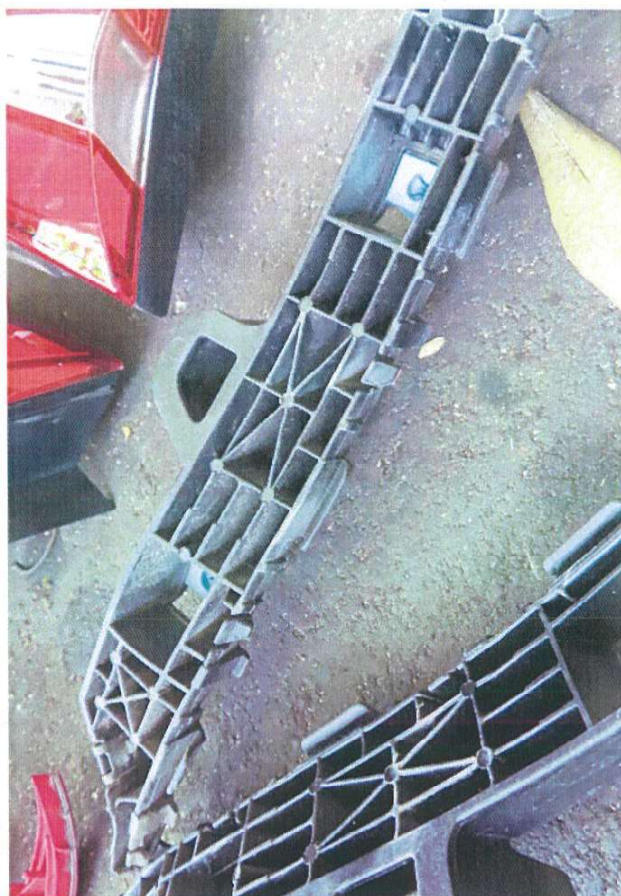
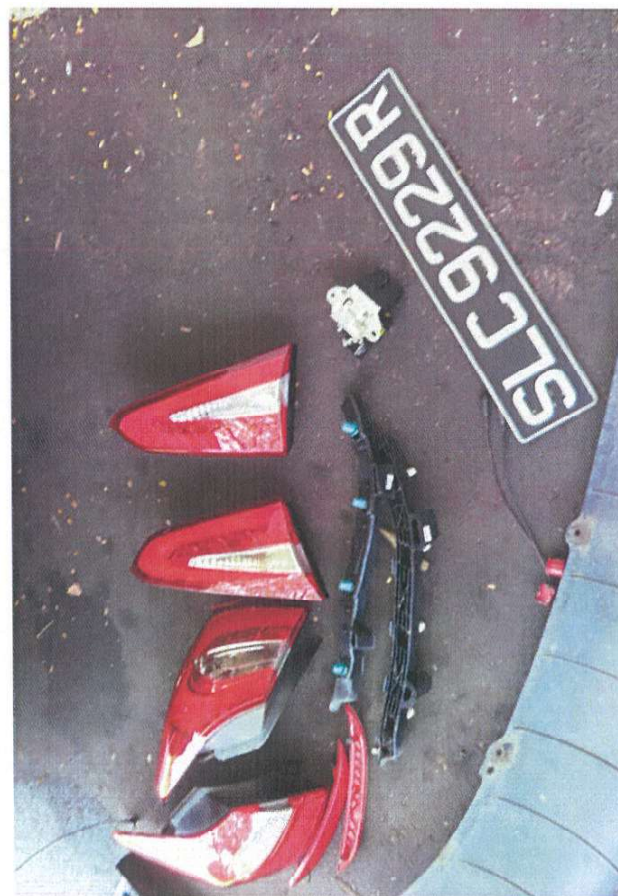
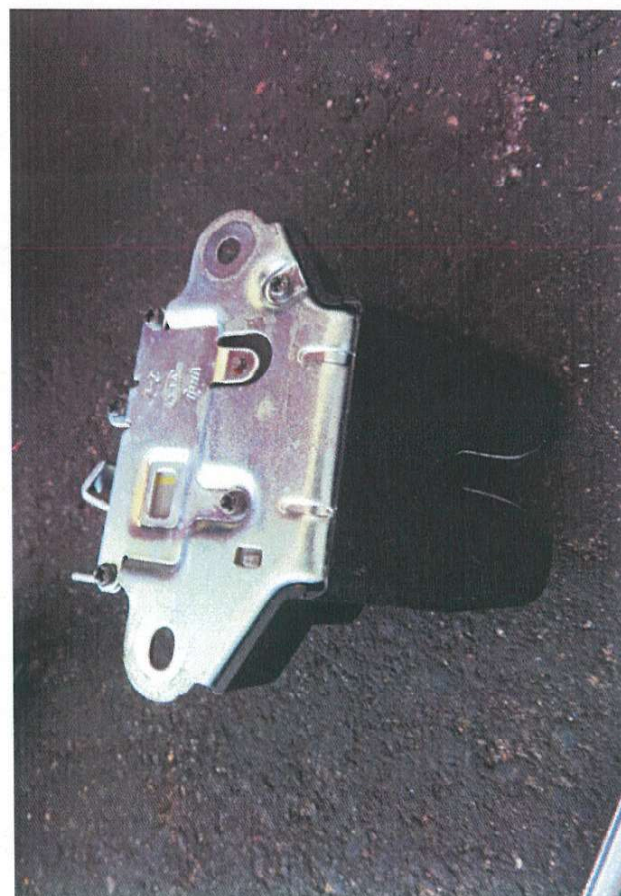
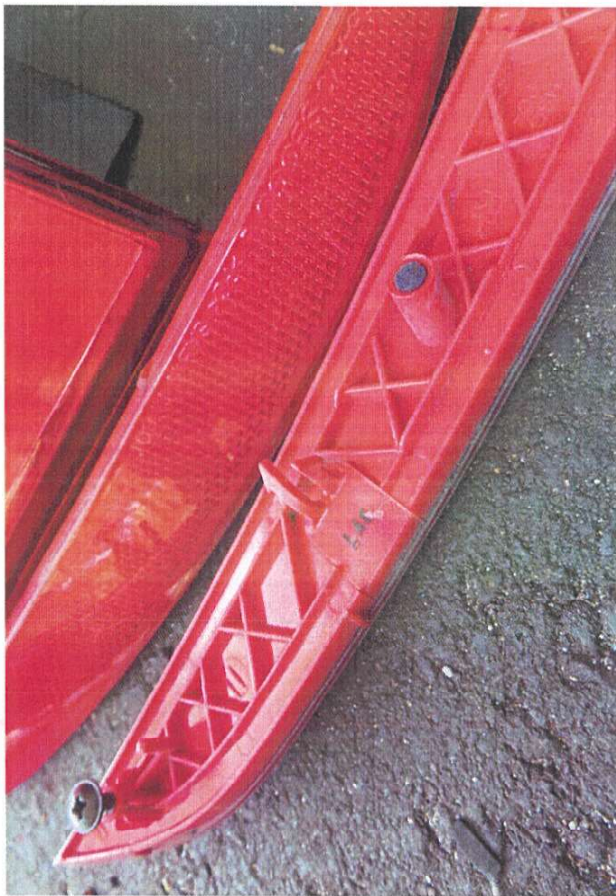
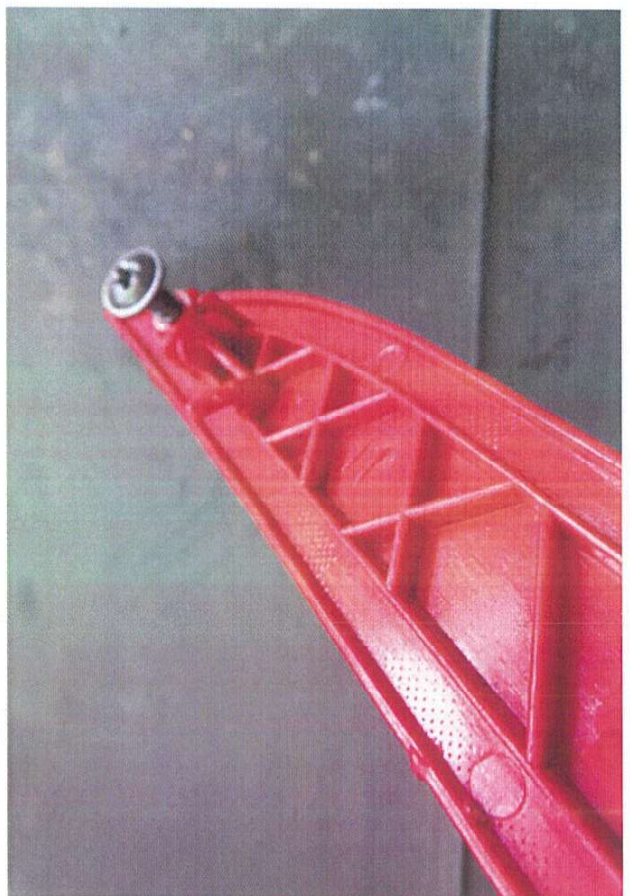
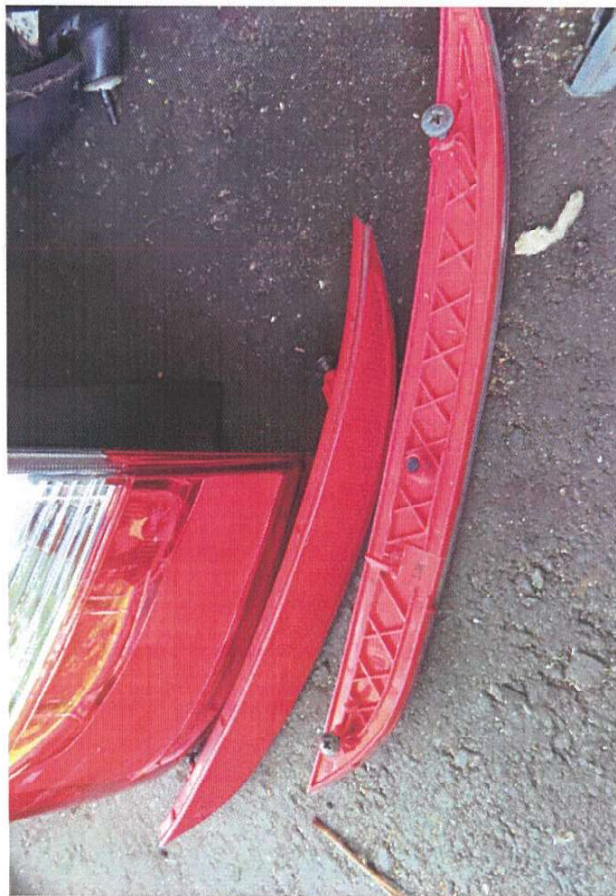
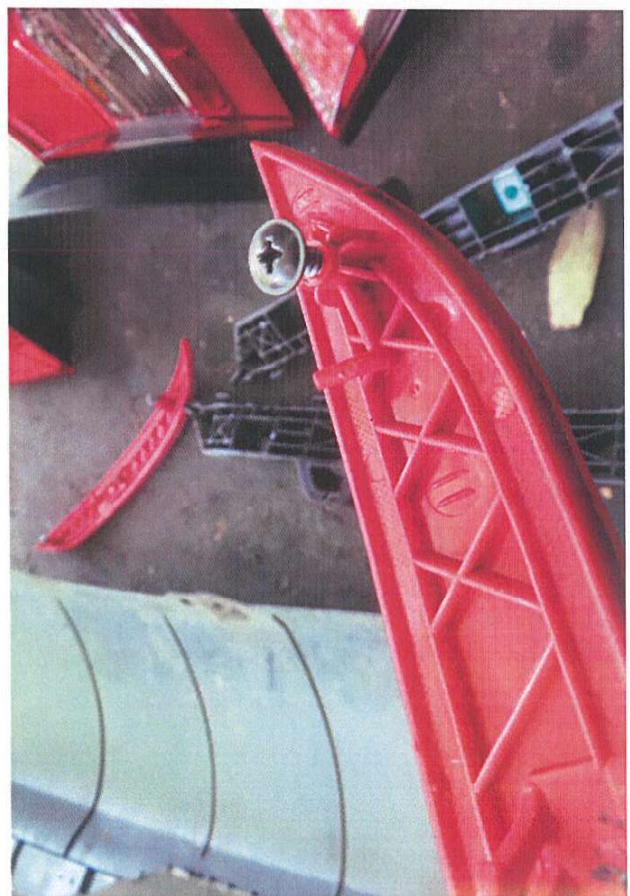
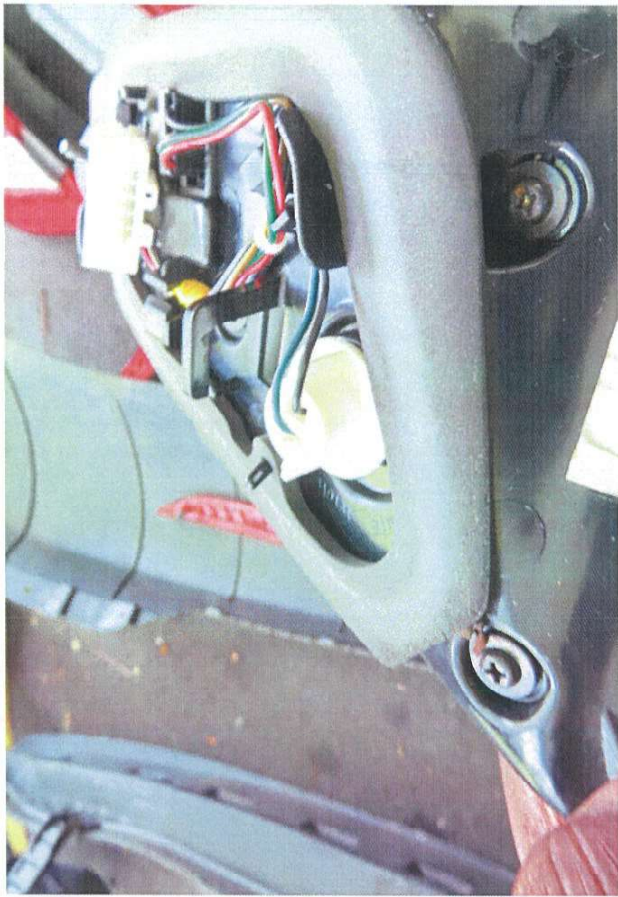
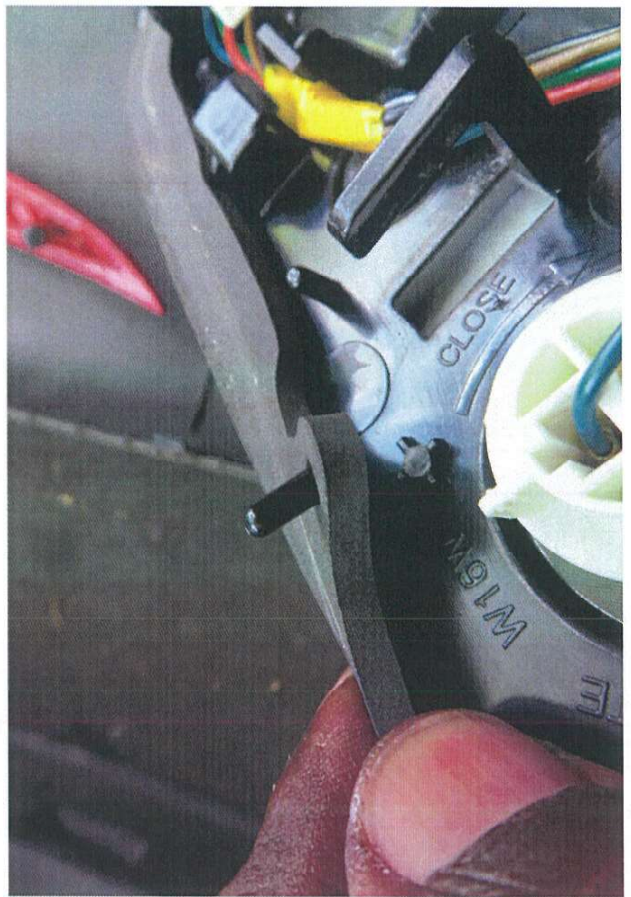
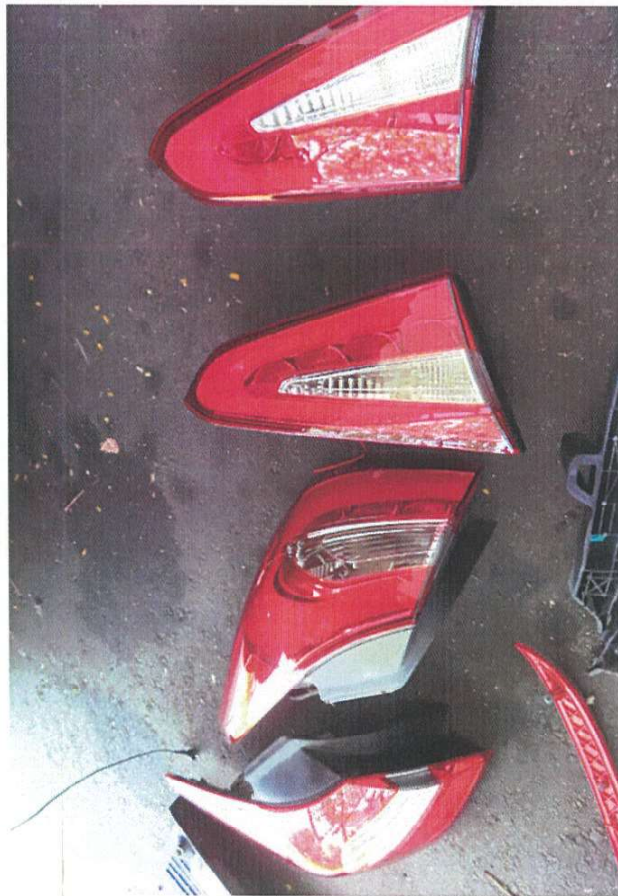
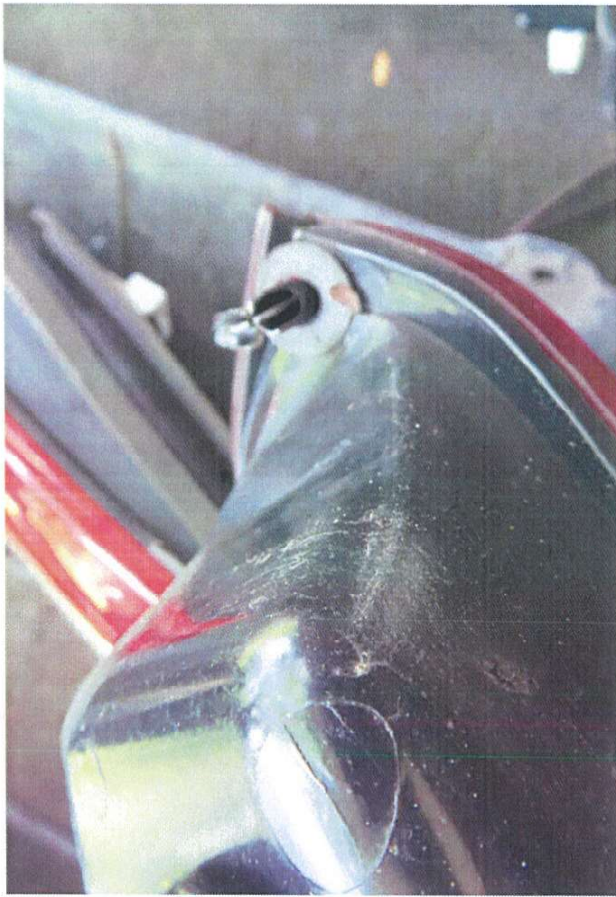
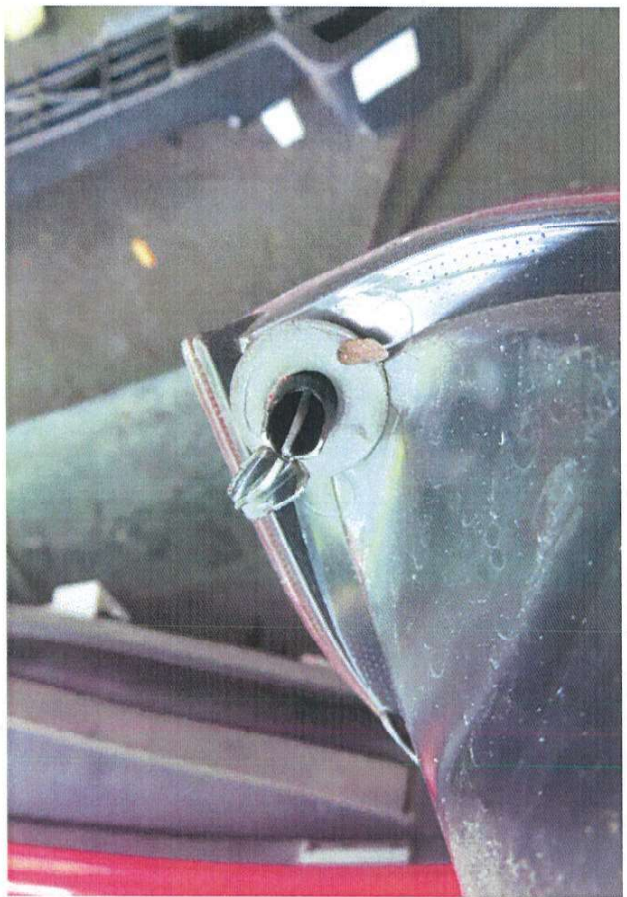
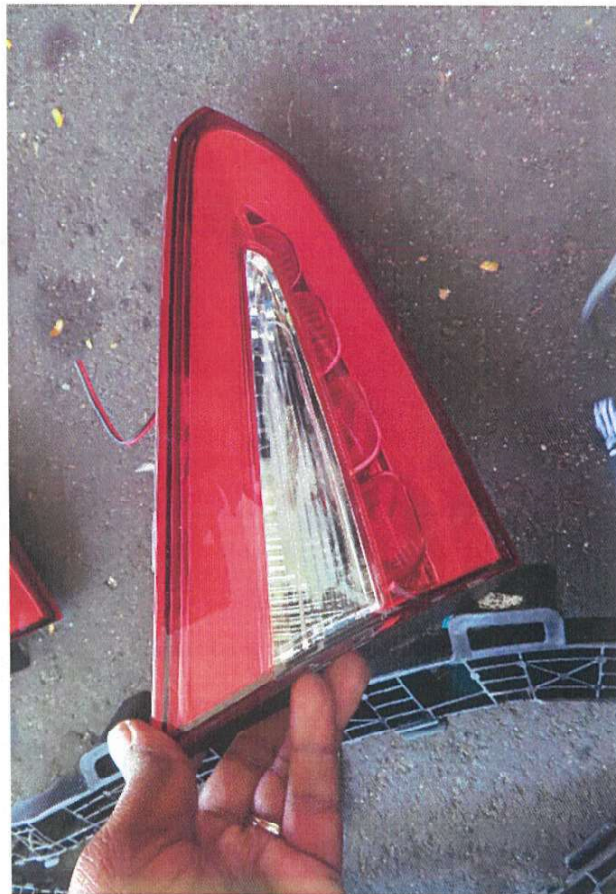
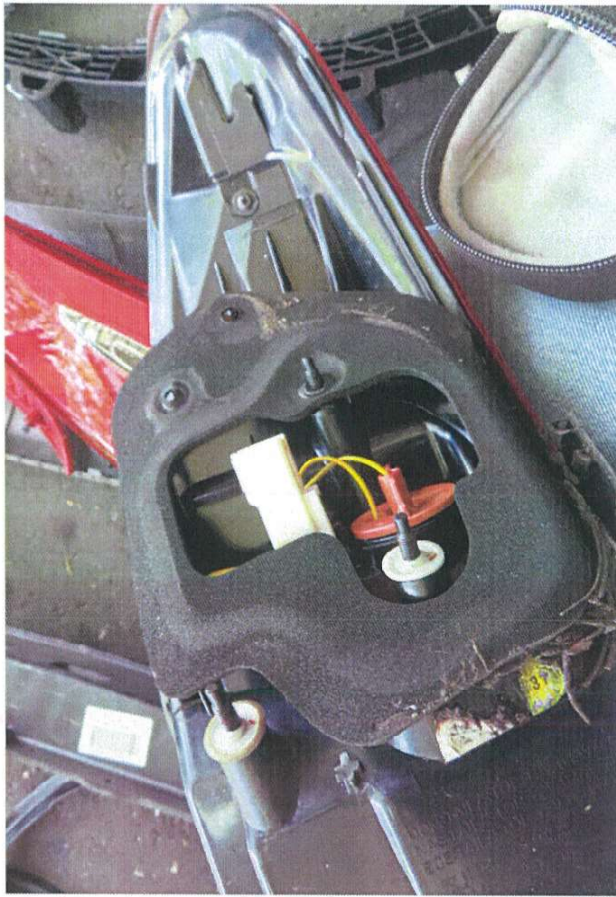
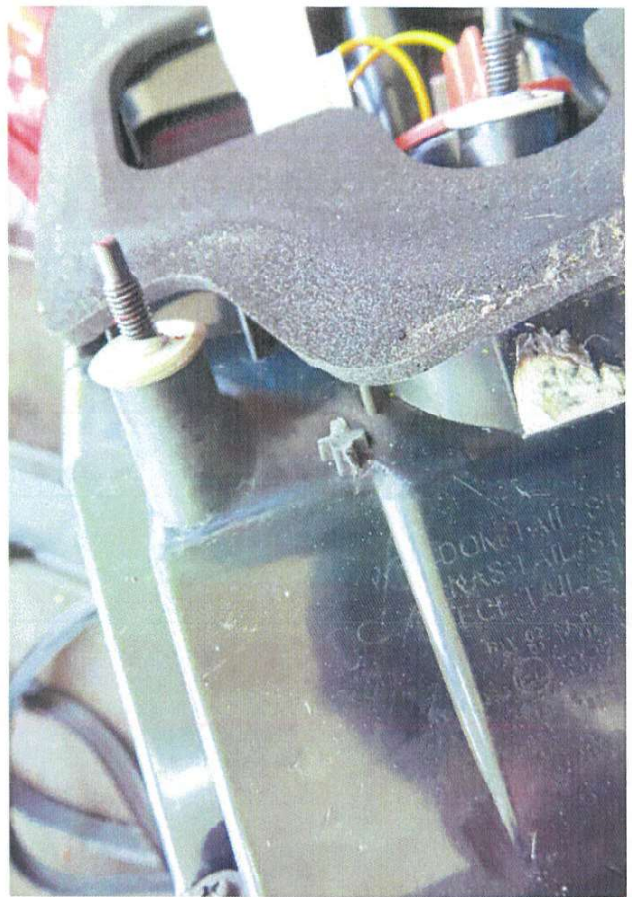
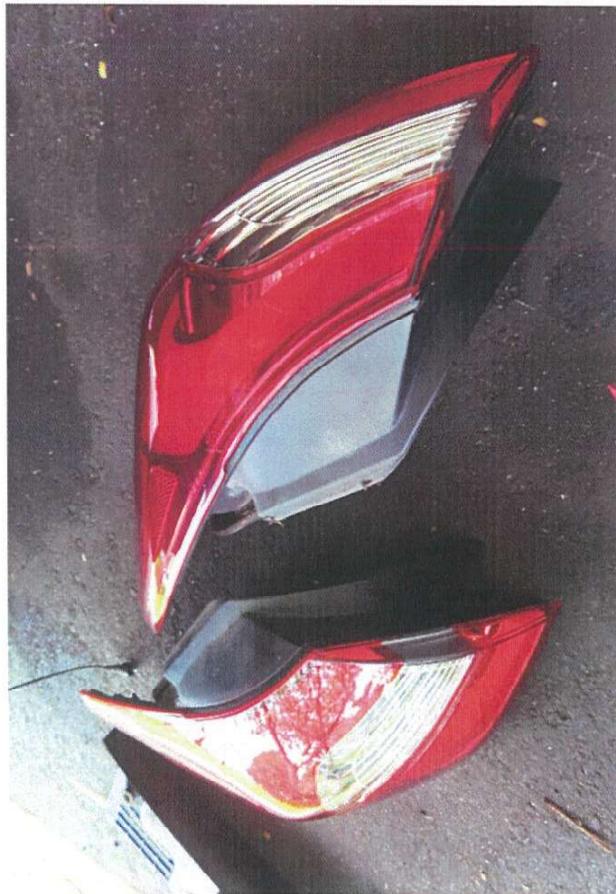
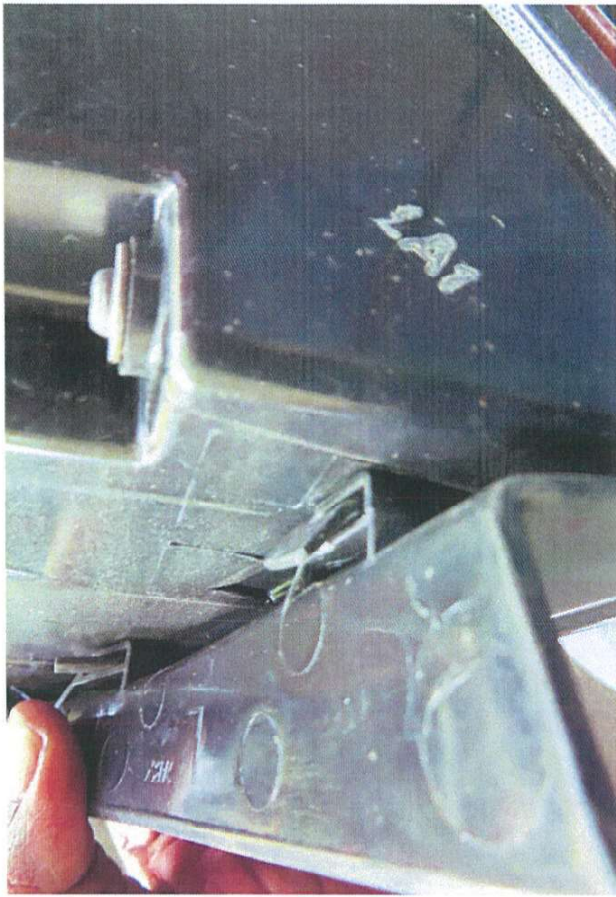
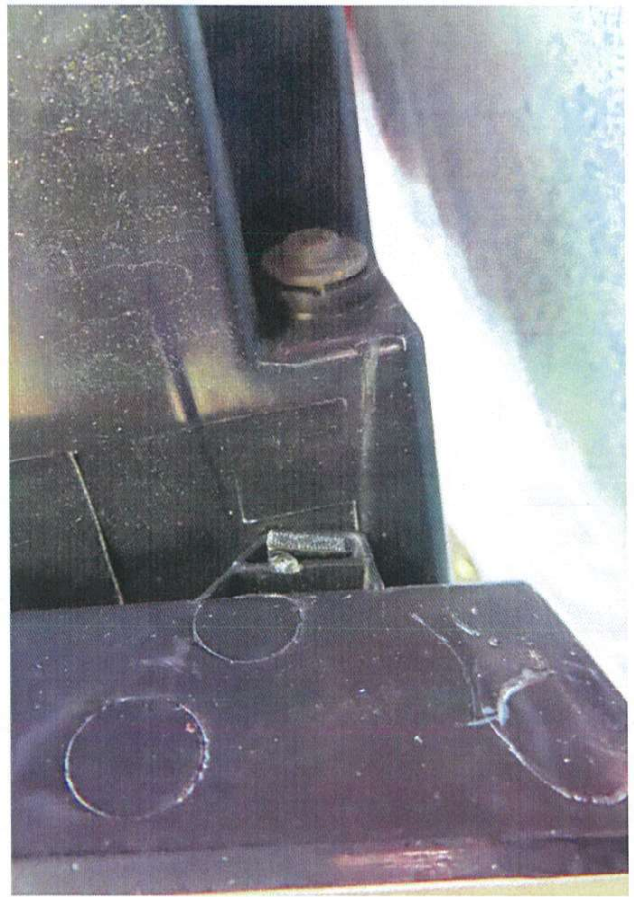
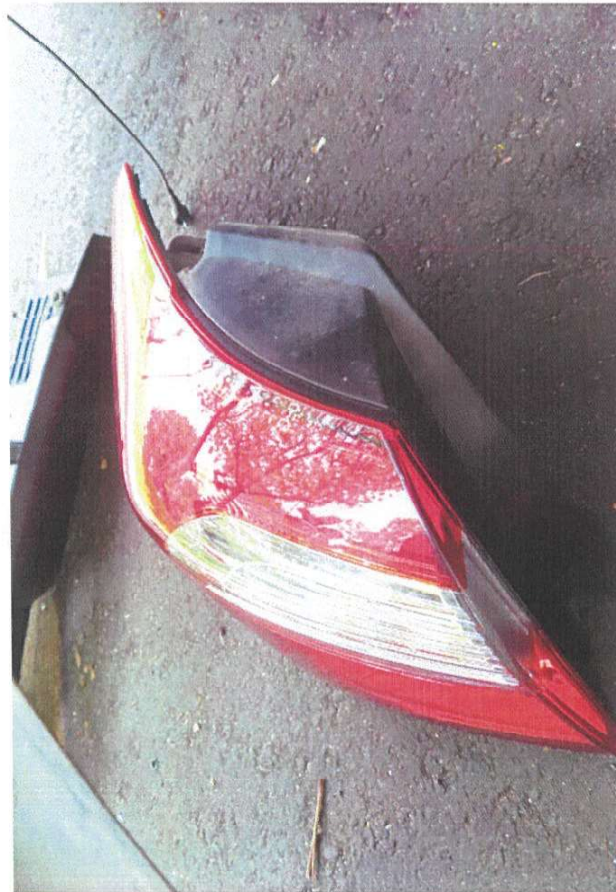
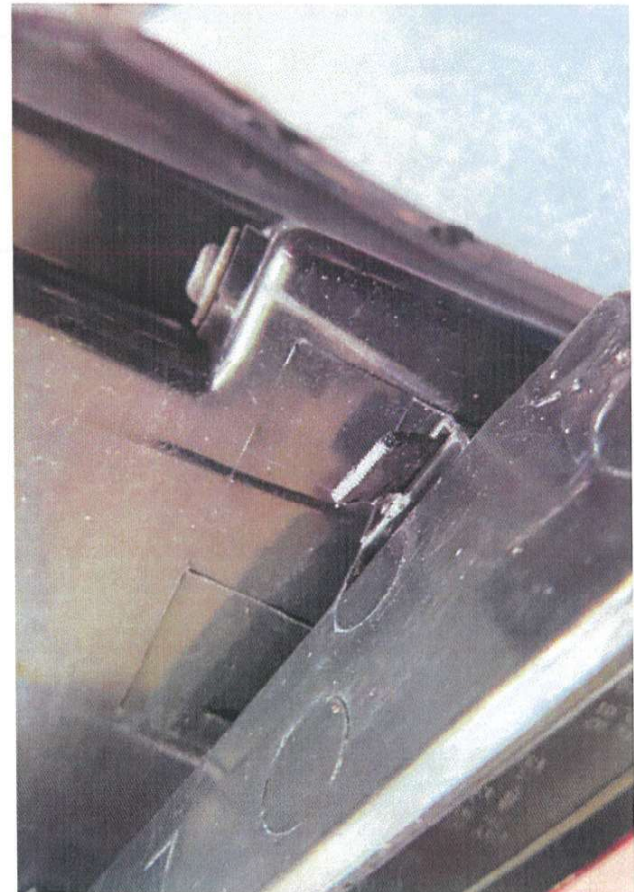
The impact of the collision has damaged/affected the boot lid, boot lid lamps, rear bumper, rear end panel, tail lamp and etc.

Please refer to the Annex for a detailed account of the damages and photographs taken.
