You're Ref: TP/IP/12302/2022  
Our Ref: CI/TPD22006181/P

6<sup>th</sup> July 2022

**MECHANICAL INSPECTION REPORT OF MOTOR CAR SJN 5560A**

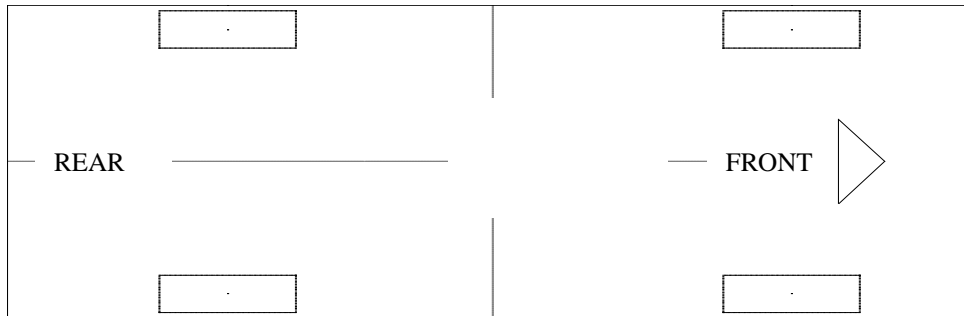
6. The condition of the Motor Car's 4 tyres was observed to be in serviceable condition. I did not find any tear, cut or burst mark(s) on the outer and the inner sidewalls as well as across the tread of the 4 tyres. The 4 tyres were also observed to be sufficiently inflated for vehicular operation. The tyre brand, tyre size and remaining tread depth of the 4 tyres were recorded as follows:-

Nexen 225/45R17 (4.7mm)

Nexen 225/45R17 (5.1mm)

Continental 225/45R17 (6.4mm)

Nexen 225/45R17 (5.3mm)
