Vehicle No.	SHA 2667M
Insured Veh.	SJJ 2670G
Claim No.	SNM22D204402/C02
Policy No.	DMPCSNW00163082102
Accident Date	22/06/2022
Inspection Date	22/06/2022

Make & Model	HYUNDAI I40	c.c	1685
Engine No.	HIDDEN	Year of Reg.	2016
Chassis No.	KMHLB41UMGU085531	Colour	BLUE
Odometer	545360 KM	Steering	IN ORDER
Brakes	IN ORDER	Modification	NIL
General	GOOD

ADJUSTMENT ON REPAIR COST FOR VEHICLE NO. SHA 2667M

PHOTOGRAPHS FOR VEHICLE NO. SHA 2667M

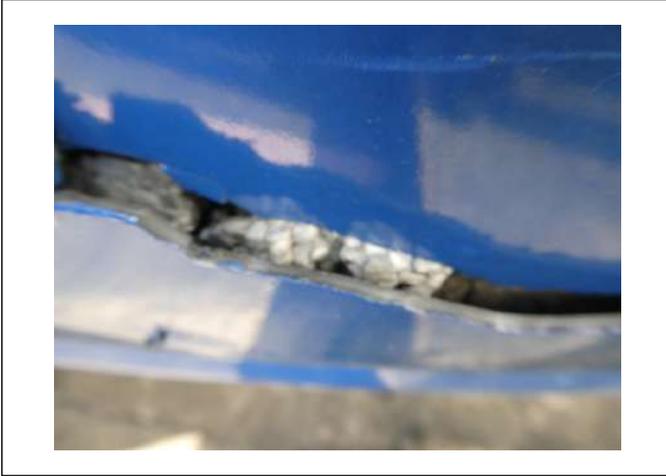
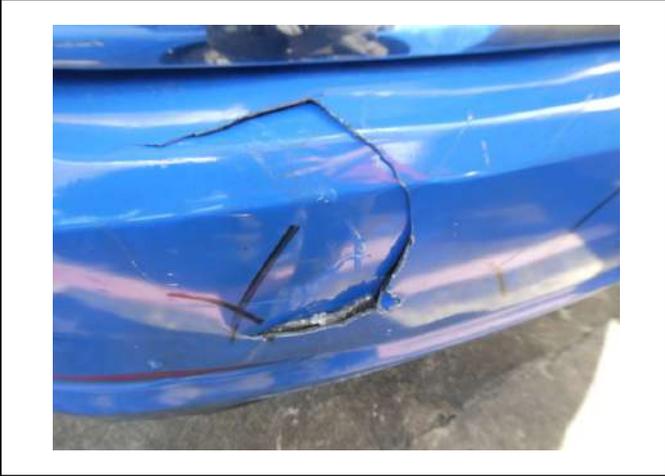
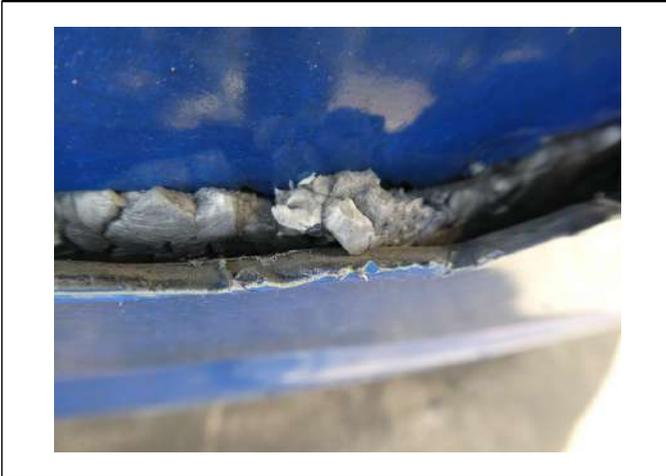
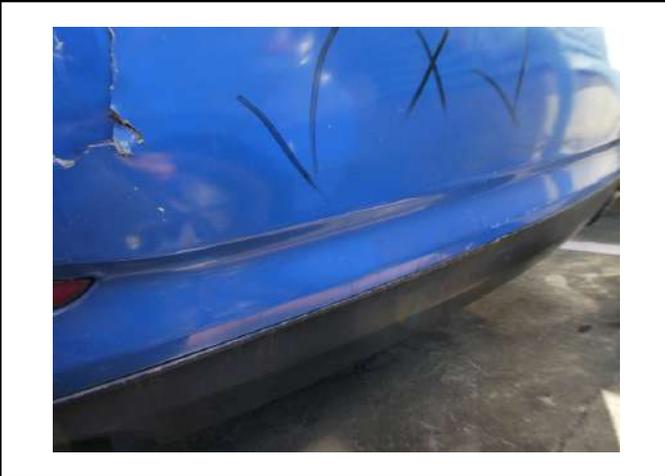
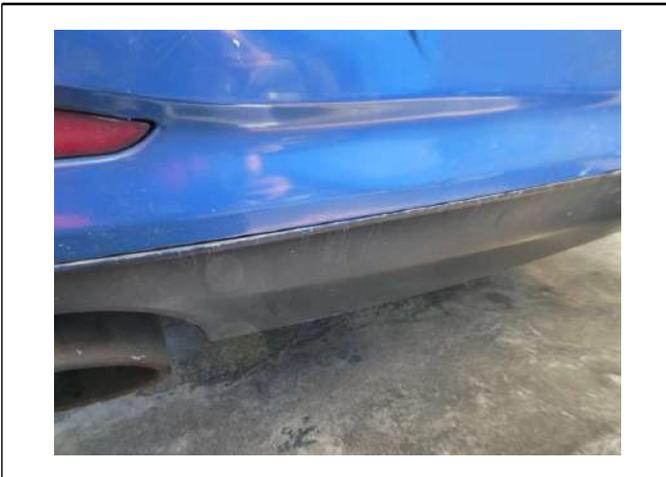
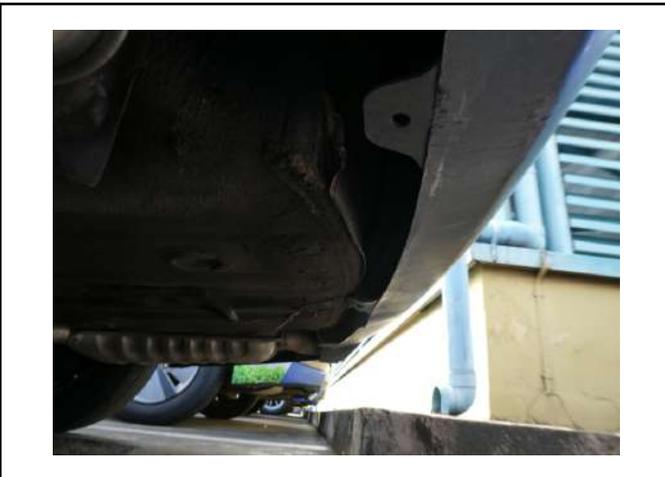
THE VEHICLE SUSTAINED DAMAGES AT THE REAR PORTION.
DAMAGES SEE DETAILS.

Qty	Description of Parts	Condition	Estimate By Workshop (\$)	Our Adjusted (\$)
<u>REPLACEMENT OF PARTS</u>				
1	COVER ASSY -RR BUMPER	CRACKED	553.00	553.00
1	COVER-RR BUMPER LWR	CUT	228.00	228.00
1	ABSORBER -RR BUMPER ENERGY	CRACKED	119.50	119.50
1	BEAM -RR BUMPER	NOT NECESSARY	428.40	-
10	BUMPER COVER CLIP REAR	NECESSARY	22.00	22.00
1	STAY RR BUMPER LH	NOT NECESSARY	160.60	-
1	STAY RR BUMPER RH	NOT NECESSARY	160.60	-
	LESS 20% DISCOUNT		-334.42	-184.50
			1,337.68	738.00
<u>SPECIAL NETT ITEMS</u>				
1	REVERSE SENSOR ASSY (SN)	NOT NECESSARY	135.70	-
			135.70	-
<u>LABOUR</u>				
	PANEL BEATING.		300.00	280.00
	SPRAYPAINT CHARGE.		300.00	250.00
	REMOVE/REFIX REVERSE SENSOR .		50.00	30.00
			650.00	560.00
GRAND TOTAL			2,123.38	1,298.00

RECOMMENDED COST OF LUMP SUM REPAIRS (TO ITS PRE-ACCIDENT CONDITION)			1,050.00
---------------------------------------------------------------------------------	--	--	-----------------
