VEHICLE APPRAISAL REPORT

Name of Workshop : Leng Wang Motor
Place of inspection : Blk 3007 Ubi Road 1, #01-414 Singapore 408701
Date of Assignment : 28 February 2022
Date of Accident : 25 February 2022
Date of Inspection : 28 February 2022

Registration No.	: SKB 9462A	Chassis Frame No.	: KMHEC41CMBA259304
Make / Model	: Hyundai i45 2.4(A)	Engine No. (Logcard)	: G4KEAU223318
Year of Manufacture/Reg	: 2010	Odometer Reading	: 255,049 KM
Colour	: White		
Class / Type	: Saloon

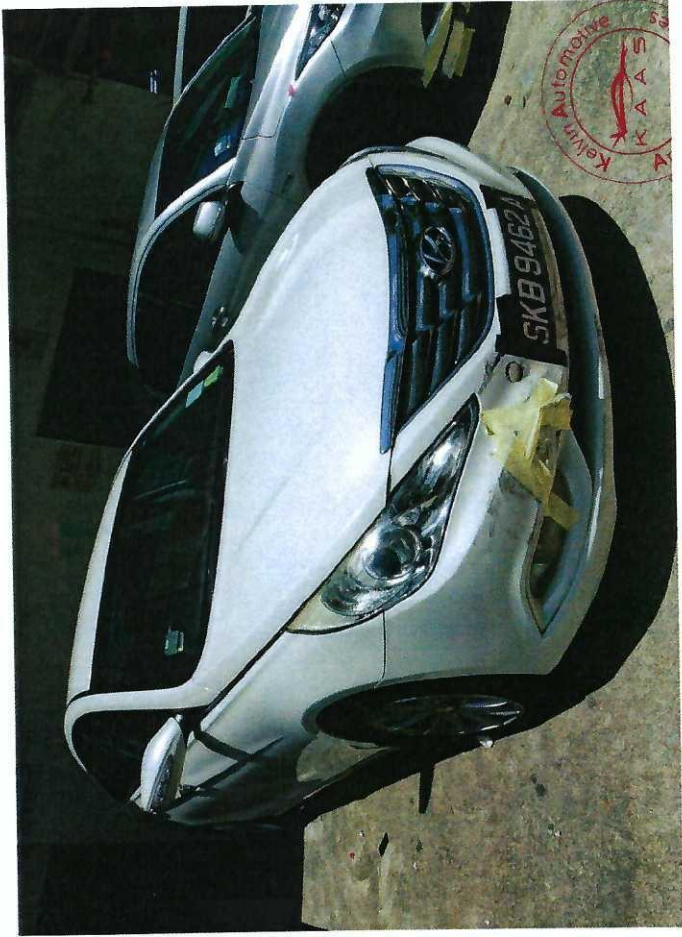
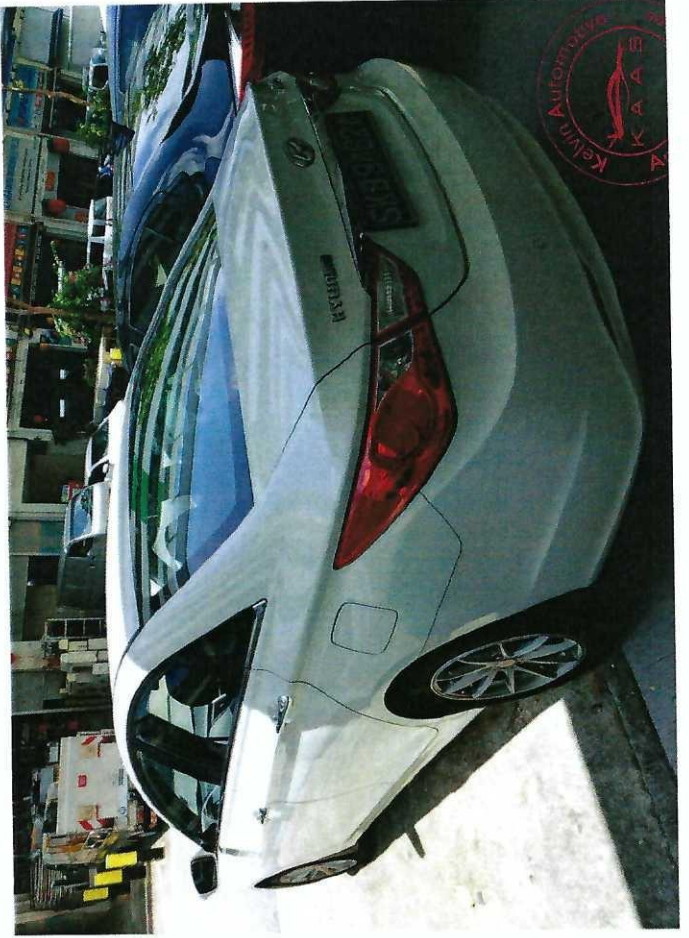
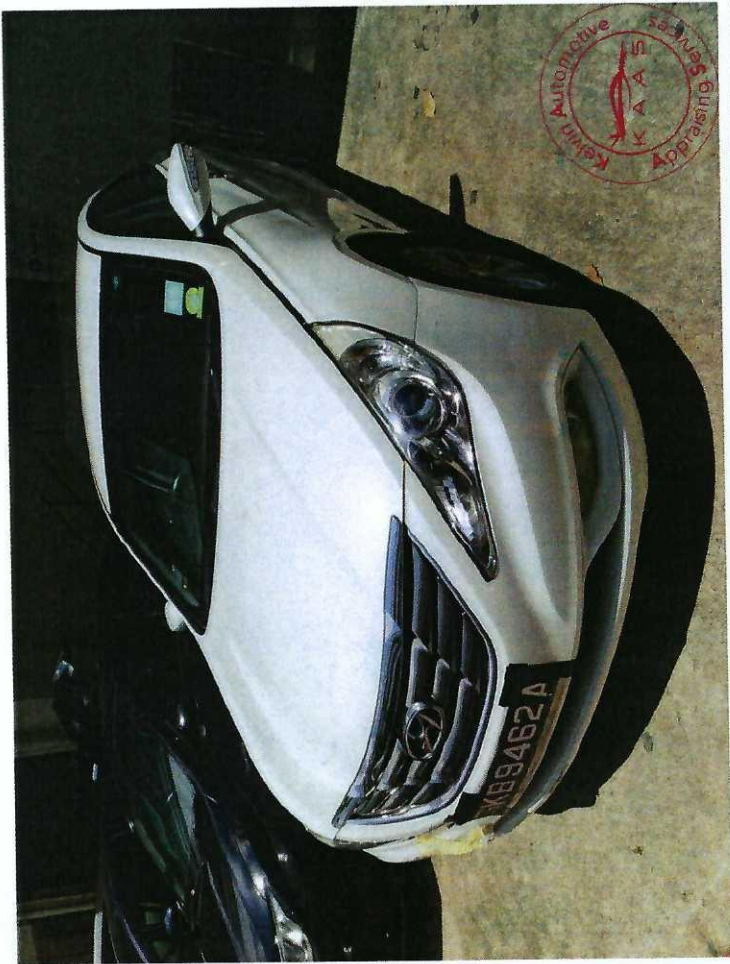
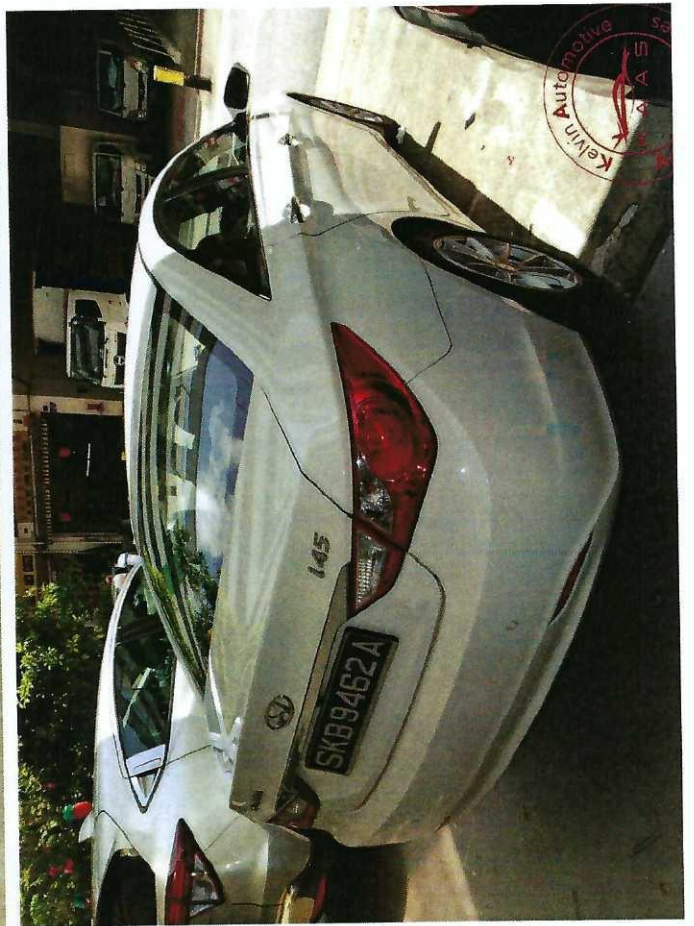
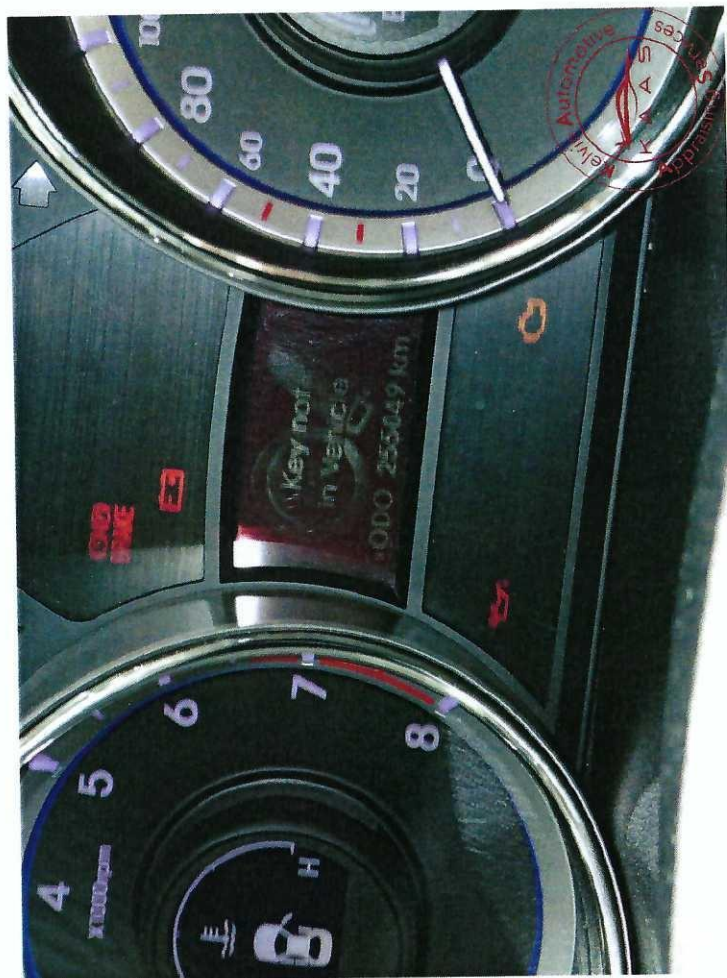
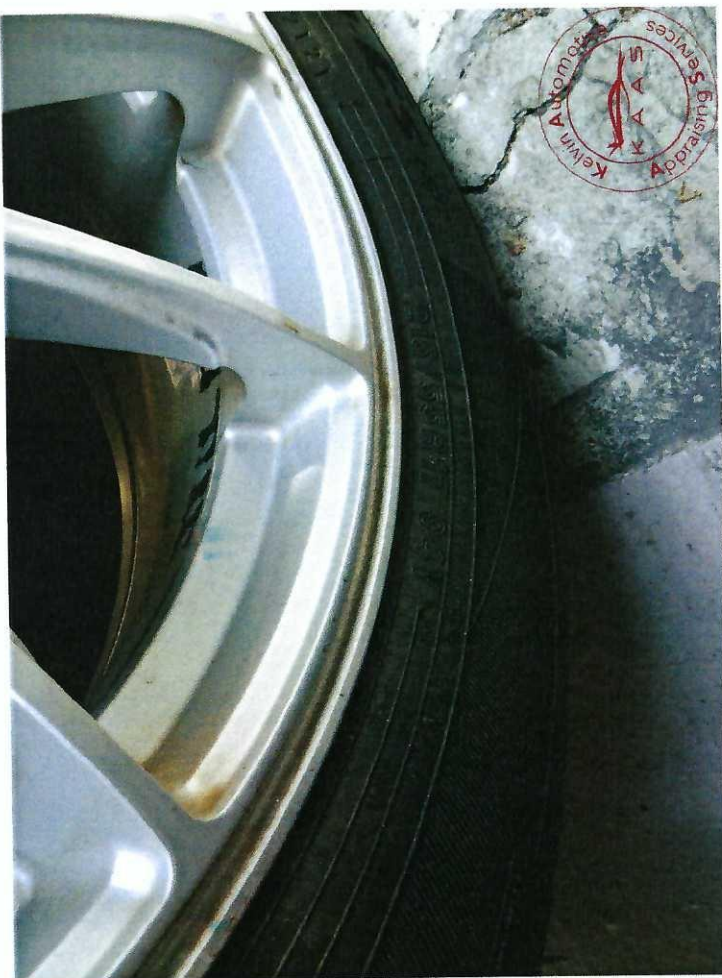
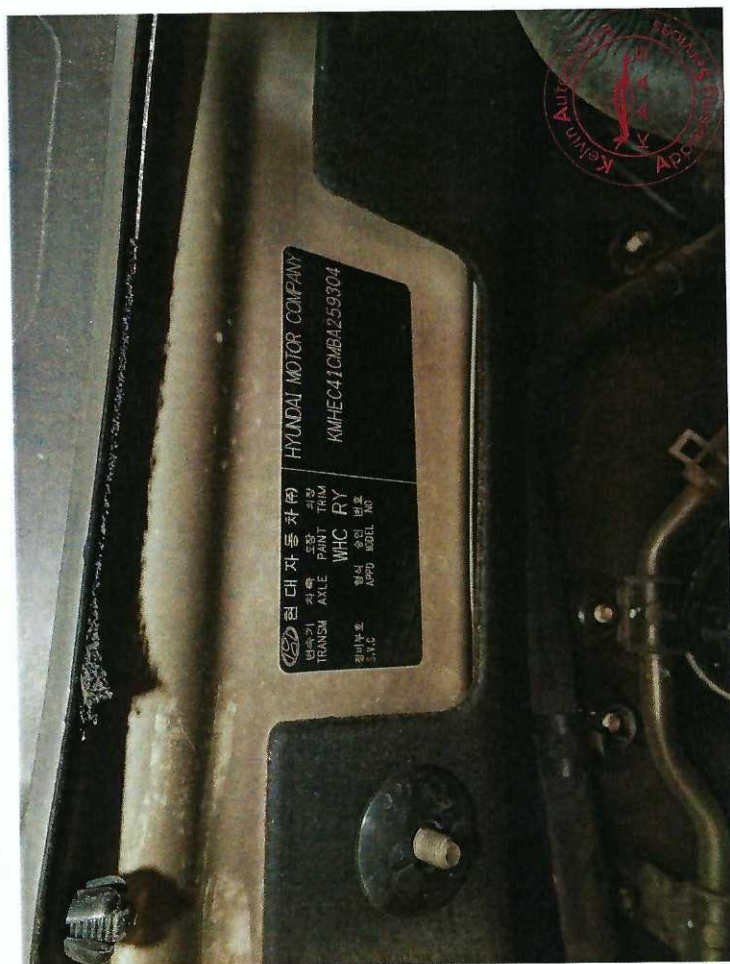
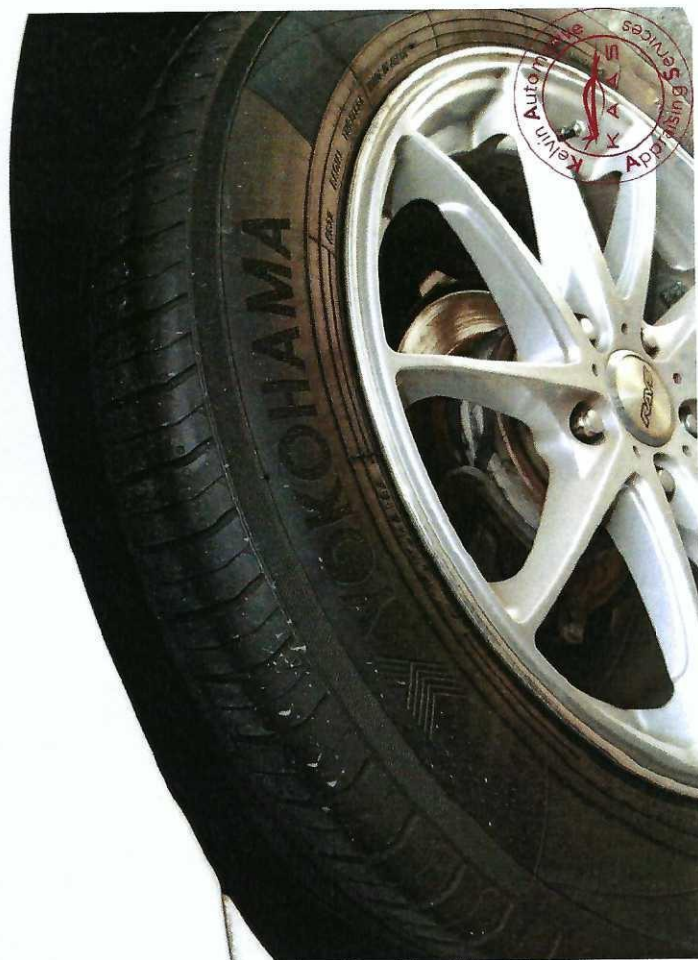
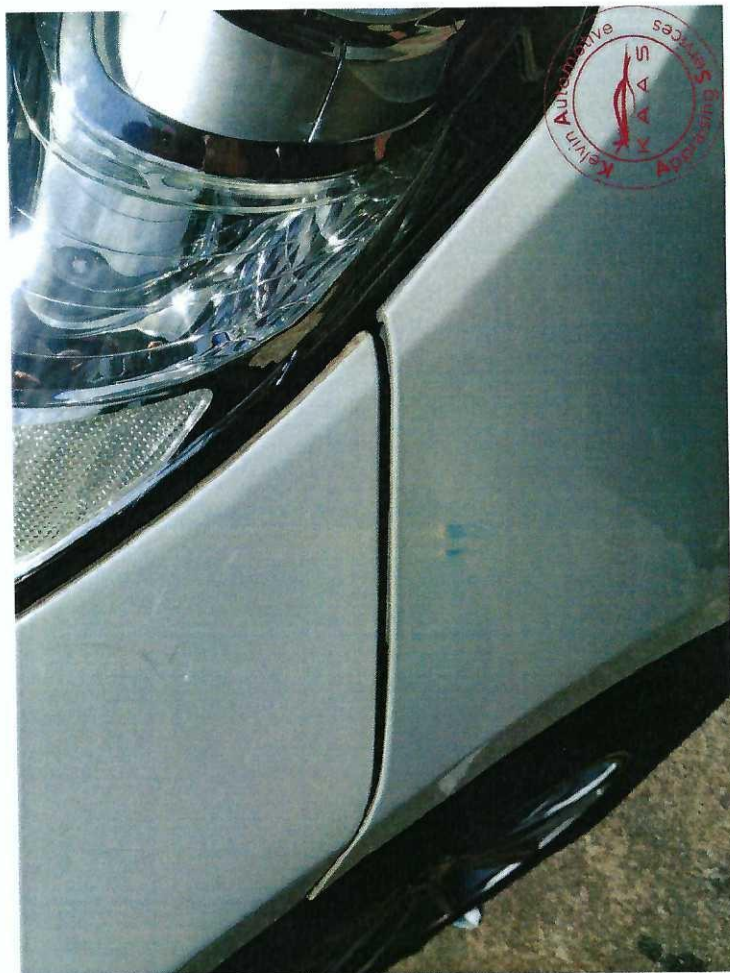
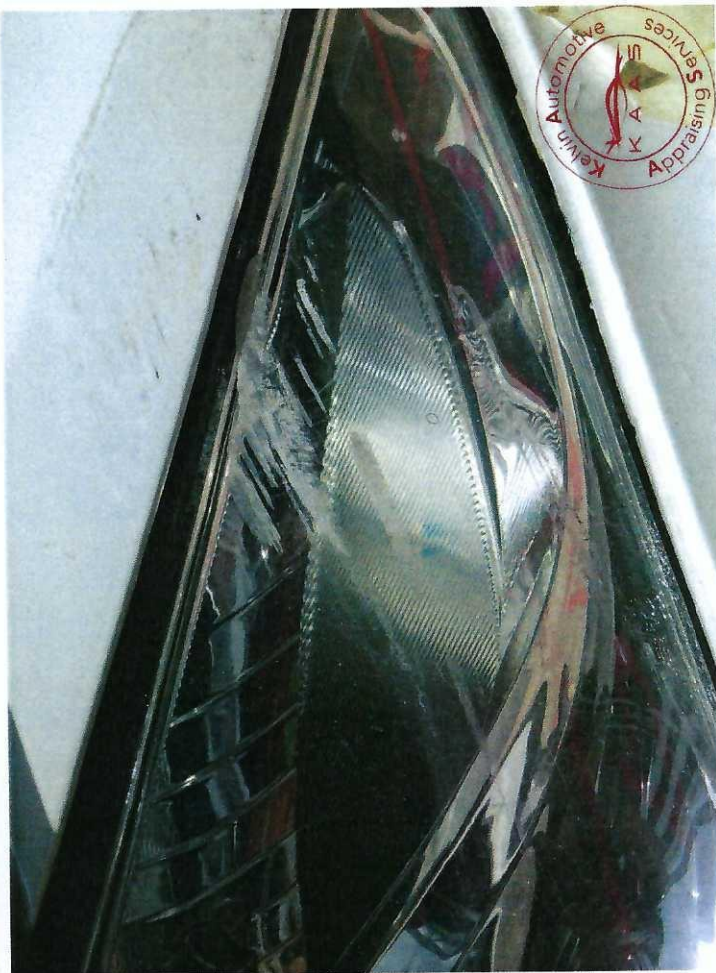
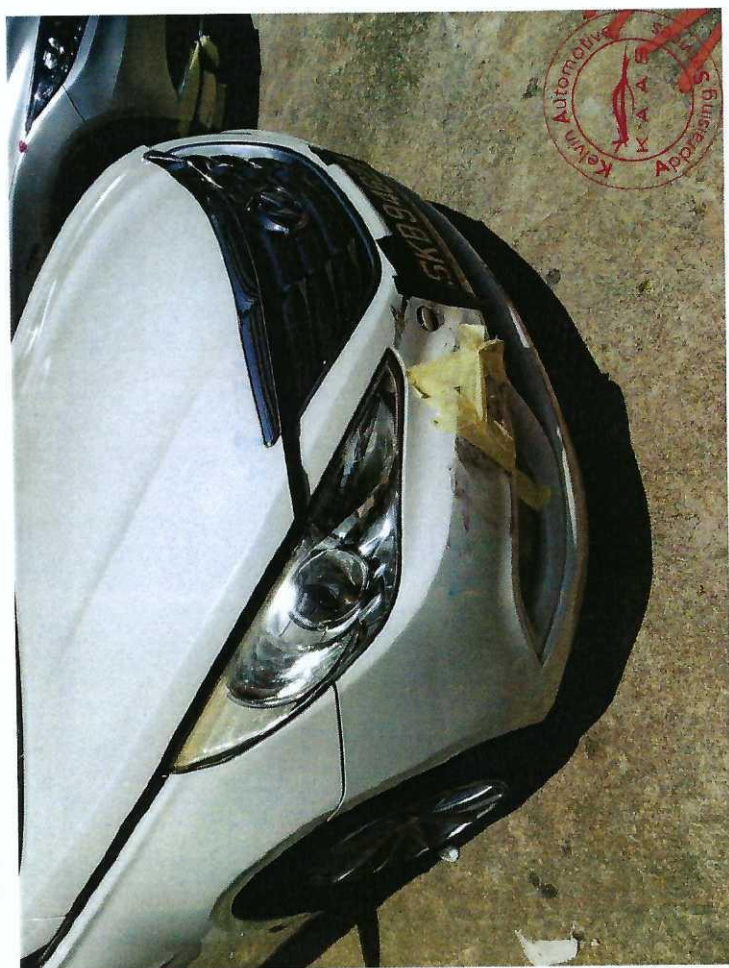
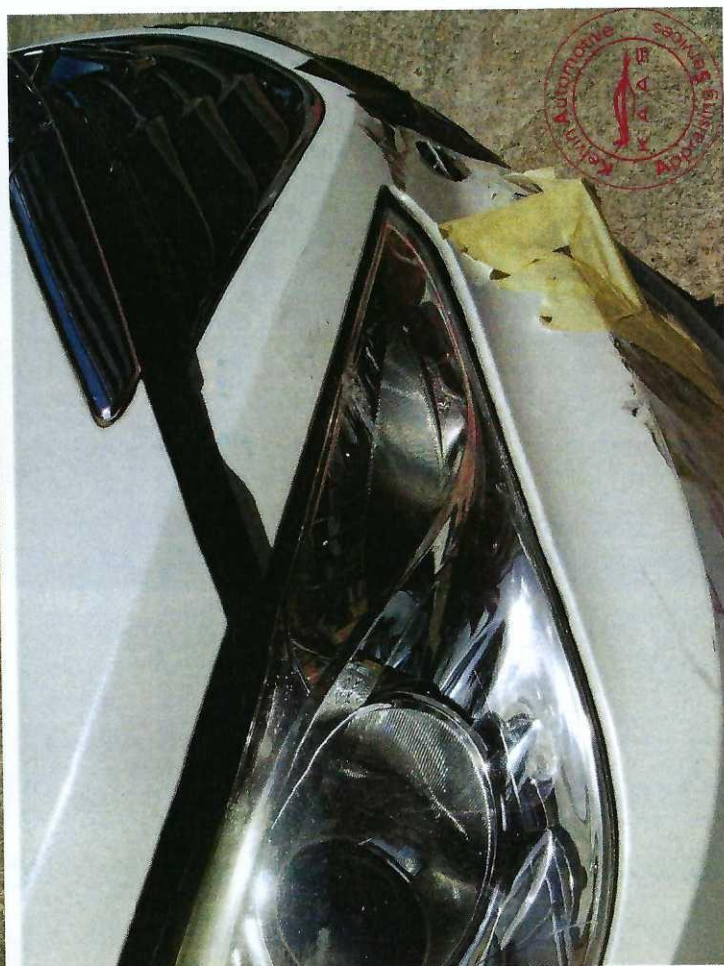
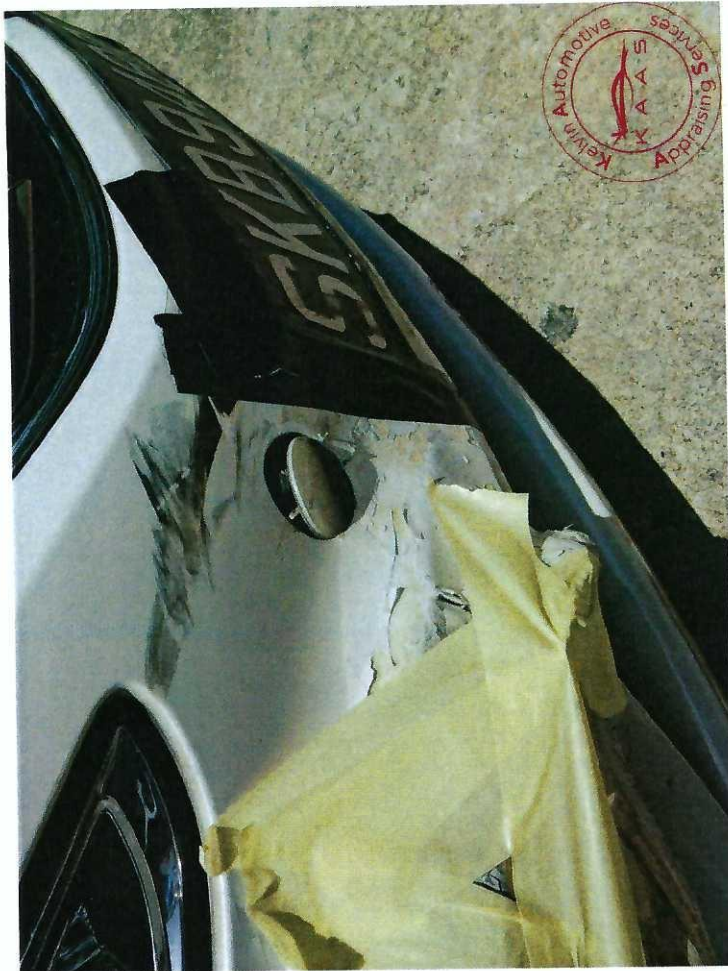
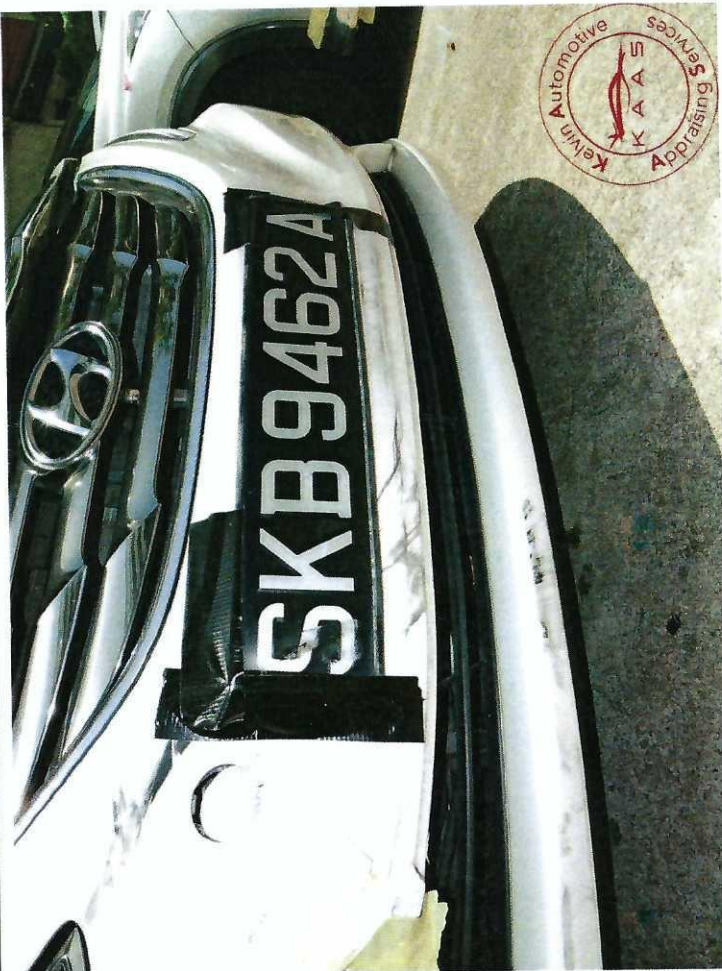
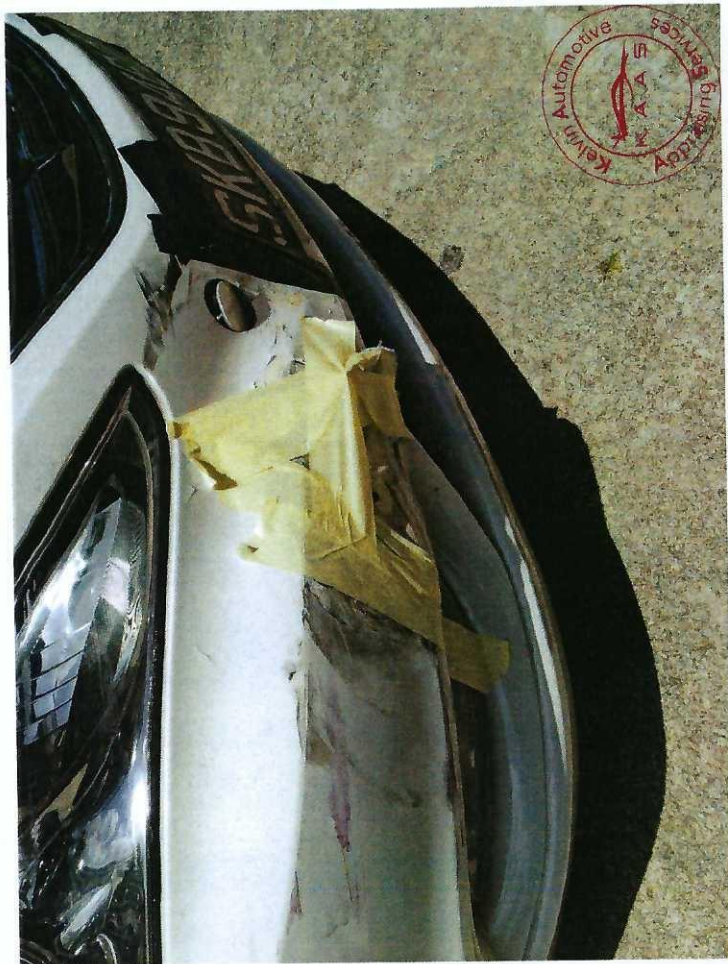
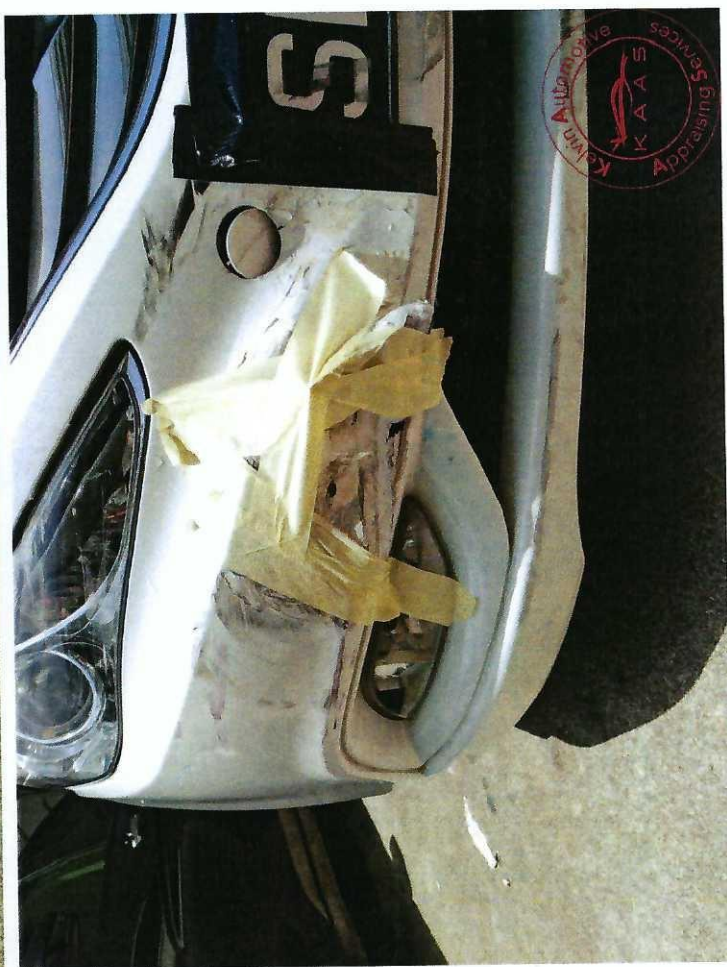
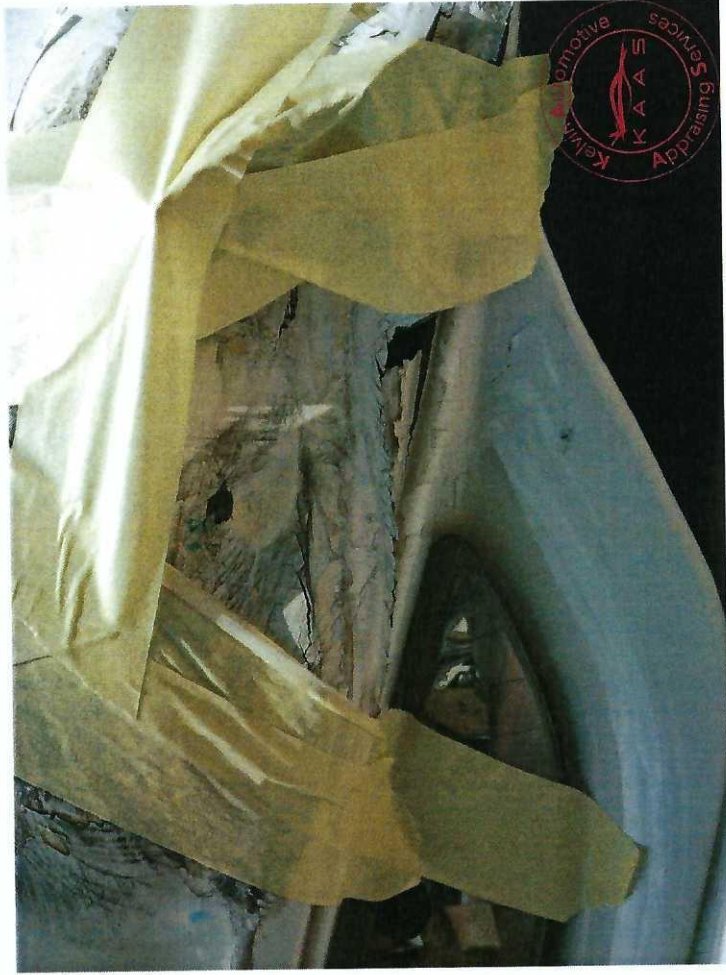
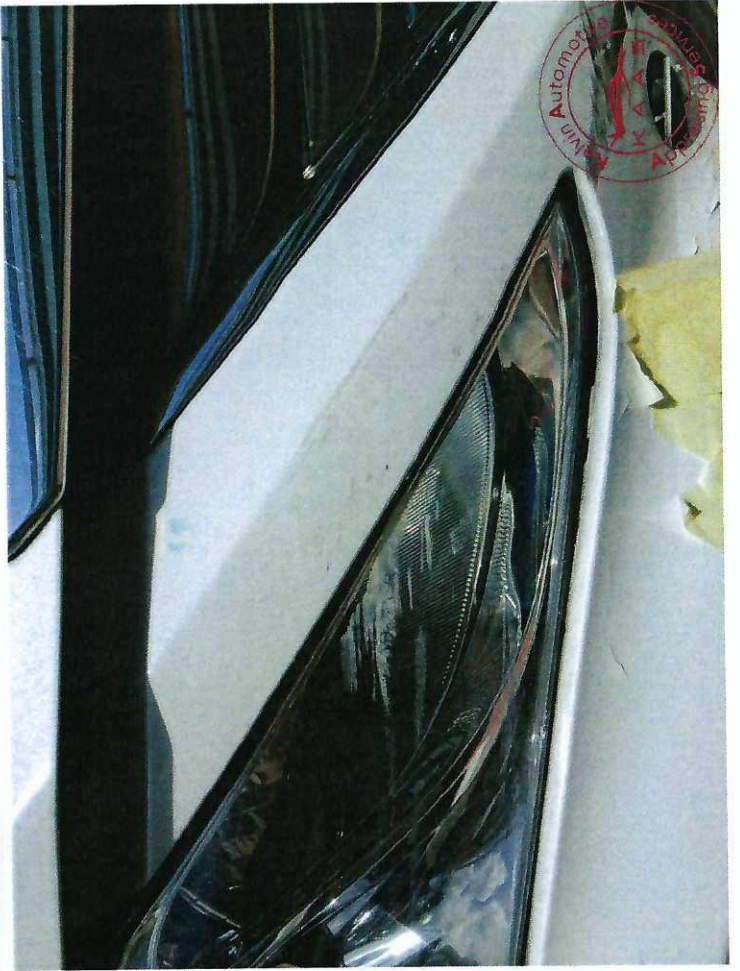
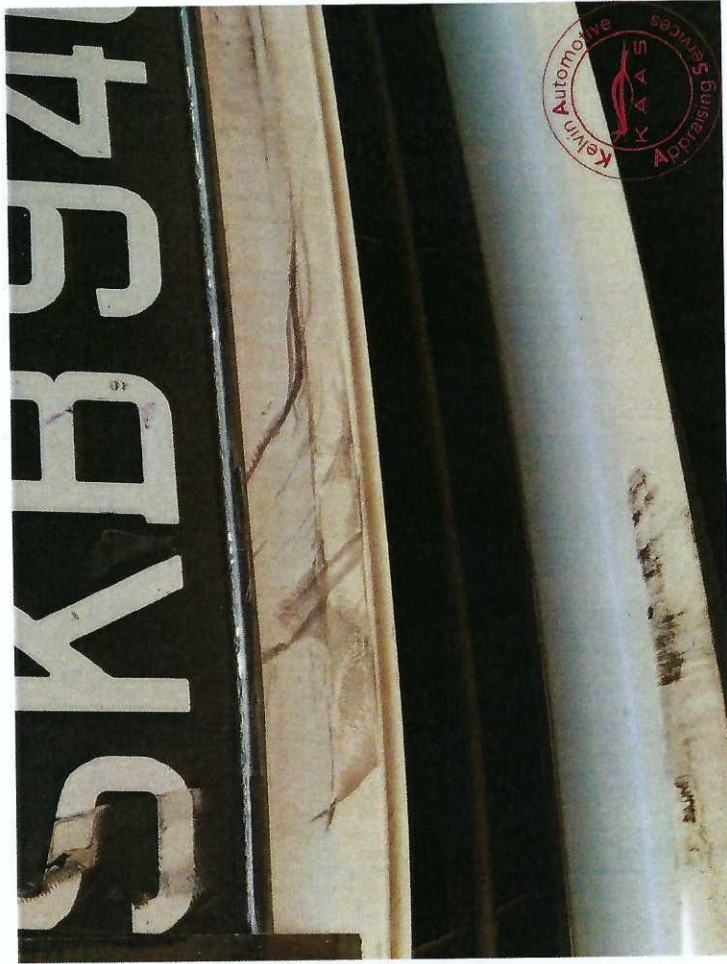
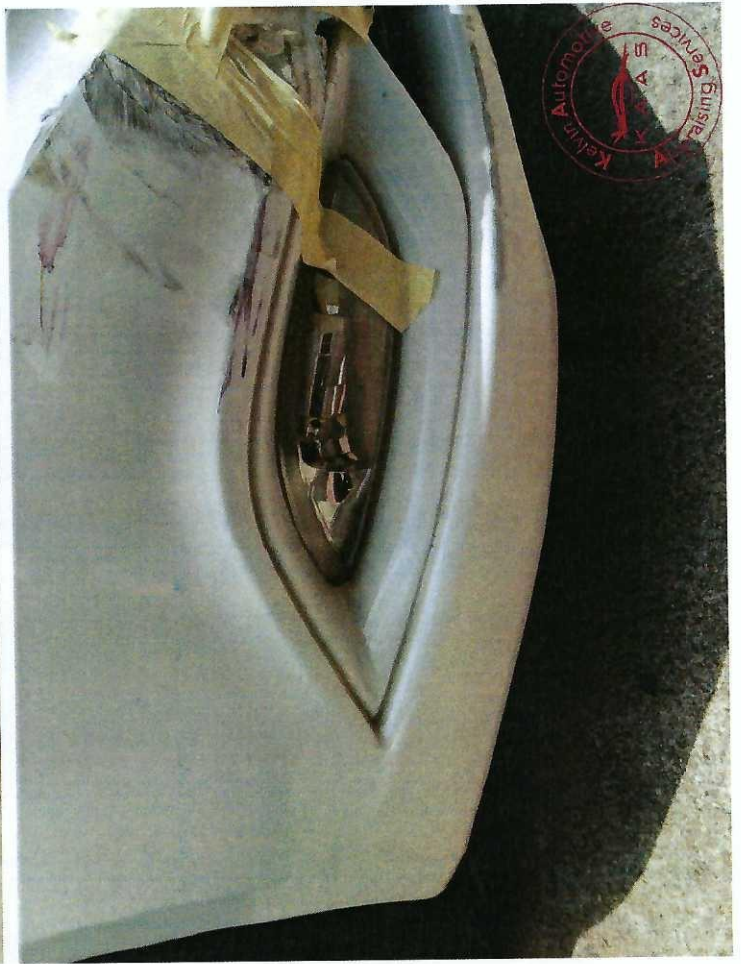
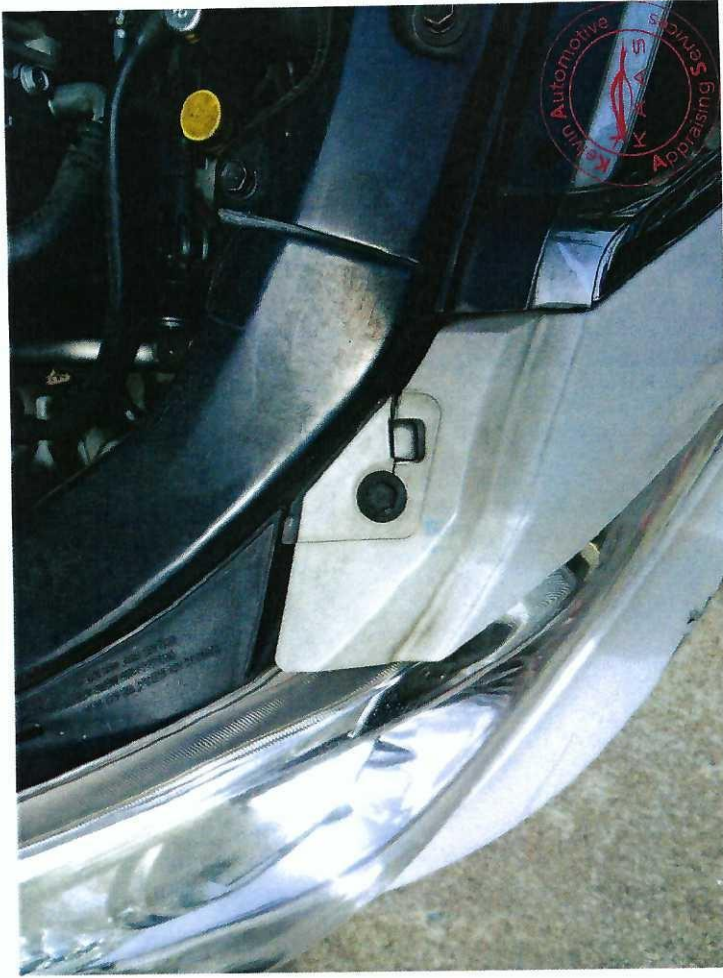
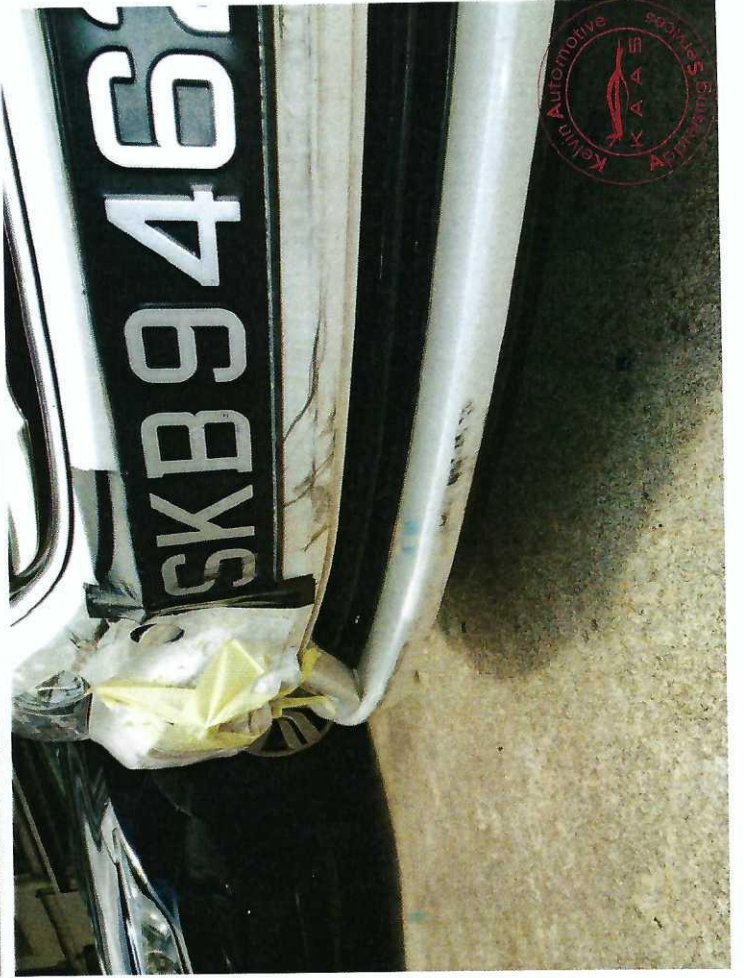
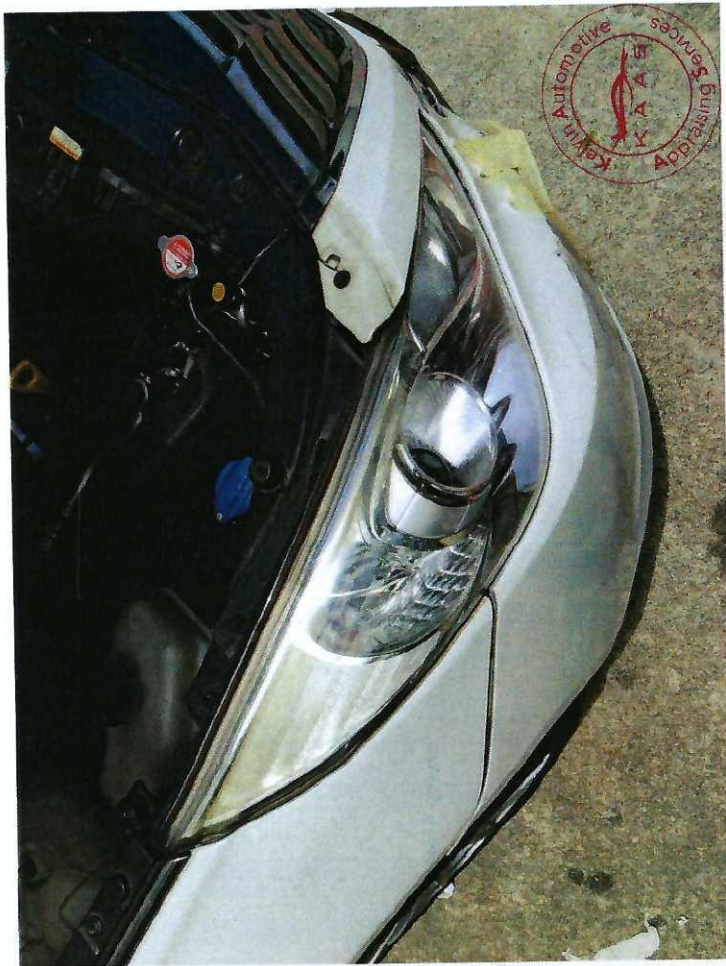
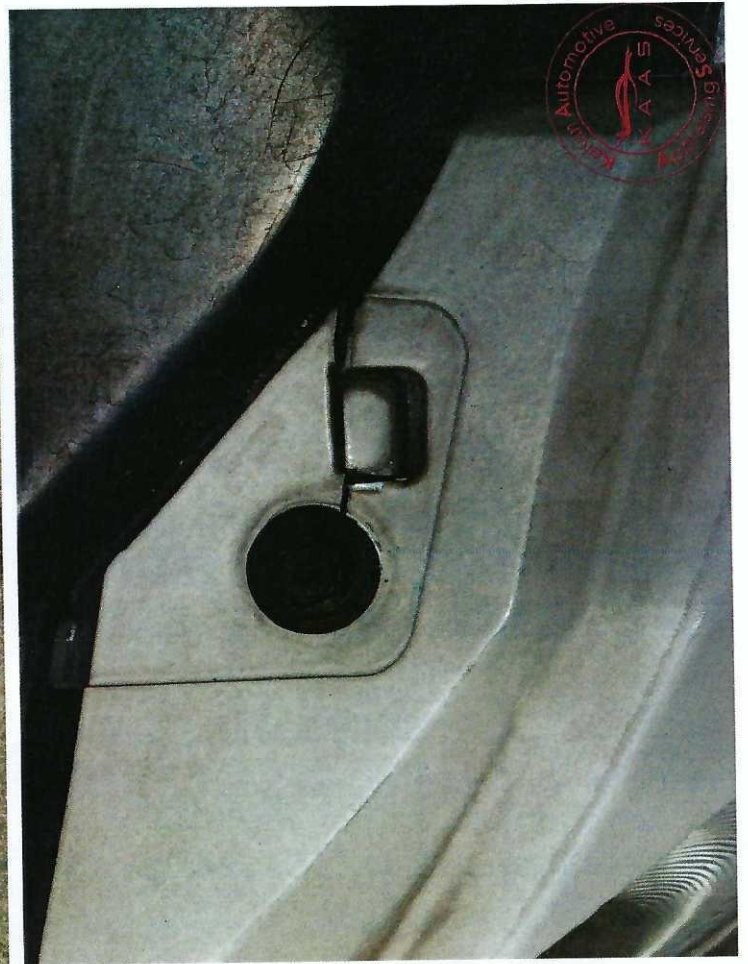
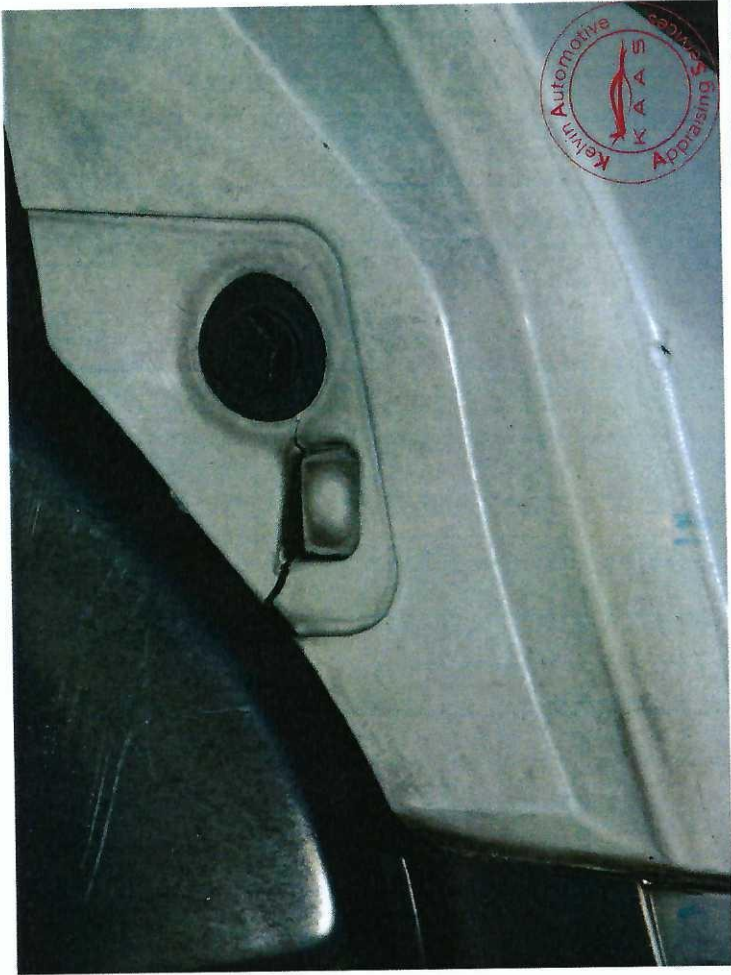
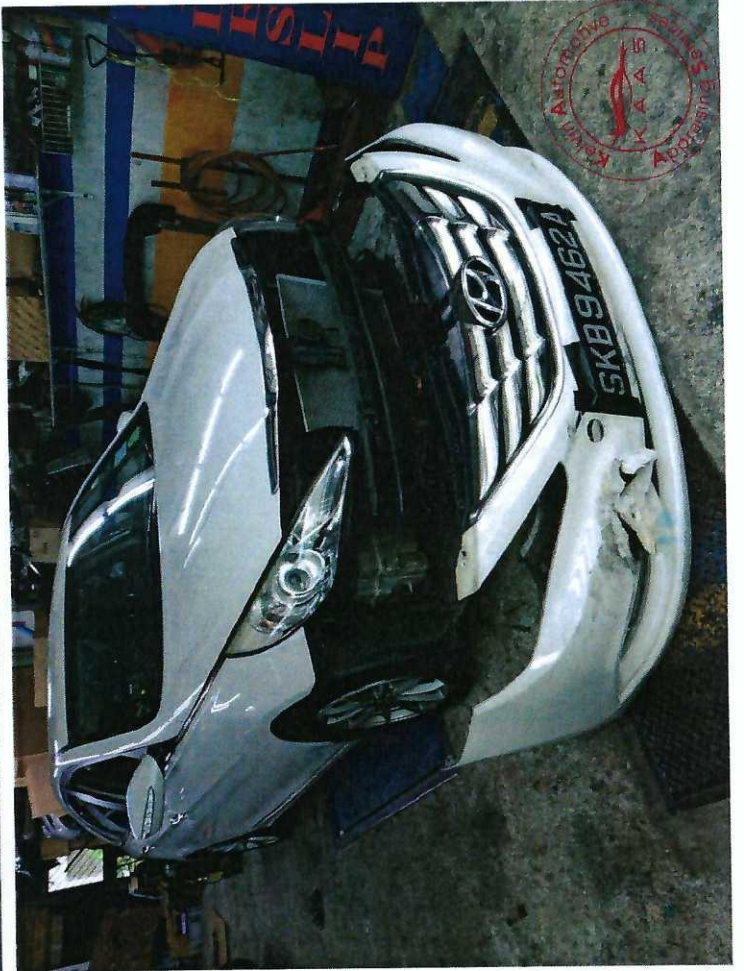
Damages sustained were consistent with the subject vehicle being involved in a collision with another vehicle and the impact was delivered **Squarely to the RH front** of the vehicle.

The general area of damages is at the **Front portion**
(Please refer to the parts list and photographs as attached for more information)

The estimated repair costs submitted by Messrs **Leng Wang Motor** is \$ 8,363.90 .
We have adjusted the cost to \$ 5,514.04 and the repairer has agreed to undertake the repairs at a **Contract Lump Sum of \$ 4,400.00** to a acceptable quality and standards.
However, we have not given authorization and instruction to the repairer to proceed with the repairs.
