INVESTIGATION REPORT:

Our Ref : CS4/CTI22007763/N
Policy No : DMPCSNW00202242101
Insured : SJQ 26T
Date of Incident : 11 August 2022
Location : Yio Chu Kang Road towards SLE (TPE)

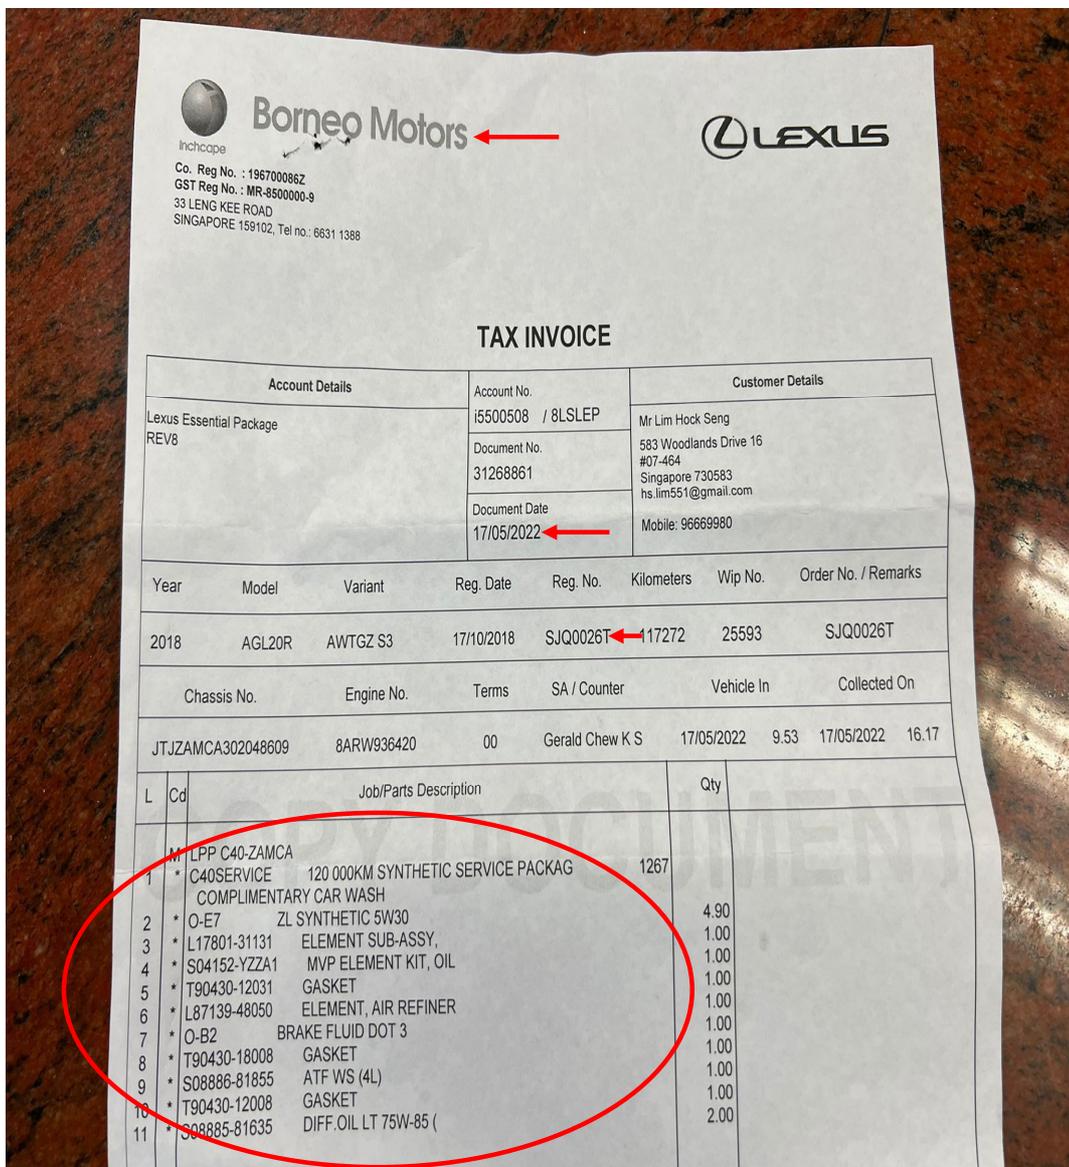
Invoice 1 shows the document relating to the last servicing that was carried out to the Insured Vehicle on 17 May 2022 at Borneo Motors (red arrows). The job scope of this servicing had included changing of engine oil, brake fluid and auto transmission fluid (ATF). The oil gaskets were also replaced (circled).
