Your Ref: TP/IP/08485/2022
Our Ref : CI/TPD22008162/P

8th September 2022

MECHANICAL INSPECTION REPORT OF MOTOR CAR SLT 1332M

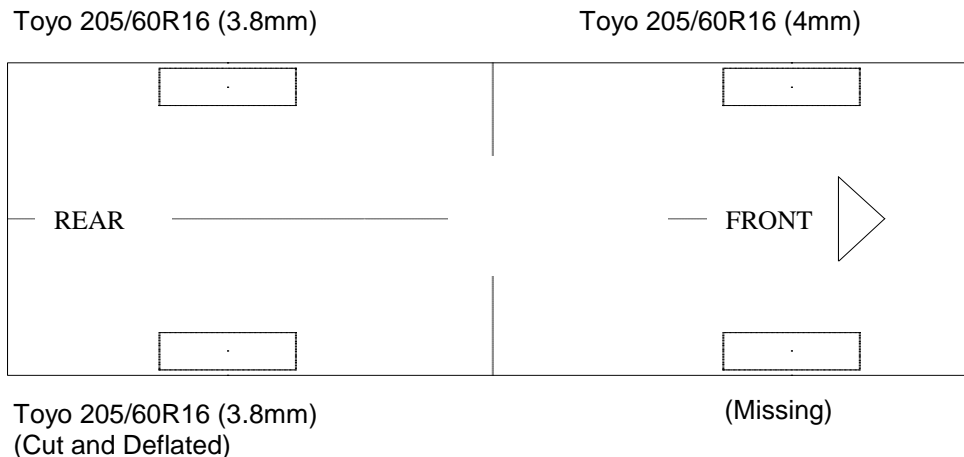
6. The Motor Car's front right tyre and wheel rim was observed to be missing and the rear right tyre was observed to be deflated and wheel rim damaged as a result of the accident. However, both front and rear left tyres and wheel rims were observed to be in serviceable condition. I did not find any tear, cut or burst mark(s) on the outer and the inner sidewalls as well as across the tread of the 2 tyres. The front and rear left tyres were observed to be sufficiently inflated for vehicular operation. The tyre brand, tyre size and remaining tread depth of the 3 tyres were recorded as follows:-
