Your Ref: TP/IP/18025/2022
Our Ref : CI/TPD22008179/P

Fatal Accident Investigation Team

MECHANICAL INSPECTION REPORT OF MOTOR CAR SJS 3974B

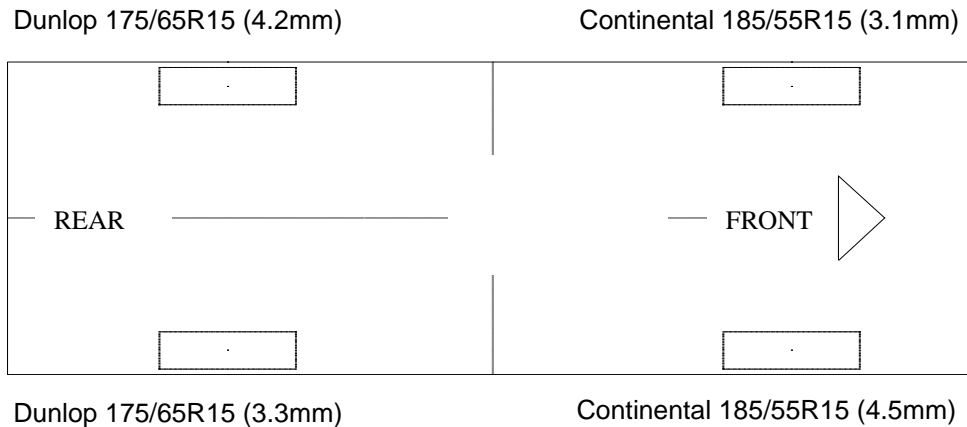
6. The condition of the Motor Car's 4 tyres was observed to be in serviceable condition. I did not find any tear, cut or burst mark(s) on the outer and the inner sidewalls as well as across the tread of the 4 tyres. The 4 tyres were also observed to be sufficiently inflated for vehicular operation. The tyre brand, tyre size and remaining tread depth of the 4 tyres were recorded as follows:-
