VEHICLE DAMAGE INSPECTION REPORT

Our Ref: 97/TP/2022

Reg No:	GBF8213U	Make &	Toyota
Reg date:	23/3/2017	Model	Hiace
Colour:	White	Engine No:	1KD2678589
Type:	Van	Chassis No:	JTFHT02P800214262
Type of Claims:	Third Party	Odometer No:	147021km
		Engine Cap:	2982cc

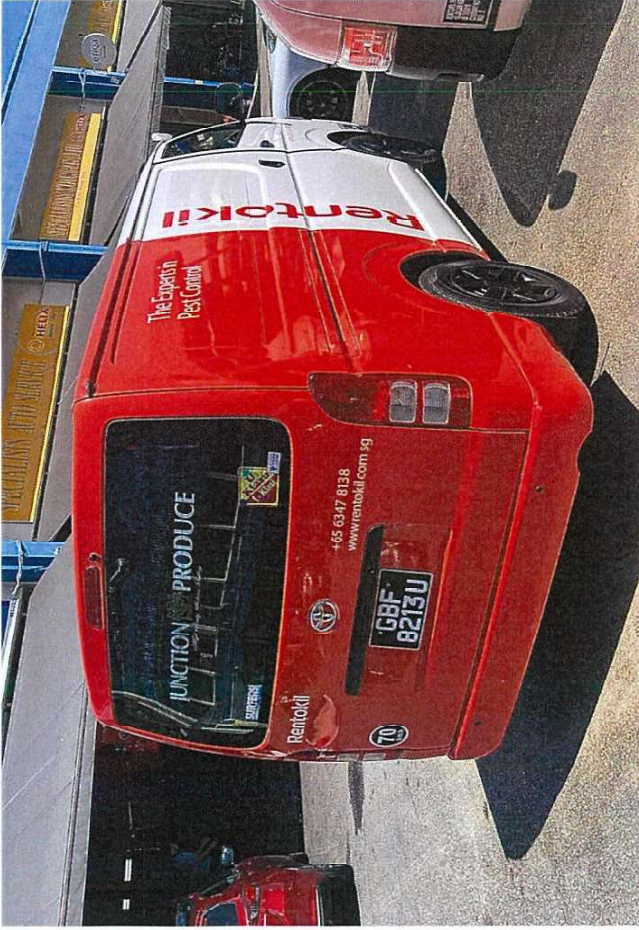
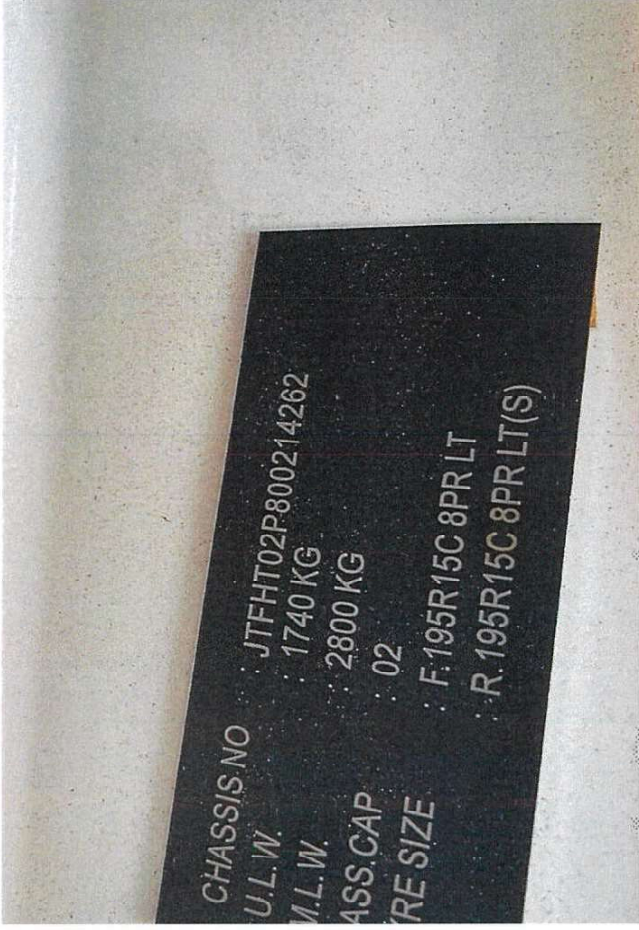
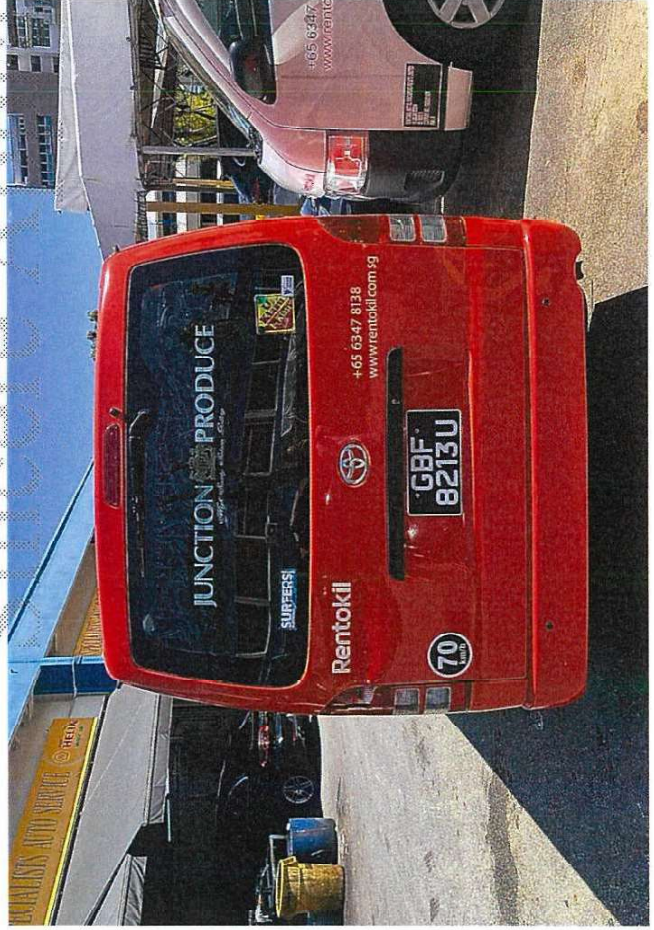
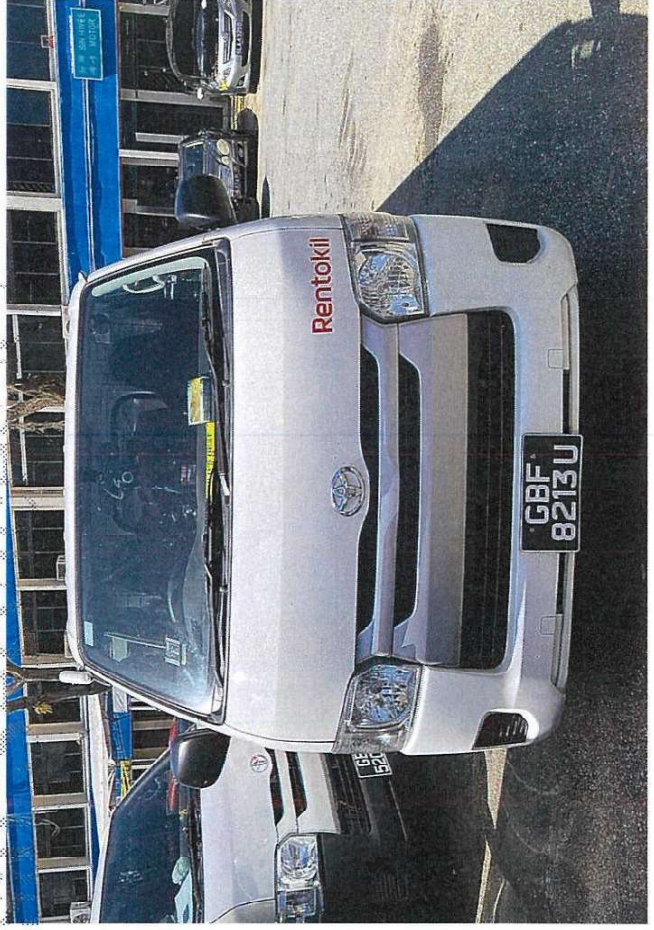
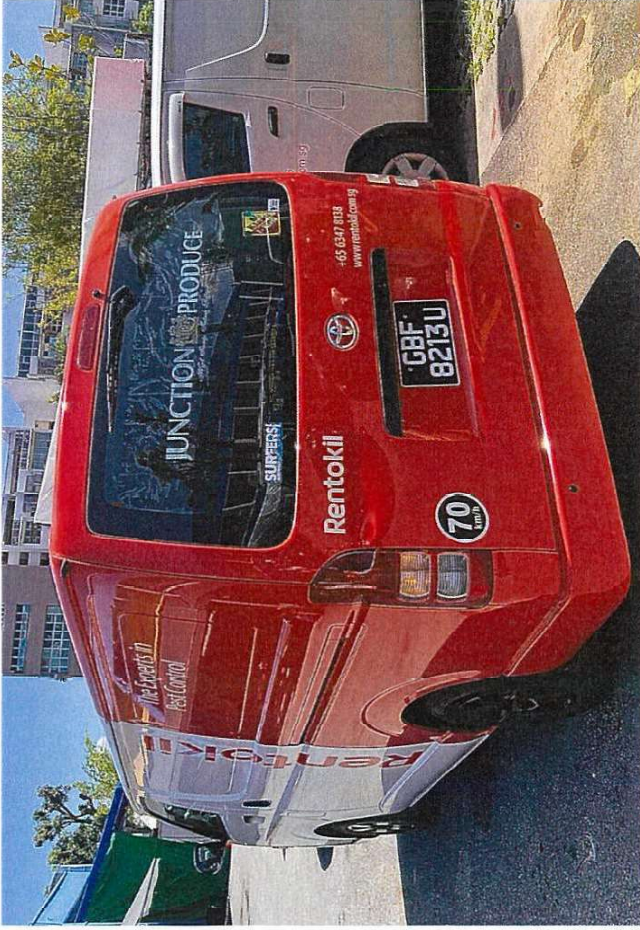
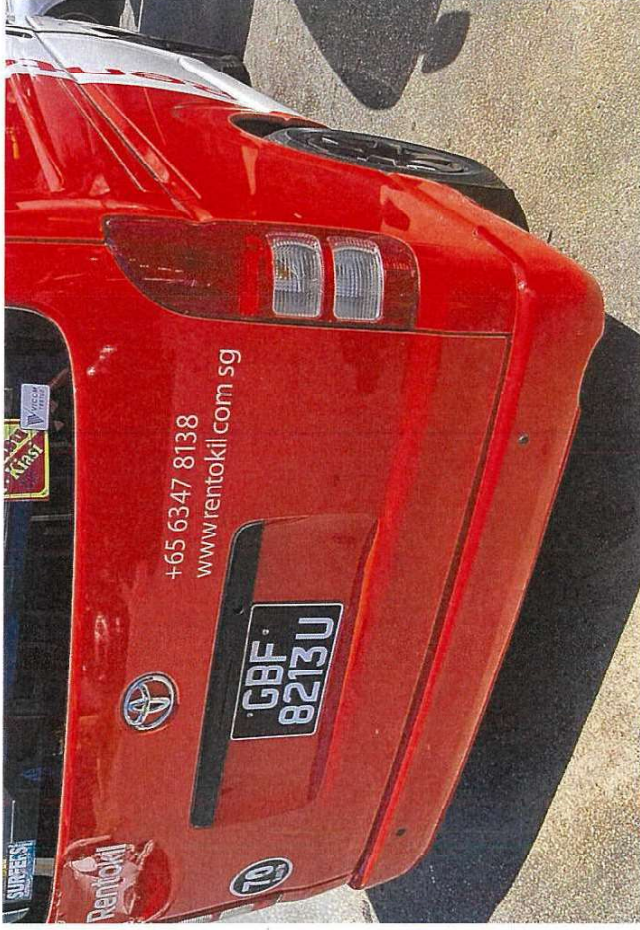
Our visual inspection of the vehicle revealed that the damages noted are at the rear portion.

We have inspected the actual damages found on the vehicle and recommend the replacement of parts and repairs accordingly. The estimated repair cost is \$9,828.75. The repairer has agreed to undertake the repairs at our adjusted lump sum amount of \$5,800.00.
