Your Ref: SNM22D206049
Our Ref : CS4/CTI22008420/N

12 September 2022

TECHNICAL INVESTIGATION REPORT OF FIRE INCIDENT INVOLVING THE INSURED VEHICLE SKL 3618E ON 25 AUGUST 2022

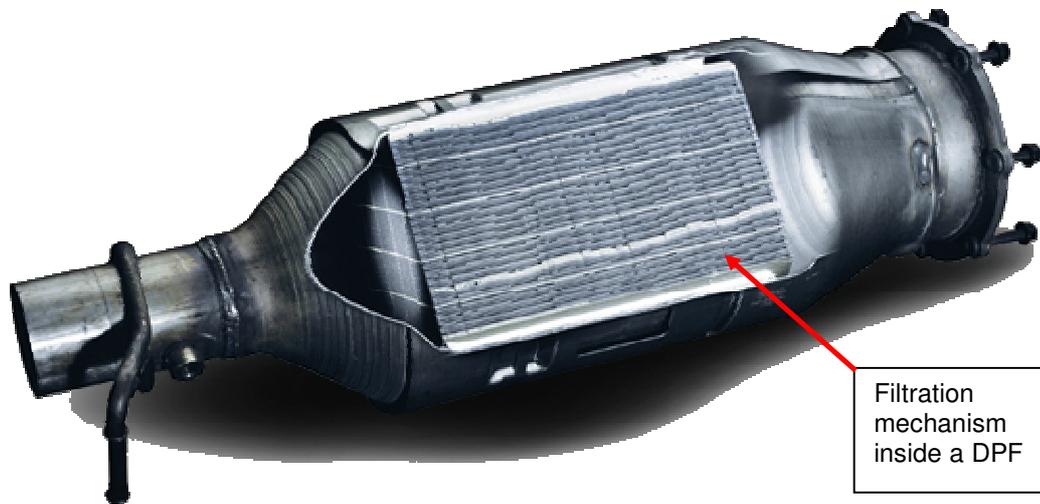
19. Our research and ground investigation revealed that this model vehicle is fitted with a Diesel Particulate Filter (DPF). As with all modern-day diesel engine motor vehicles like the Insured Vehicle, DPF, a cannister like component (part), is fitted along the exhaust system of such type of motor vehicles. Briefly, DPF is a component (part) that captures diesel particulates through a combination of filtration mechanisms, preventing the diesel particulates from being release into the atmosphere as harmful gases. An illustration of a simple filtration mechanism inside a PDF is shown below.

20. Like all filter element, the filter element inside the DPF will begin to clog as soot (carbon) and other diesel particulate starts to accumulate on the filter element inside the DPF over a period of time. Cleaning of DPF is therefore required as part of its periodic maintenance. This is usually done through a process call “regeneration”, when the exhaust temperature becomes high enough (usually at 600°C) to burn off the soot and other diesel particulate that have accumulated in the DPF. Driving a vehicle over long distance at speeds higher than road speeds allowed for urban city driving is the most common method of regenerating (cleaning) the DPF.

21. Smoke and/or fire from the underside of the vehicle or flames emanating form within the exhaust tailpipe can occur for such diesel engine vehicles when the exhaust temperature within the DPF increases due to clogging (exhaust gases becomes restricted and unable to flow out smoothly) or even when “regeneration” (cleaning). Heat from a fire within the DPF may possibly radiate to the surrounding vehicle components leading to heating of the vehicle underside, melting of interior components and in worst case, a potential interior fire. The DPF of the Insured Vehicle is located at the underside centre of the Insured Vehicle, below the centre console of the Insured Vehicle. This area was the area where smoke and flames were seen emitting from the Insured Vehicle. The evidence gathered would then appear to indicate that the fire to the Insured Vehicle was a result of heat radiating from a fire that had occurred within the DPF that was fitted at the underside centre of the Insured Vehicle.
