Your Ref: Honda Engine

(number R18A1030923)

Our Ref: CI/TP22008631/D

INSPECTION REPORT OF A HONDA ENGINE WITH NUMBER R18A1030923

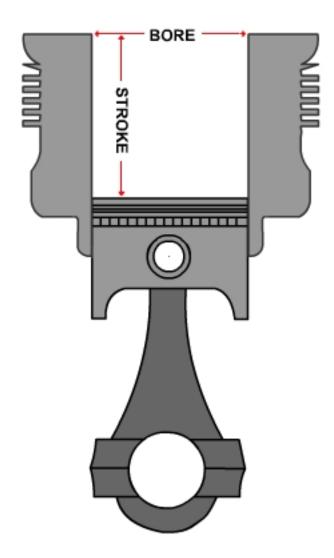
9. The bore refers to the measurement of the inside diameter of the cylinder while the stroke refers to the distance the piston moves in one direction of upward or downward movement in the cylinder. See diagram below for illustration purposes.
