Your Ref: TP/IP/17223/2022
Our Ref : CI/TPD22008685/N

16 September 2022

INSPECTION REPORT OF MOTORCYCLE FBR 8195A

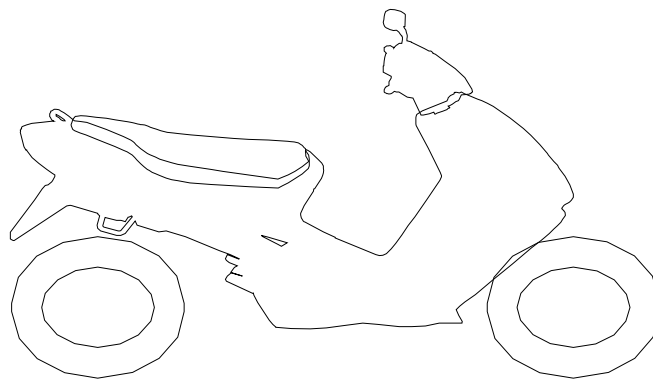
6. The condition of the Motorcycle's 2 tyres was observed to be in serviceable condition. The tread pattern of the 2 tyres was clearly visible. We did not observe any tear, burst mark(s) and/or punctured hole(s) on the sidewalls as well as across the tread of the 2 tyres. The 2 tyres were both observed to be sufficiently inflated for vehicular operation. The tyre brand, tyre size and remaining tread depth of the 2 tyres were recorded as follows:-

Maxxis 130/70 – 13 (3mm)

Maxxis 110/70 - 13 (4mm)
(Deflated)
