Your Ref: TP/IP/14027/2022
Our Ref : CI/TPD22010187/N

Fatal Accident Investigation Team

INSPECTION REPORT OF MOTORCYCLE FBA 1696G

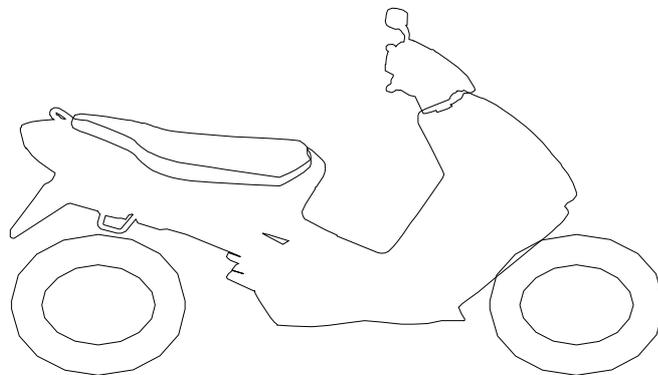
6. The condition of the Motorcycle's 2 tyres was observed to be in serviceable condition. The tread pattern of the 2 tyres was clearly visible. We did not observe any tear, burst mark(s) and/or punctured hole(s) on the sidewalls as well as across the tread of the 2 tyres. The 2 tyres were both observed to be sufficiently inflated for vehicular operation. The tyre brand, tyre size and remaining tread depth of the 2 tyres were recorded as follows:-

Pirelli 130/70 - 13 (4mm)

Pirelli 110/70 - 13 (3mm)
