Your Ref: TP/IP/27983/2022  
Our Ref : CI/TPD22010881/P

14<sup>th</sup> November 2022

**Fatal Accident Investigation Team**

**MECHANICAL INSPECTION REPORT OF MOTOR VAN GBJ 3333T**

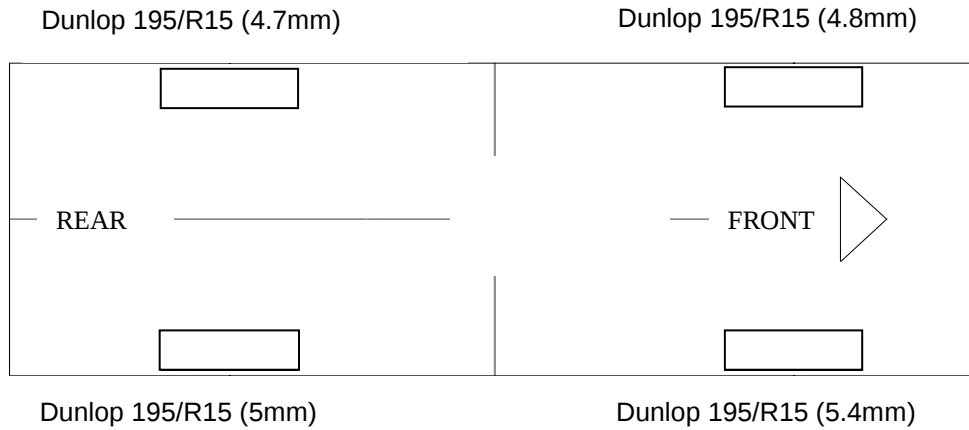
6. The 4 tyres of the Motor Van were observed to be in serviceable condition and sufficiently inflated for vehicular operation. I did not find any tear, cut or burst mark(s) on the outer and the inner sidewalls as well as across the tread of the 4 tyres. The tyre brand, tyre size and remaining tread depth of the 4 tyres of the Motor Van were recorded as follows:-
