You're Ref: TP/IP/23316/2022
Our Ref: CI/TPD22010893/P

Fatal Accident Investigation Team

MECHANICAL INSPECTION REPORT OF MOTOR LORRY GR 6833X

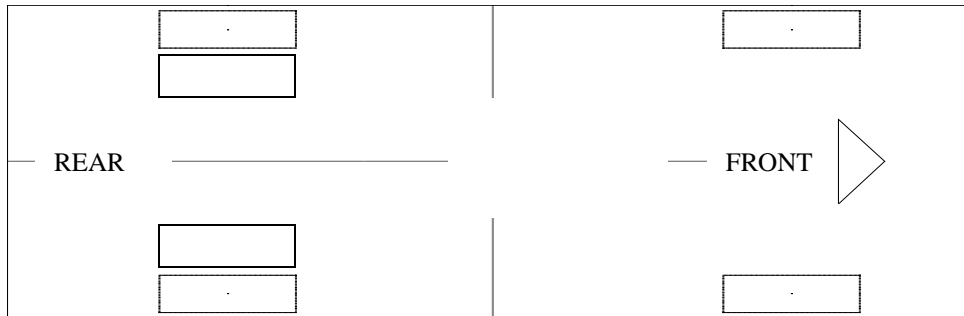
6. The condition of the Motor Lorry's 6 tyres was observed to be in serviceable condition. I did not find any tear, cut or burst mark(s) on the outer and the inner sidewalls as well as across the tread of the 6 tyres. The 6 tyres were also observed to be sufficiently inflated for vehicular operation. The tyre brand, tyre size and remaining tread depth of the 6 tyres were recorded as follows:-

Yokohama 155/R12 (3.1mm)

Michelin 195/R15 (5.8mm)

Yokohama 155/R12 (3.5mm)

Michelin 195/R15 (6.3mm)
