Your Ref: TP/IP/27581/2022
Our Ref : CI/TPD22011566/N

Fatal Accident Investigation Team

INSPECTION REPORT OF MOTORCYCLE FBQ 1383A

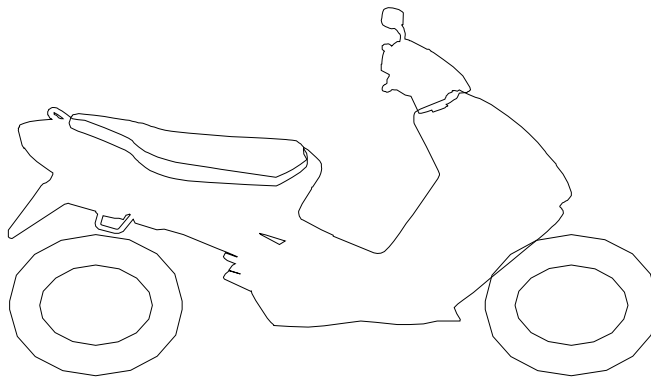
6. The condition of the Motorcycle's 2 tyres was observed to be in serviceable condition. The tread pattern of the 2 tyres was clearly visible. We did not observe any tear, burst mark(s) and/or punctured hole(s) on the sidewalls as well as across the tread of the 2 tyres. The 2 tyres were both observed to be sufficiently inflated for vehicular operation. The tyre brand, tyre size and remaining tread depth of the 2 tyres were recorded as follows:-

Maxxis 140/70 - 14 (2mm)

Maxxis 110/80 - 14 (3mm)
