# PRO-OPTION SERVICES

## ACCIDENT VEHICLE INSPECTION REPORT

Report no : 930M22.MCS  
Vehicle no : SMH4861J

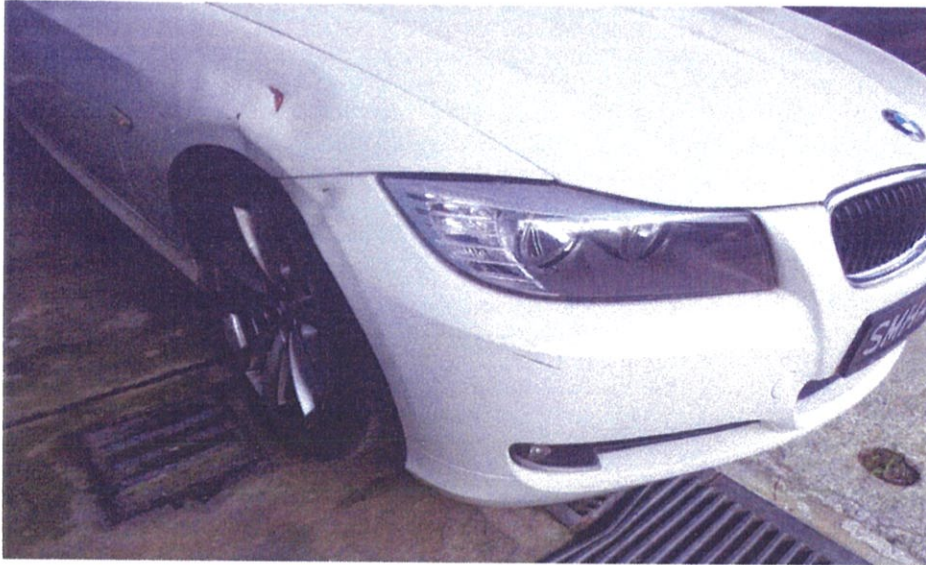
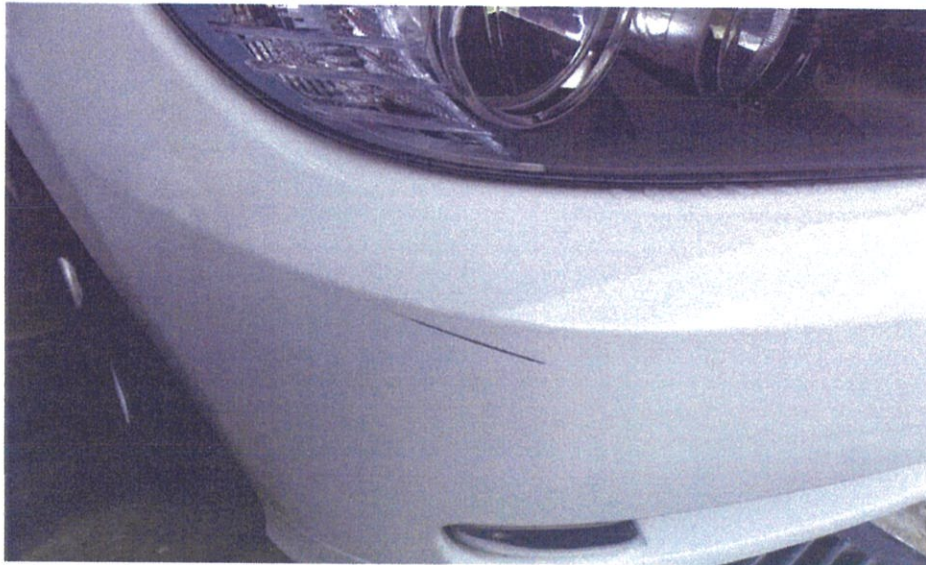
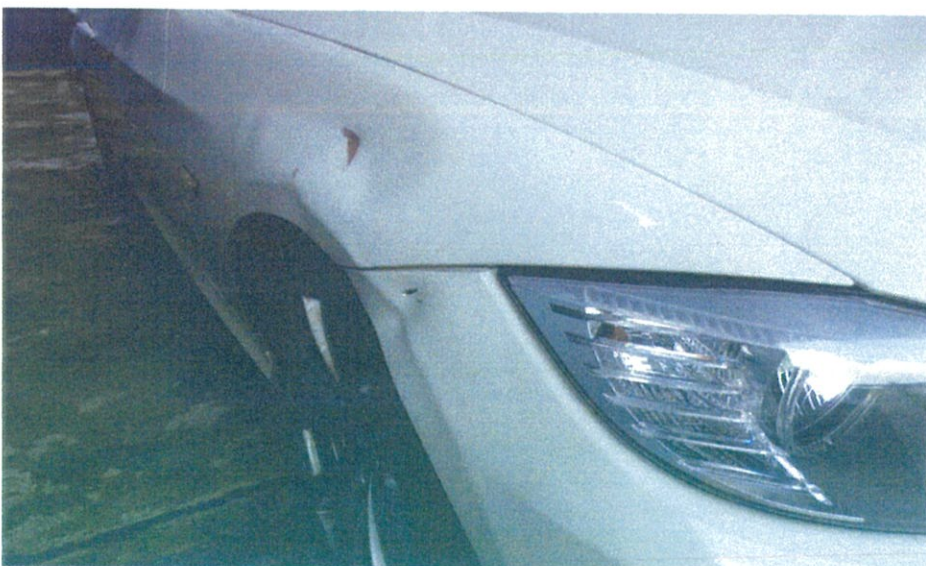
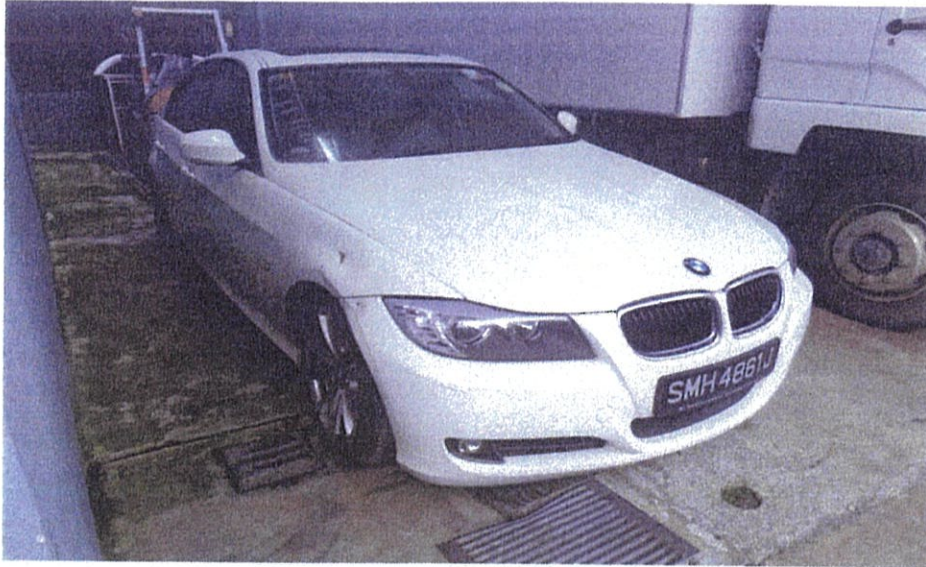
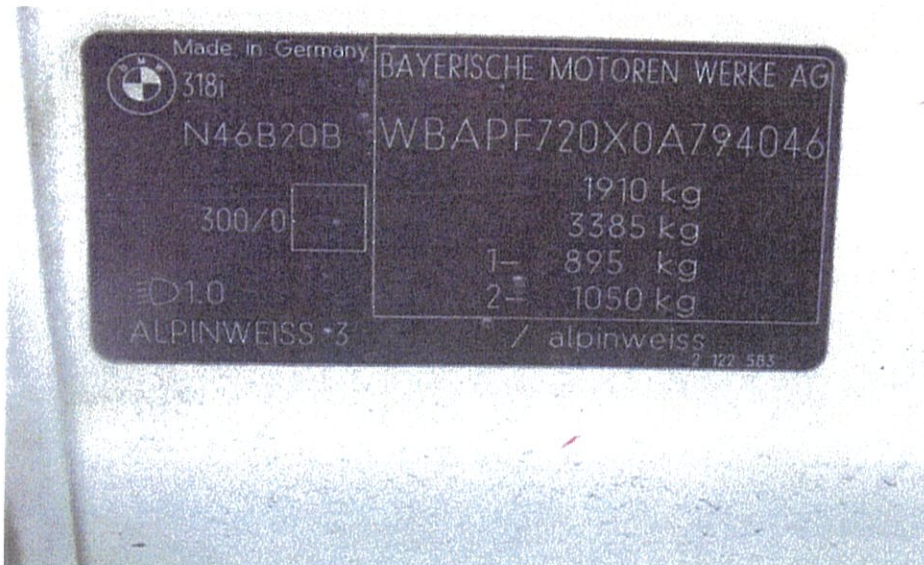
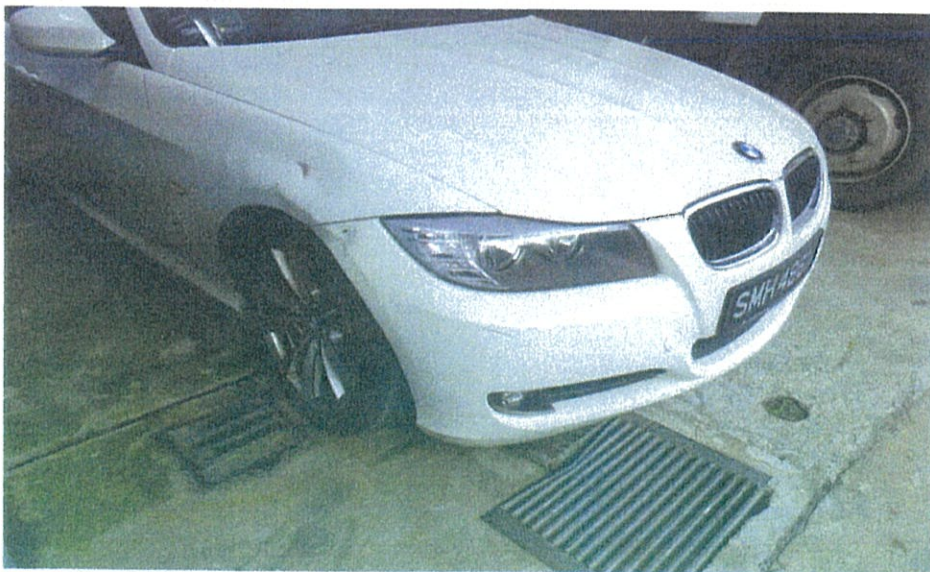
Front RH suspension and undercarriage parts damaged, front RH fender dented/bent/distorted, front bumper dented/bent/deformed, etc. Please see para. 8 of this report for more details.
