Your Ref: L/20221022/0016
Our Ref: CI/SPF22012698/P

28th December 2022

MECHANICAL INSPECTION REPORT OF MOTOR LORRY YN 7315B

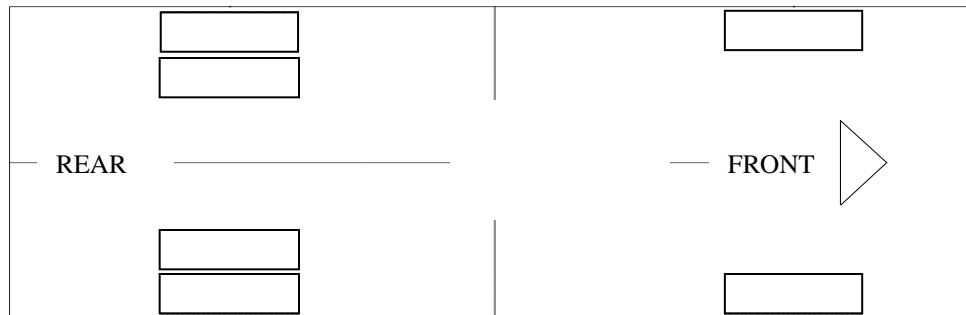
6. The both front tyres and wheel rims was observed to be damaged with cut marks on the sidewall of the both front tyres as a result of the accident. However, the rear 4 tyres and wheel rims of the Motor Lorry were observed to be in serviceable condition and sufficiently inflated for vehicular operation. The tyre brand, tyre size and remaining tread depth of the 6 tyres of the Motor Lorry were recorded as follows:-

Bridgestone 205/70R16 (5.7mm)

Yokohama 205/70R16 (7mm) (Cut)

Bridgestone 205/70R16 (2.1mm)

Yokohama 205/70R16 (6.5mm) (Cut)

The both front tyres and wheel rims was observed to be damaged. The 4 rear tyres were observed to be wrapped around standard steel wheel rims that were found to be without any damage. See photo 1 - 17 below.
