LKK Auto Consultants Pte Ltd

Vehicle No.	SMQ 3356K
Insured Veh.	SMS 8804R
Claim No.	SNM22D209391/C02
Policy No.	DMCVSNW00280592200
Accident Date	20/12/2022
Inspection Date	30/12/2022

ADJUSTMENT ON REPAIR COST FOR VEHICLE NO. SMQ 3356K

PHOTOGRAPHS FOR VEHICLE NO. SMQ 3356K

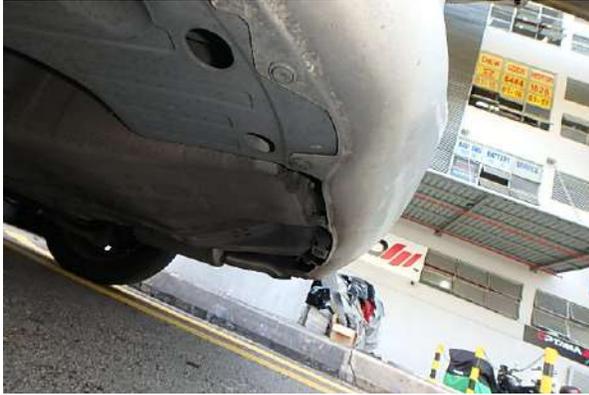
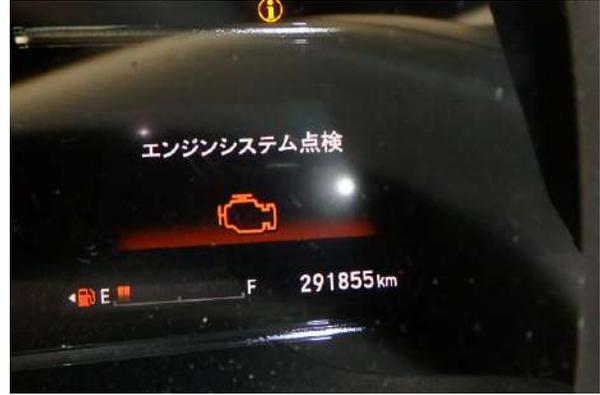
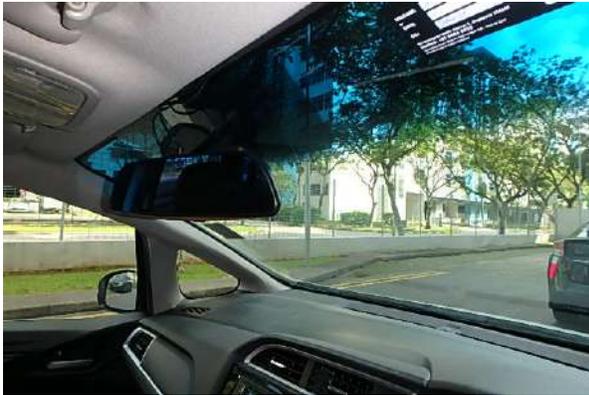
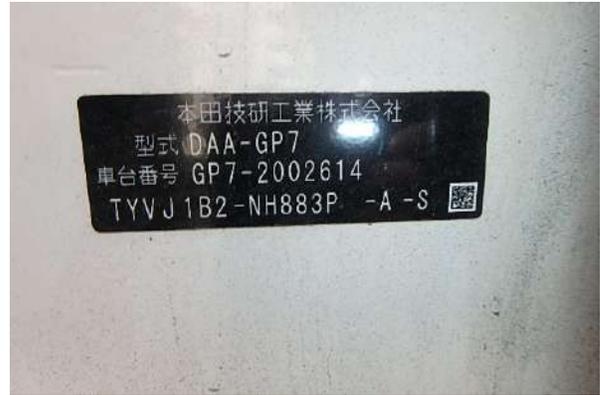
4. Description of Damages			
THE VEHICLE SUSTAINED DAMAGES AT THE REAR PORTION. DAMAGES SEE DETAILS.			
5. General Information			
Accident Date	20/12/2022	Inspection Date	30/12/2022
Survey held at	OPTIMA WERKZ PTE LTD 10 ANG MO KIO INDUSTRIAL PARK 2A #01-05 AMK AUTOPOINT SINGAPORE 568047		
5a. Remarks			
A)THE INSPECTION WAS CONDUCTED ON A"WITHOUT PREJUDICE" BASIS. B)IN ACCORDANCE TO YOUR INSTRUCTIONS, WE HAVE NOT AUTHORISED REPAIRS.			
5b. Estimate Days of Repair			
ESTIMATED NORMAL PERIOD FOR REPAIR:		4 Working Days
