Your Ref: TP/IP/000305/2023  
Our Ref : CI/TPD23001377/N

**Fatal Accident Investigation Team**

**MECHANICAL INSPECTION REPORT OF MOTOR CAR SMQ 764K**

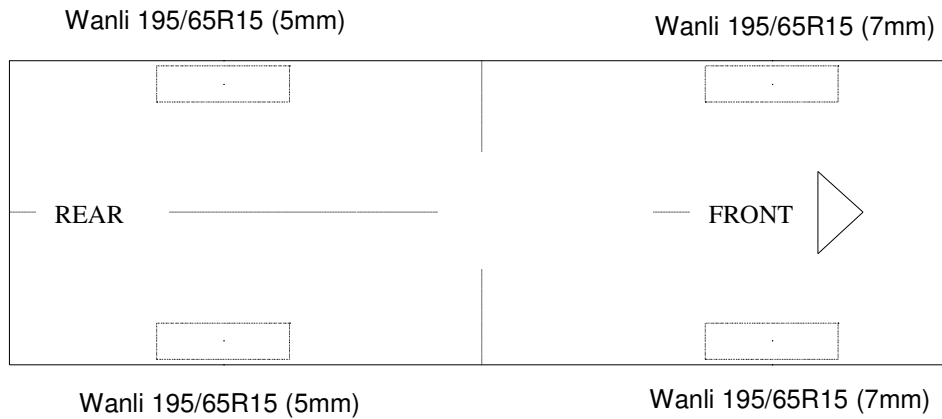
6. The condition of the Motor Car's 4 tyres was observed to be in serviceable condition. We did not find any tear, cut or burst mark(s) on the outer and the inner sidewalls as well as across the tread of the 4 tyres. The 4 tyres were also observed to be sufficiently inflated for vehicular operation. The tyre brand, tyre size and remaining tread depth of the 4 tyres were recorded as follows:-
