Your Ref: TP/IP/22827/2022  
Our Ref : CI/TPD23001383/N

**Fatal Accident Investigation Team**

**MECHANICAL INSPECTION REPORT OF MOTOR VAN GBL 5084M**

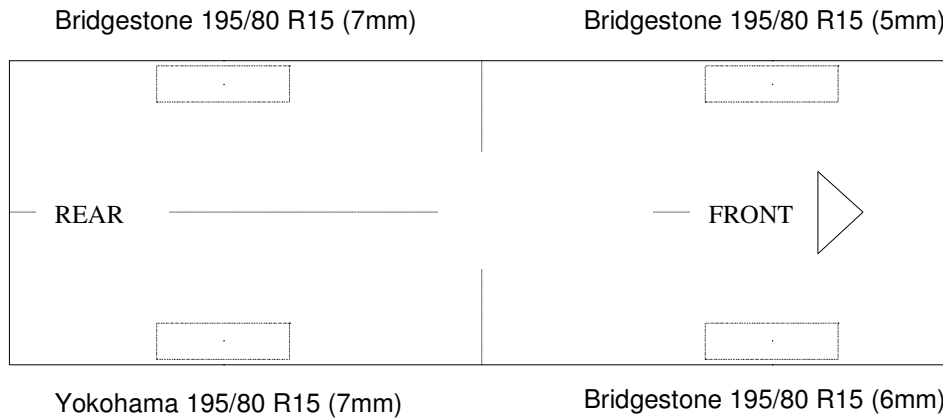
6. The 4 tyres were observed to be in serviceable condition and sufficiently inflated for vehicular operation. We did not find any tear, cut or burst mark(s) on the outer and the inner sidewalls as well as across the tread of the 4 tyres. The tyre brand, tyre size and remaining tread depth of the 4 tyres of the Motor Van were recorded as follows:-
