Your Ref: TP/IP/25487/2022
Our Ref : CI/TPD23001386/N

Fatal Accident Investigation Team

MECHANICAL INSPECTION REPORT OF MOTOR CAR SMZ 5135X

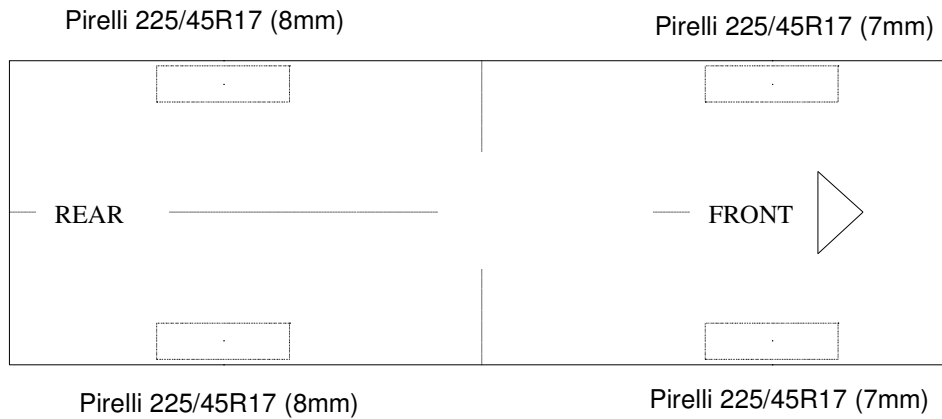
6. The condition of the Motor Car's 4 tyres was observed to be in serviceable condition. We did not find any tear, cut or burst mark(s) on the outer and the inner sidewalls as well as across the tread of the 4 tyres. The 4 tyres were also observed to be sufficiently inflated for vehicular operation. The tyre brand, tyre size and remaining tread depth of the 4 tyres were recorded as follows:-
