: PRE-REPAIR SURVEY

PRE-REPAIR SURVEY REPORT

FBA6091T

Honda Super 4

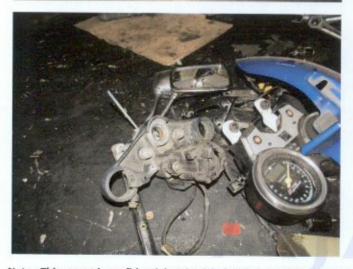
Pre-repair survey

The vehicle sustained damage on the front portion.

Based on visual survey of the vehicle without any repair estimate provided, we viewed that the repair cost should not be more than S\$1,800.00 and could take approximately third (3) working days to complete.
