Your Ref: TP/IP/02096/2023
Our Ref : CI/TPD23001587/P

Fatal Accident Investigation Team

MECHANICAL INSPECTION REPORT OF MOTOR CAR SLU 5837S

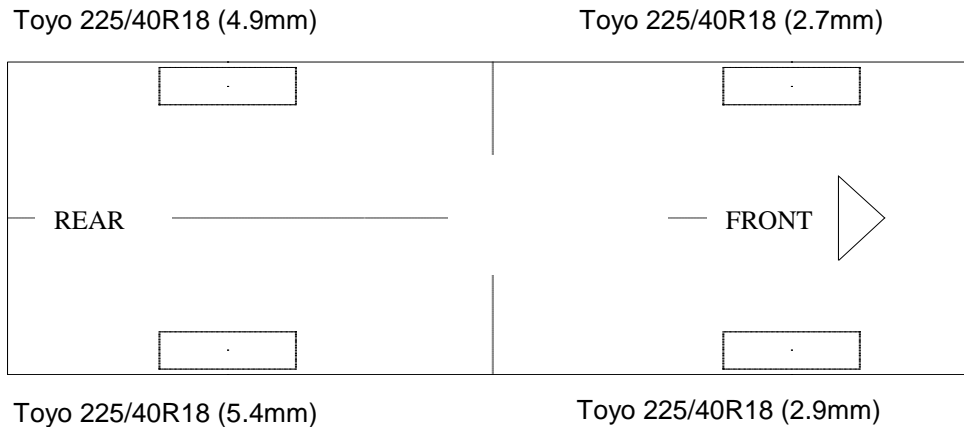
6. The condition of the Motor Car's 4 tyres was observed to be in serviceable condition. I did not find any tear, cut or burst mark(s) on the outer and the inner sidewalls as well as across the tread of the 4 tyres. The 4 tyres were also observed to be sufficiently inflated for vehicular operation. The tyre brand, tyre size and remaining tread depth of the 4 tyres were recorded as follows:-
