Your Ref: TP/IP/05063/2023
Our Ref : CI/TPD23003229/P

General Investigation Team

MECHANICAL INSPECTION REPORT OF MOTOR VAN PC 3506H

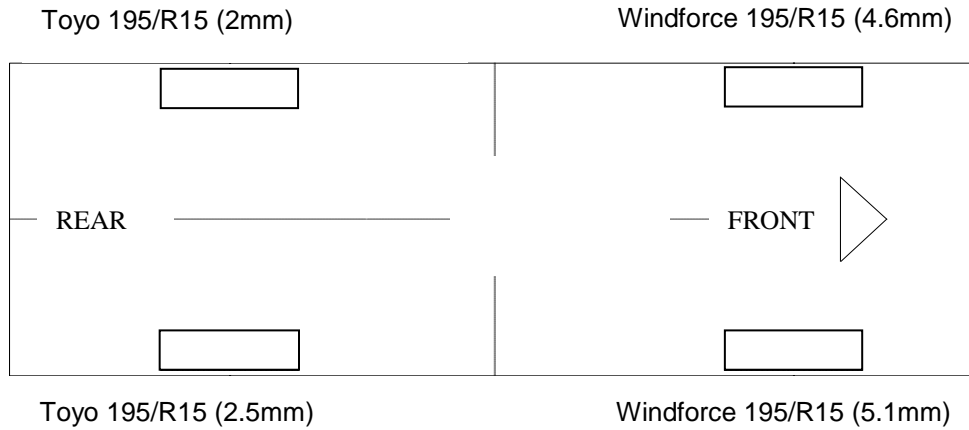
6. The 4 tyres of the Motor Van were observed to be in serviceable condition and sufficiently inflated for vehicular operation. I did not find any tear, cut or burst mark(s) on the outer and the inner sidewalls as well as across the tread of the 4 tyres. The tyre brand, tyre size and remaining tread depth of the 4 tyres of the Motor Van were recorded as follows:-
