Your Ref: TP IP/35294/2022  
Our Ref : CI/TPD23003241/P

**Fatal Accident Investigation Team**

**MECHANICAL INSPECTION REPORT OF MOTOR VAN GBB 9115J**

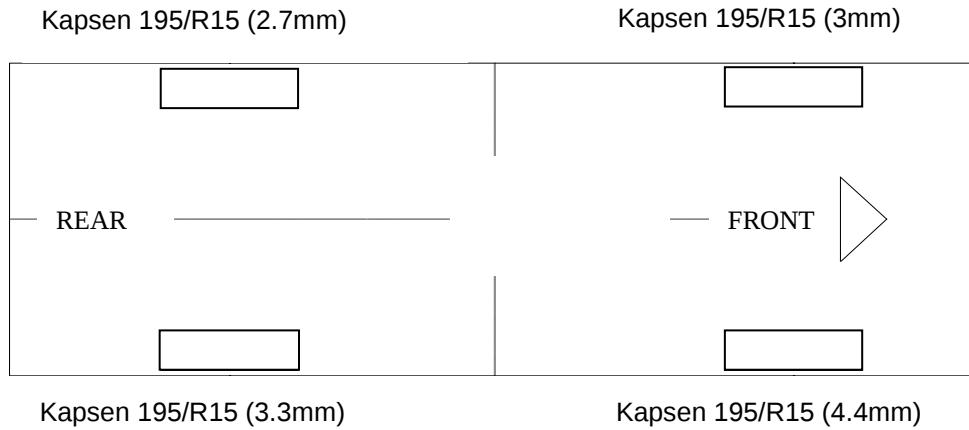
6. The 4 tyres of the Motor Van were observed to be in serviceable condition and sufficiently inflated for vehicular operation. I did not find any tear, cut or burst mark(s) on the outer and the inner sidewalls as well as across the tread of the 4 tyres. The tyre brand, tyre size and remaining tread depth of the 4 tyres of the Motor Van were recorded as follows:-
