Your Ref: TP IP/04303/2023
Our Ref : CI/TPD23003249/P

20th June 2023

Fatal Accident Investigation Team

MECHANICAL INSPECTION REPORT OF MOTOR LORRY GBH 1623E

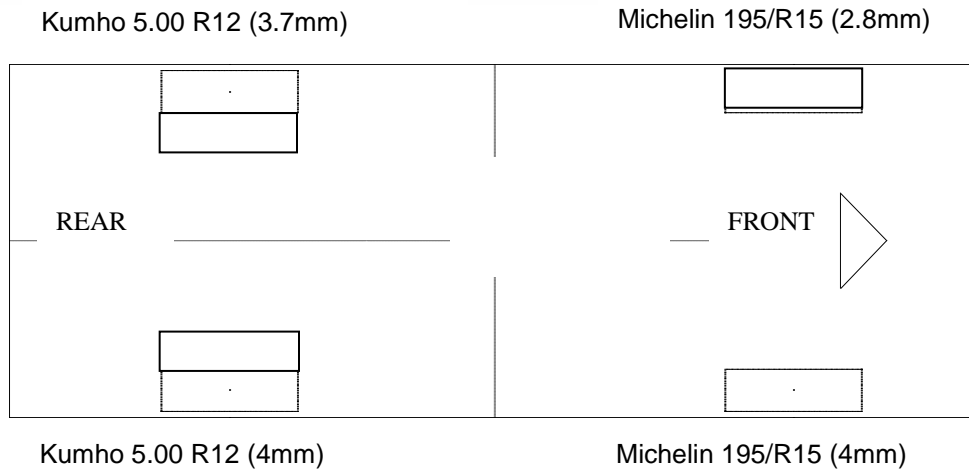
6. The 6 tyres of the Motor Lorry were observed to be in serviceable condition and sufficiently inflated for vehicular operation. I did not find any tear, cut or burst mark(s) on the outer and the inner sidewalls as well as across the tread of the 6 tyres. The tyre brand, tyre size and remaining tread depth of the 6 tyres of the Motor Lorry were recorded as follows:-
