UNITED Appraisal And Management Pte Ltd

Re : Third Party Claim For Vehicle Registration No. SKT4511E

VEHICLE INSPECTION REPORT

Our ref. : UAM21.11.15-AK-STP-19A-SKT4511E

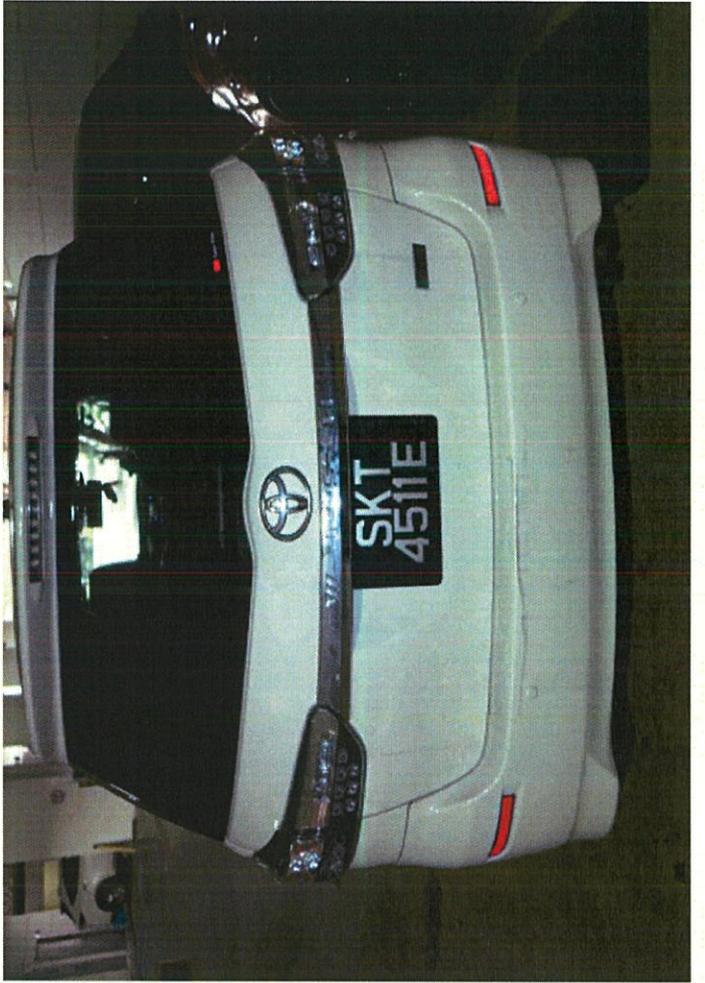
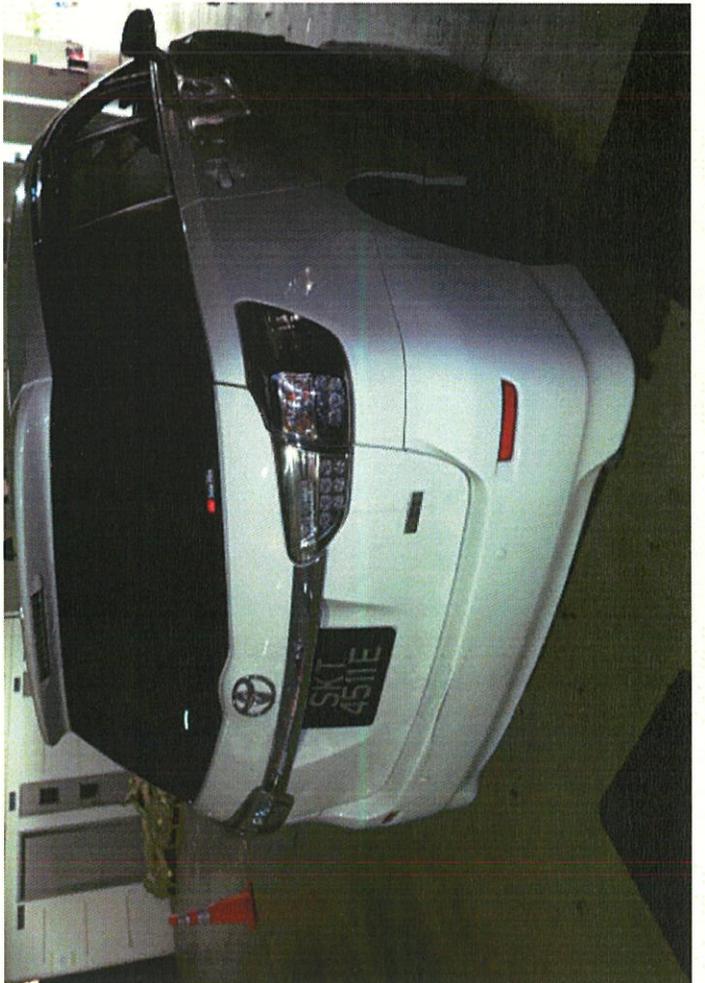
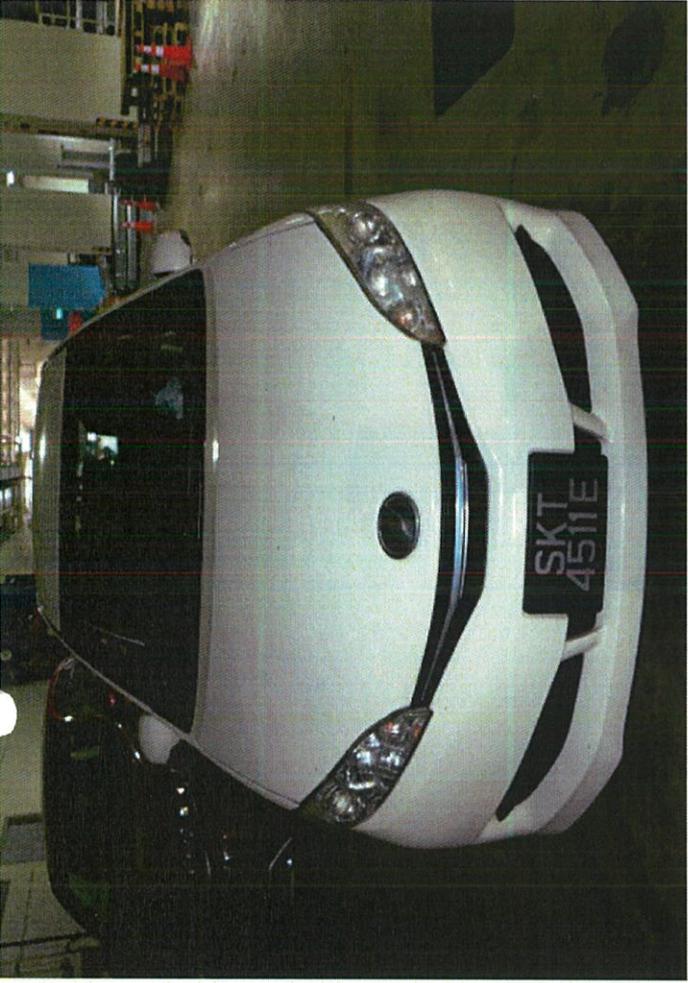
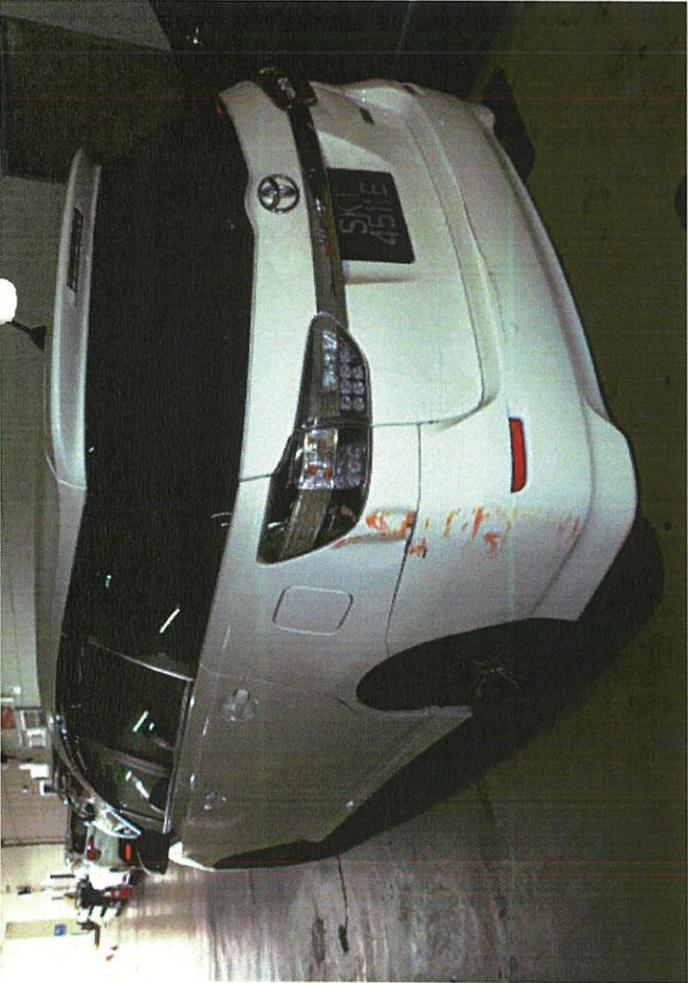
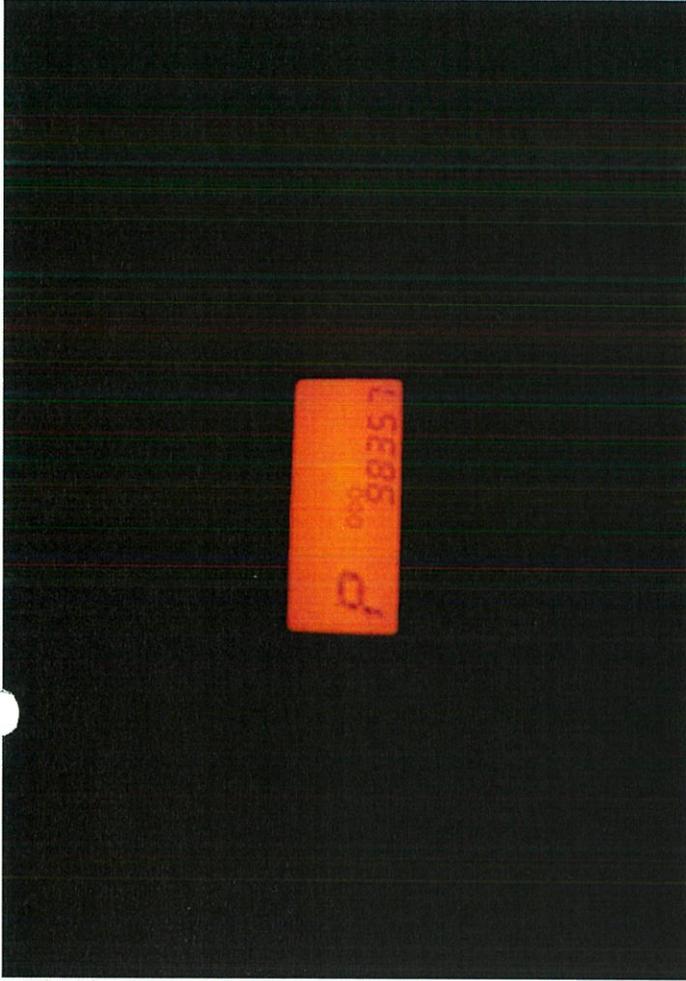
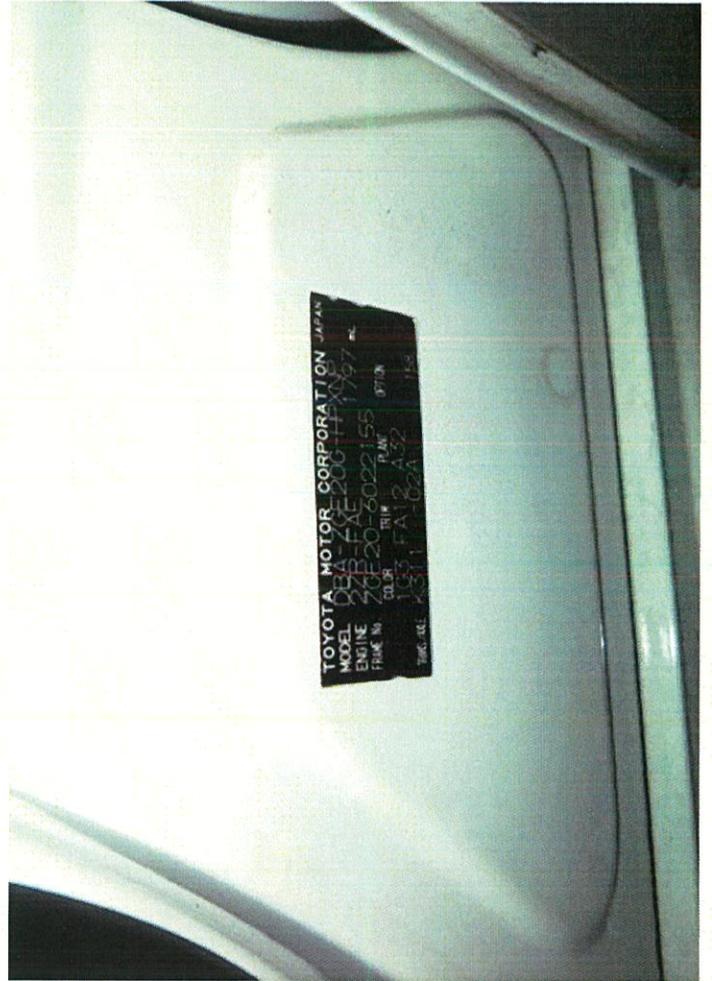
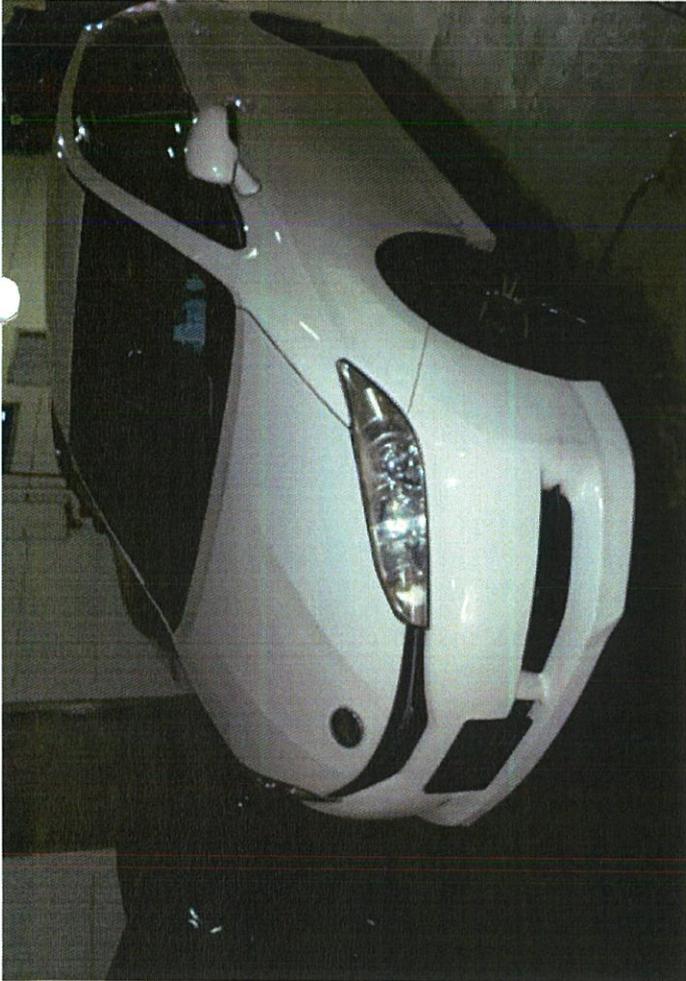
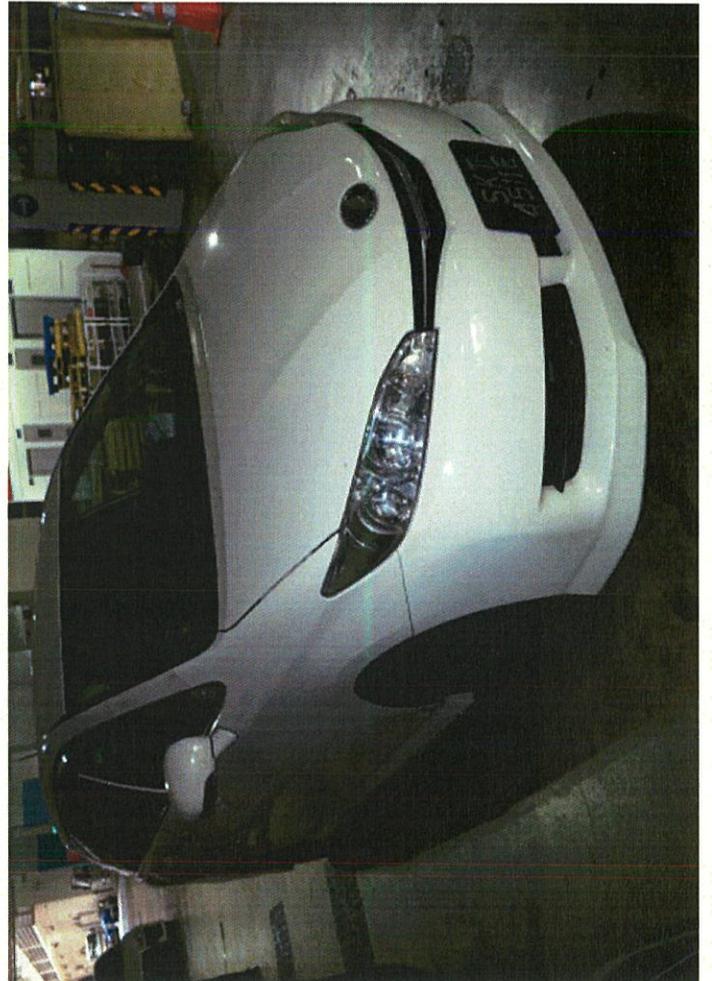
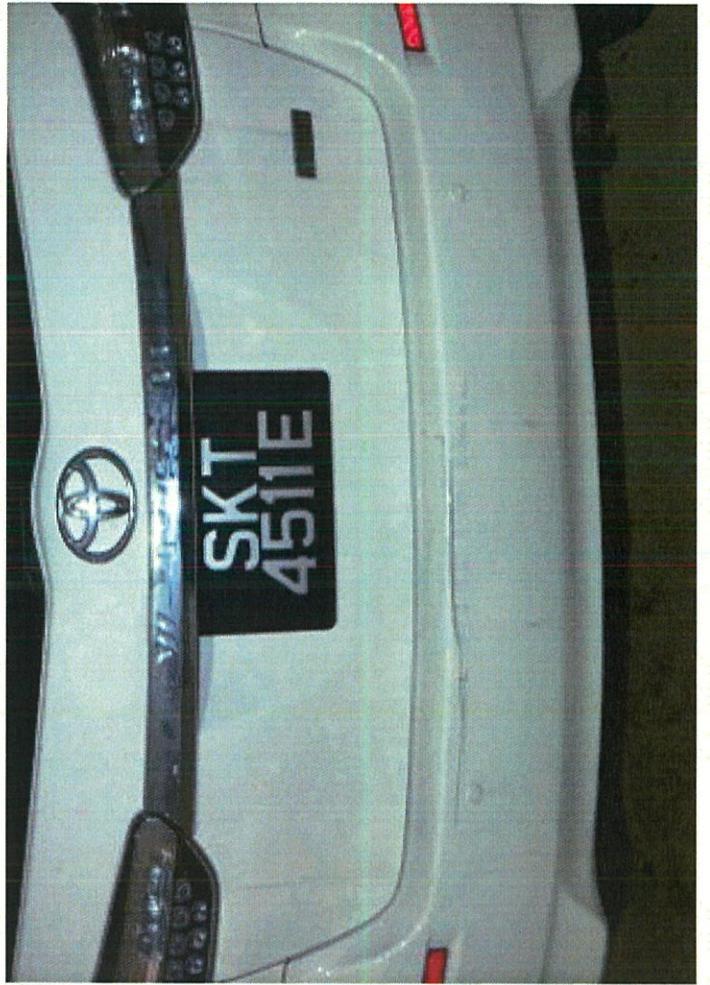
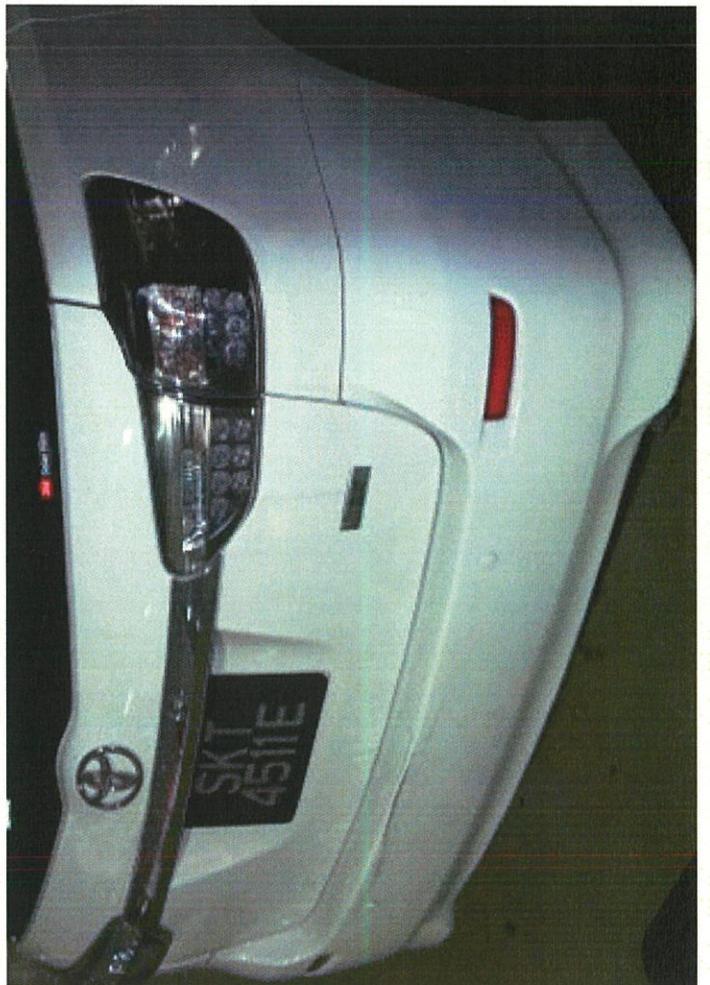
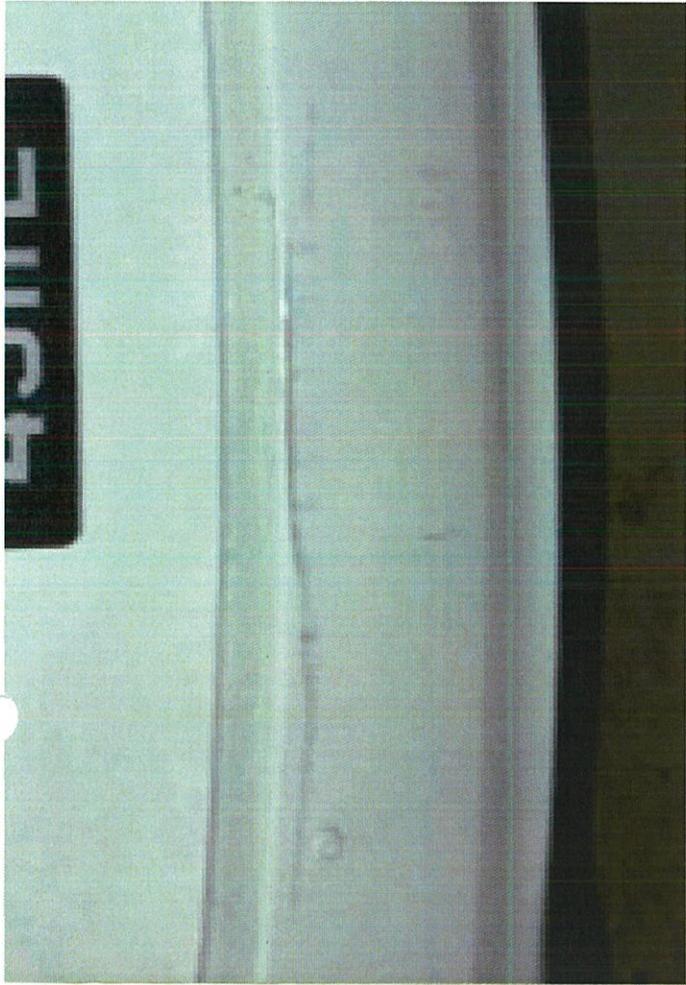
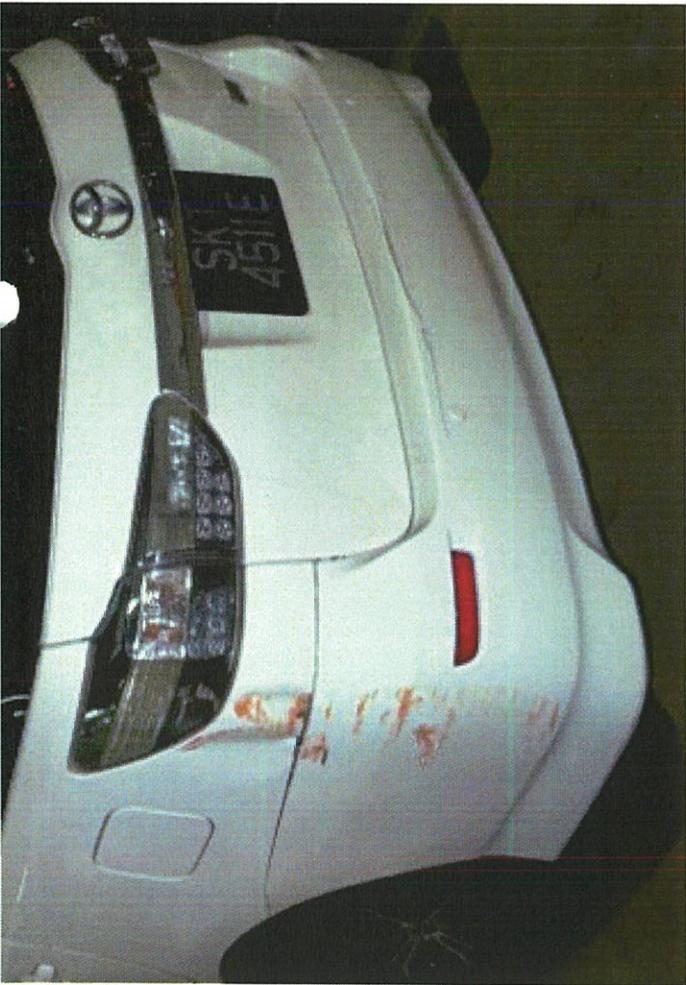
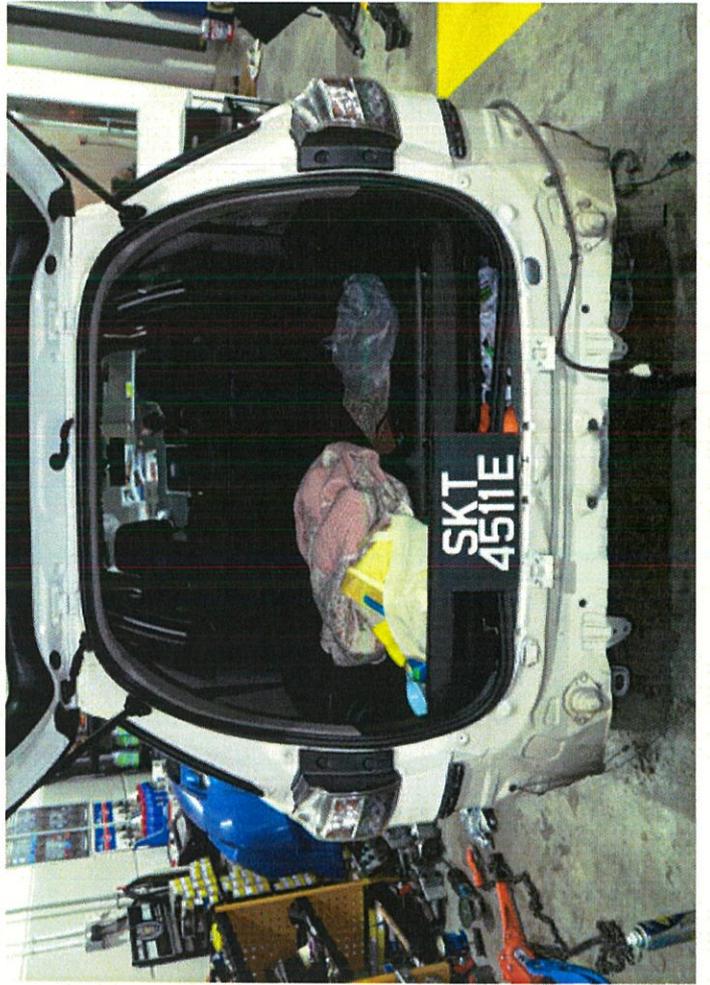
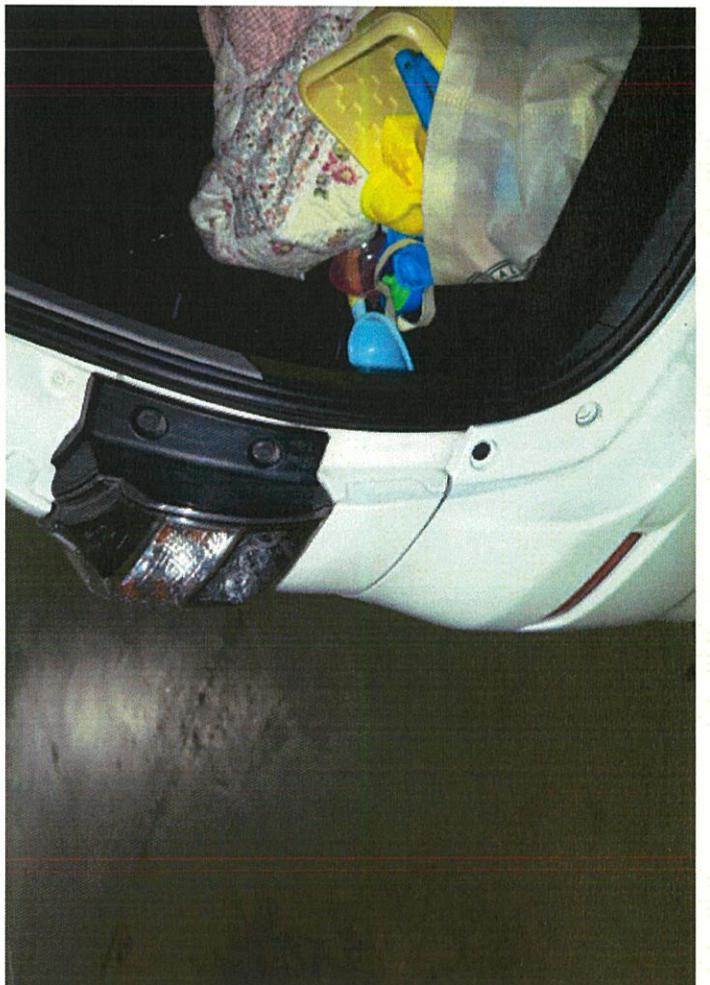
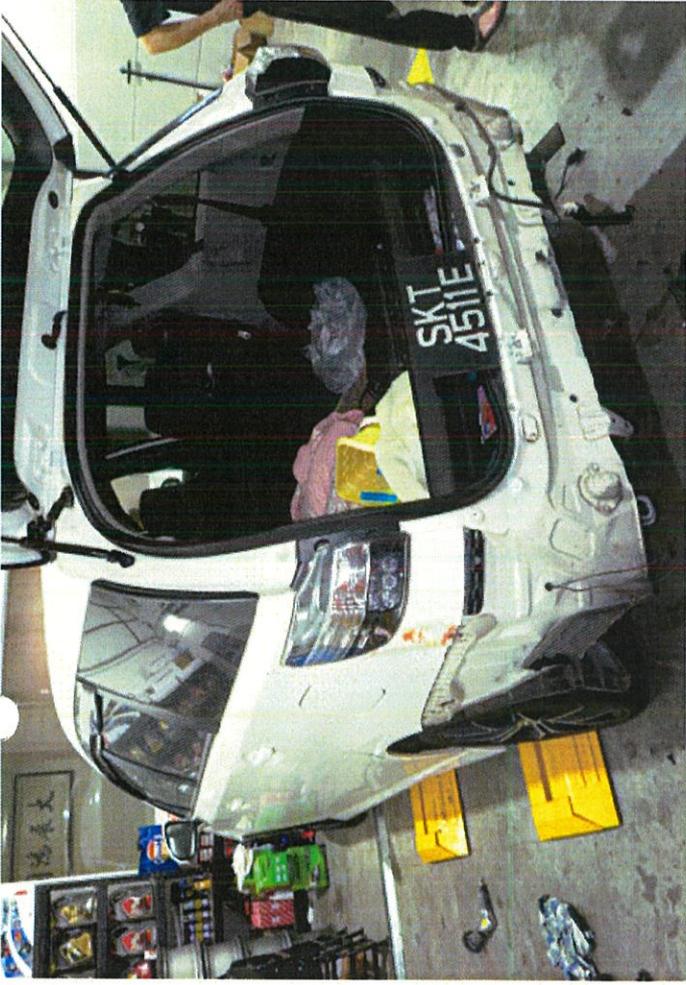
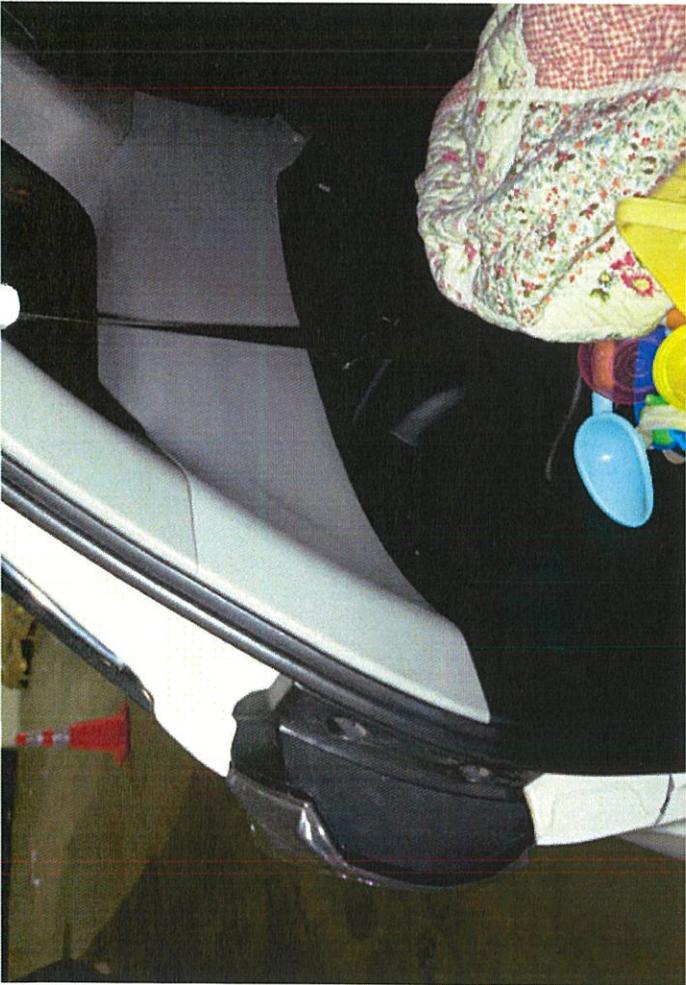
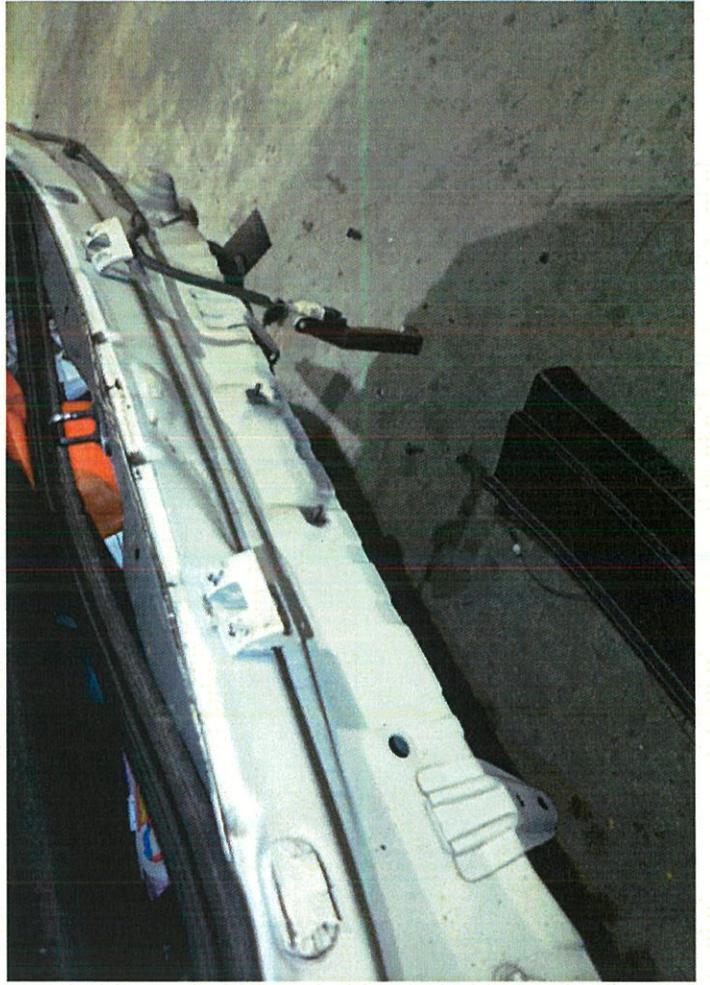
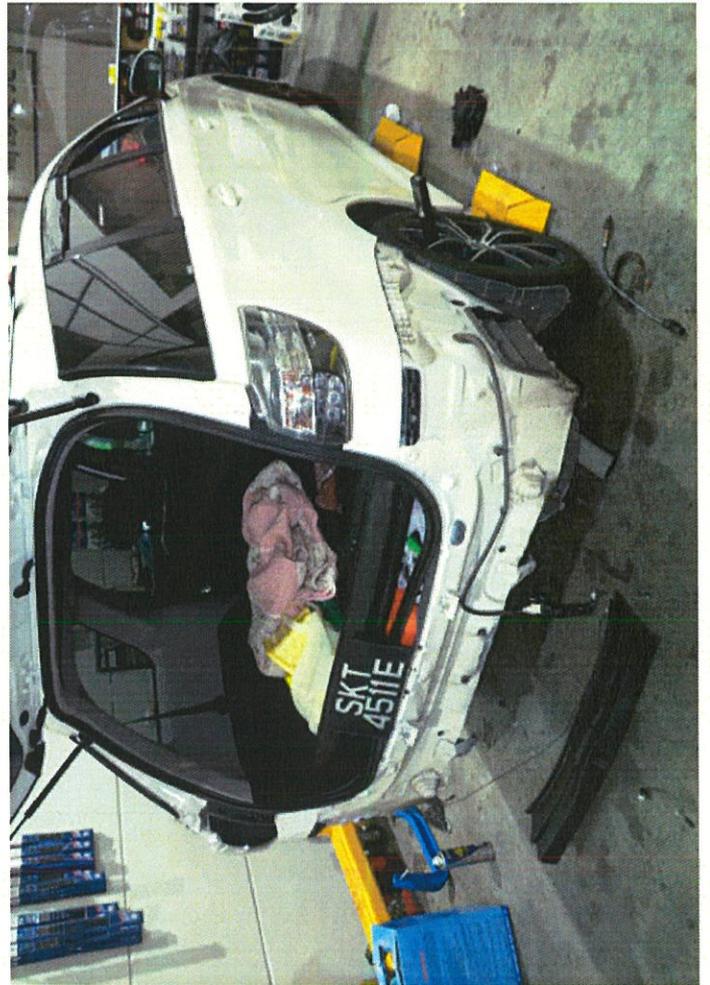
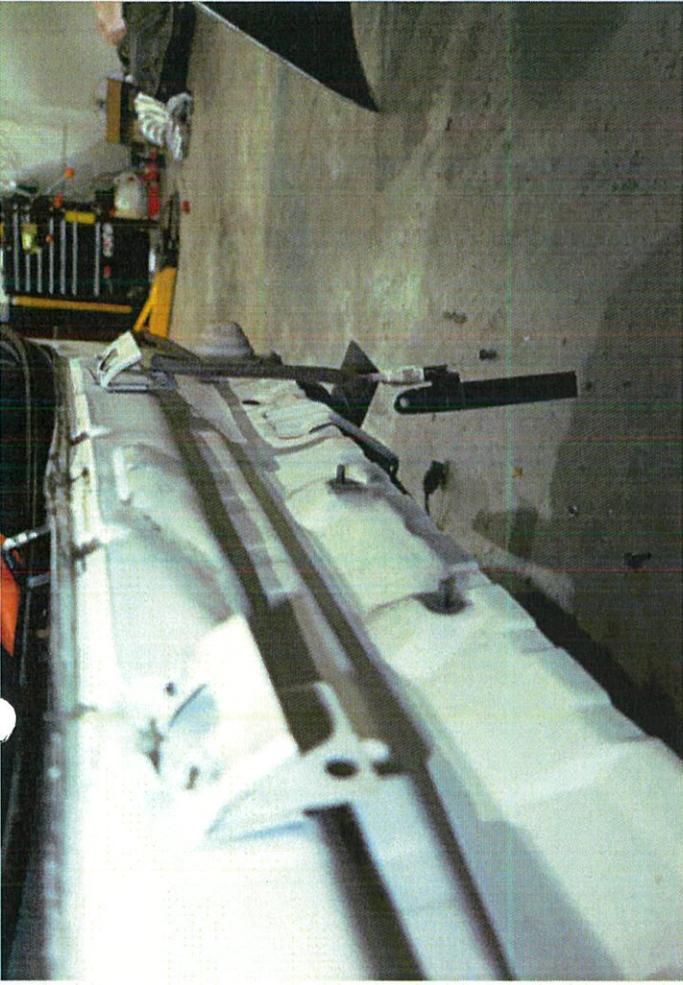
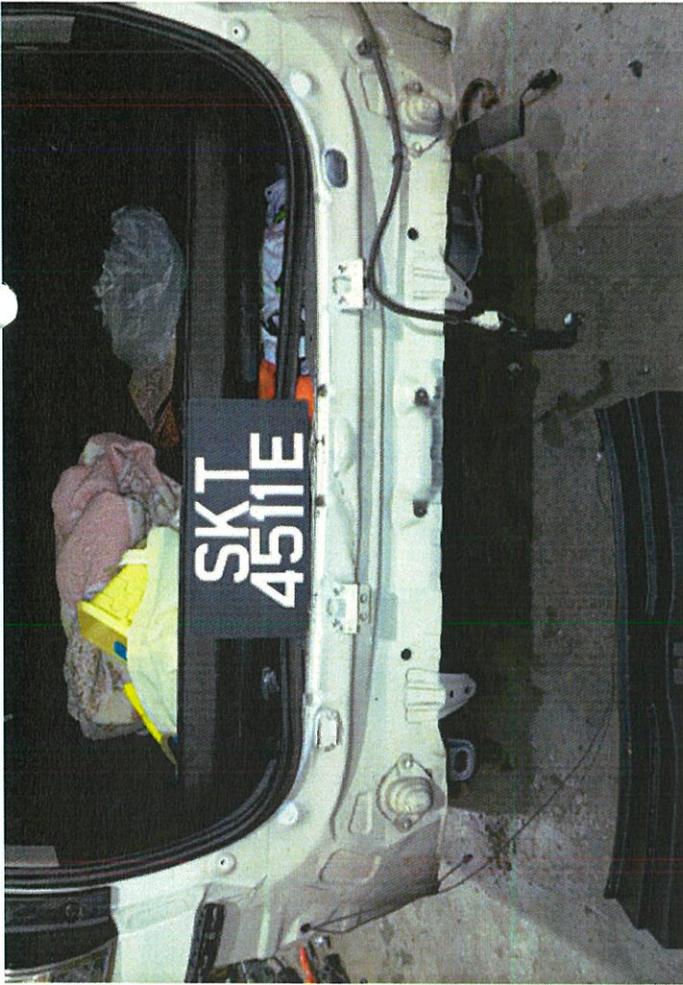
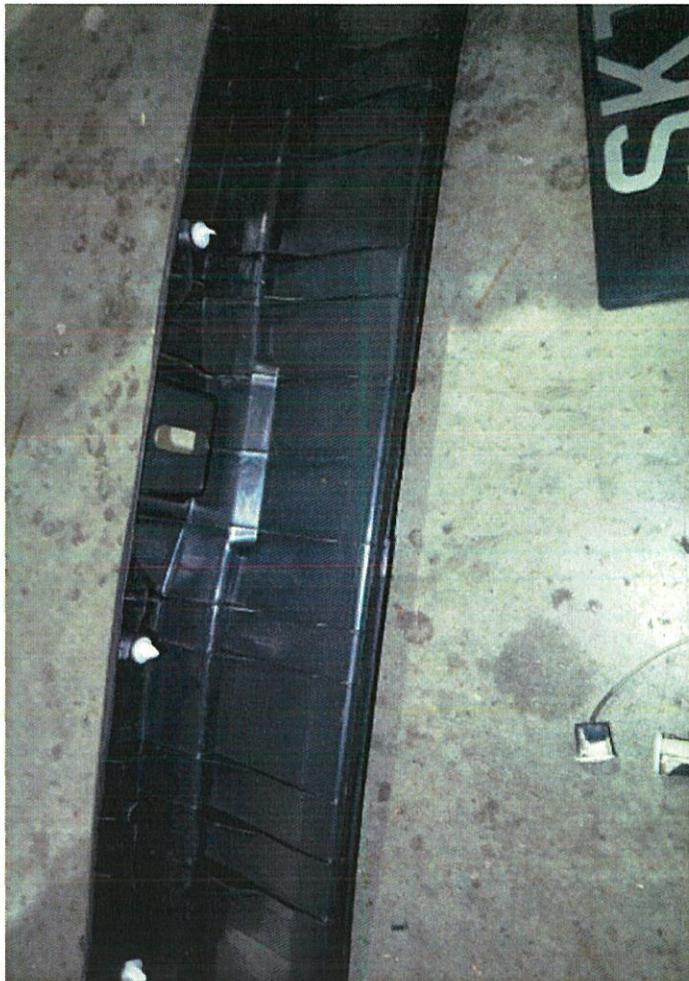
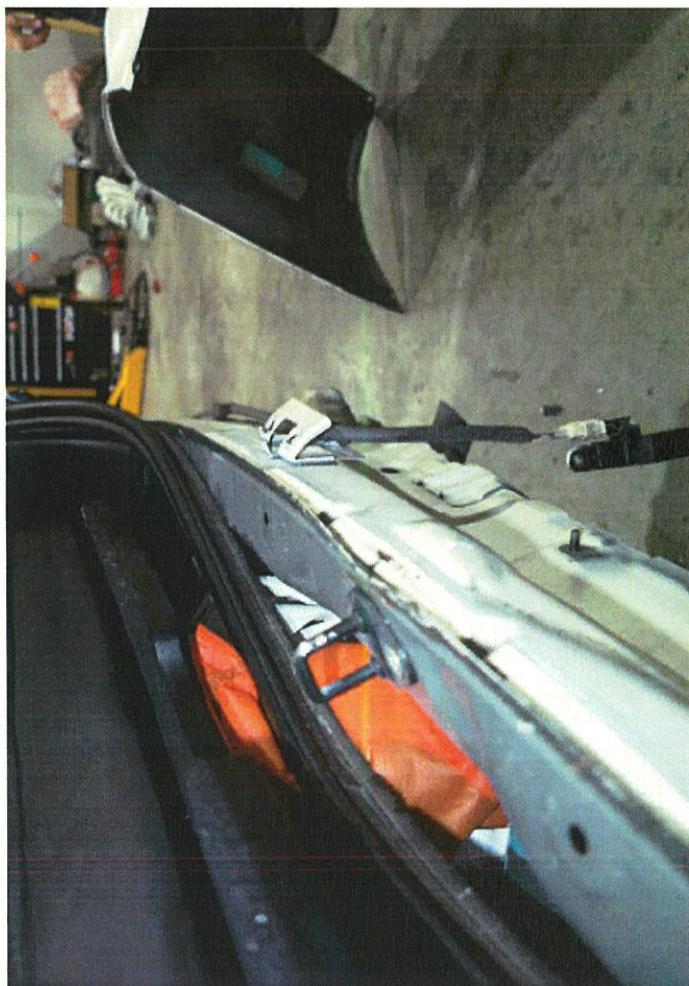
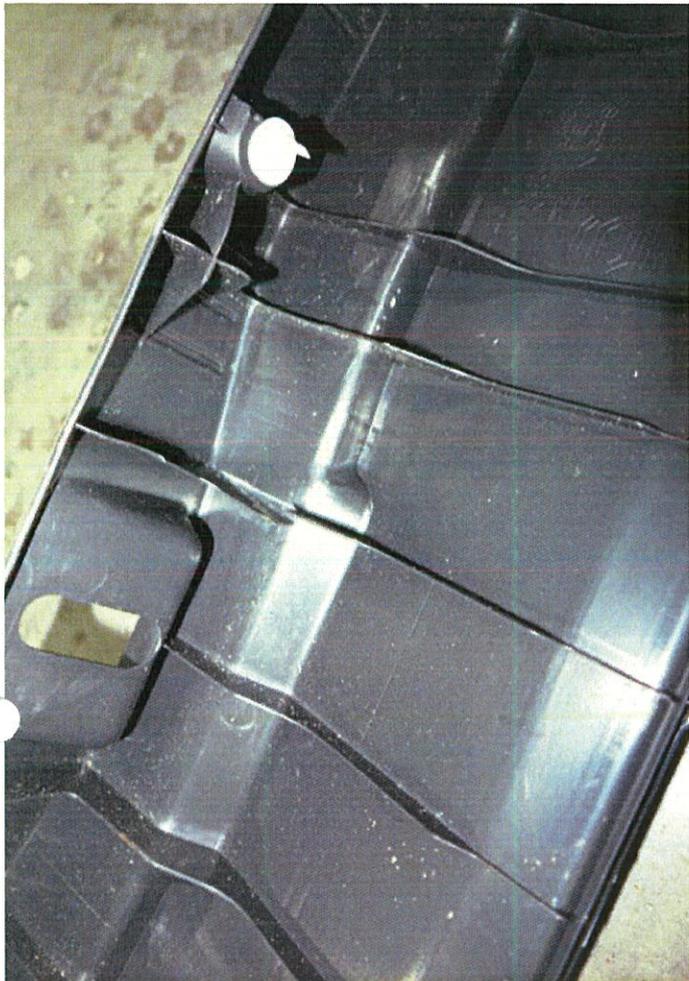
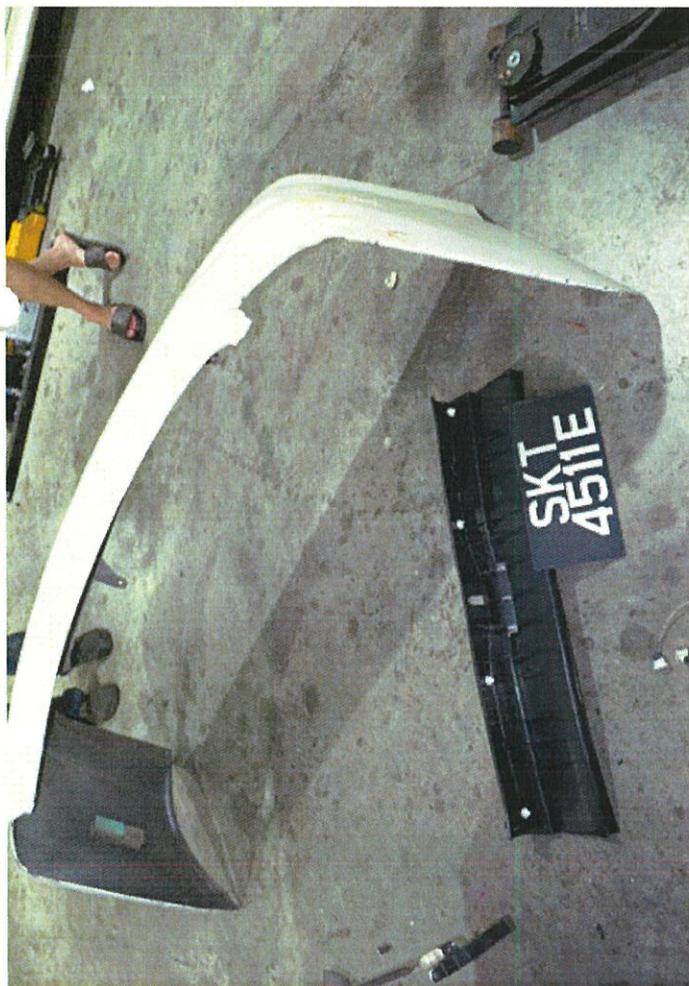
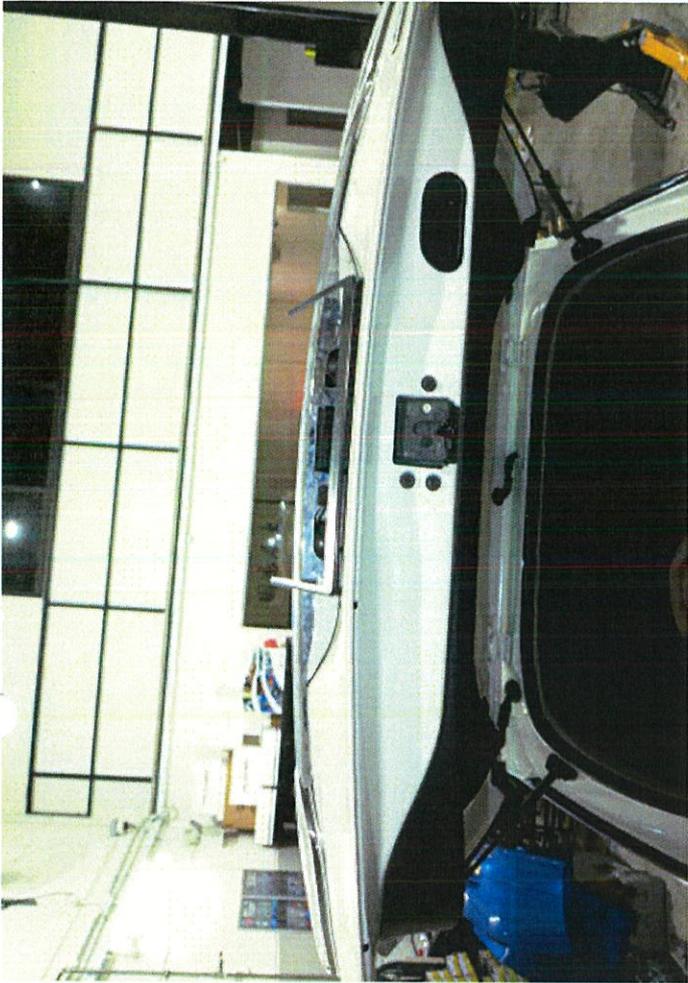
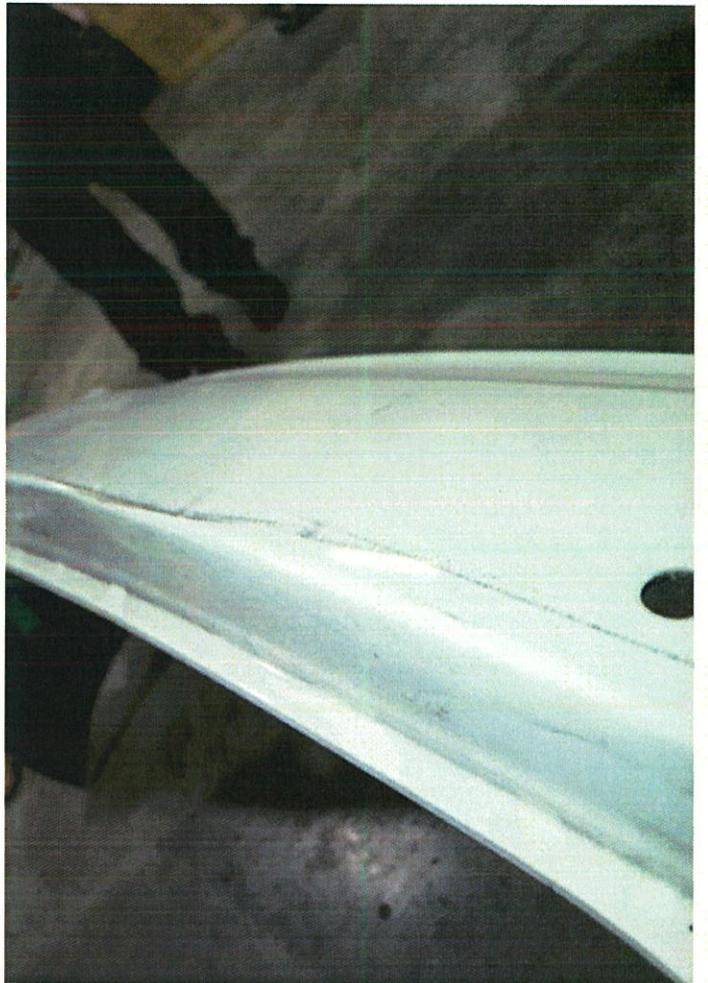
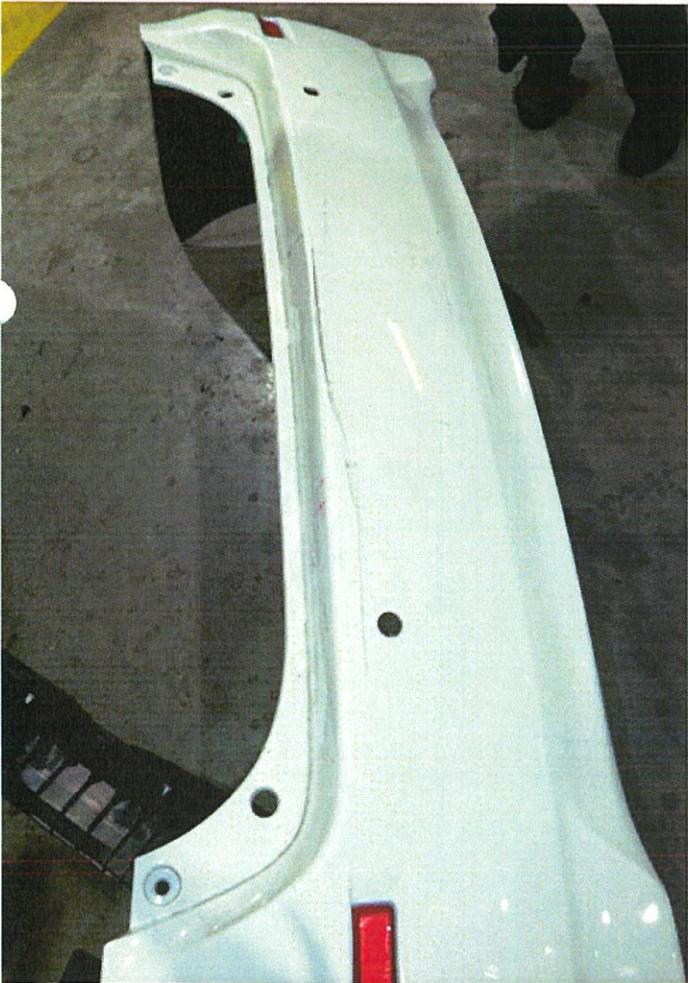
The impact of the collision has damaged / affected the tailgate, rear bumper, rear end panel and etc...

Please refer to Annex A (Appraisal Schedule) for a detailed account of the damages and photographs taken.

Our adjusted cost of repair is SGD 5,900.00 to carry out the repairs. Please refer to Annex A (Appraisal Schedule) for a detailed account of the cost estimates.
