ACCIDENT VEHICLE INSPECTION REPORT

Report no : 109M0323.PMG
Vehicle no : GBL7620C

Make/model : **NISSAN NV350 URVAN PANEL VAN 5MT**
Chassis no : JN1MA2E26Z0000418
Engine no : QR20020948R
Date of registration : 28 March 2022 *COE Expiry Date:* 27 March 2032
Engine capacity : 1998 cc
Odometer reading : 11327 km
Colour : Grey

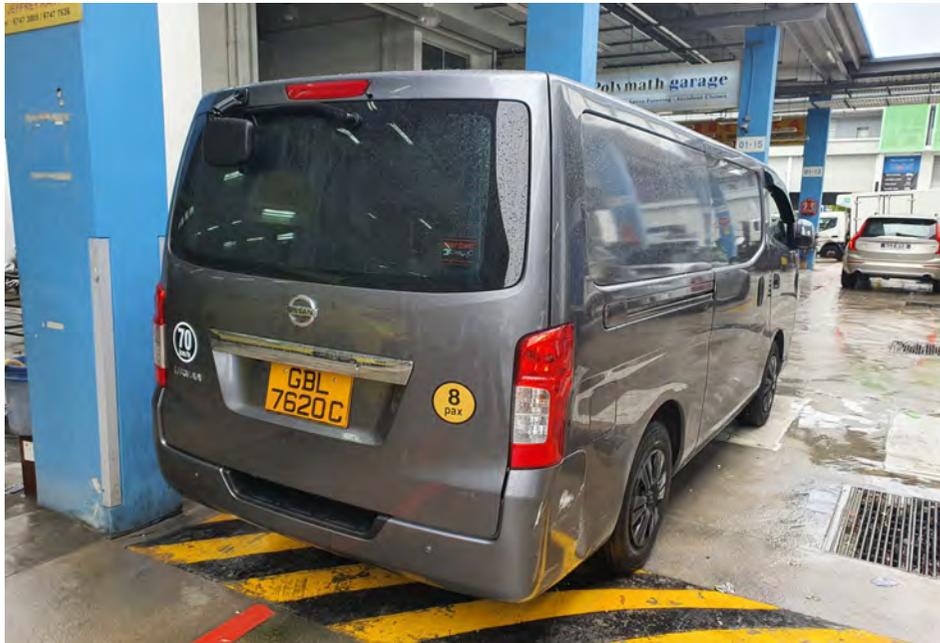
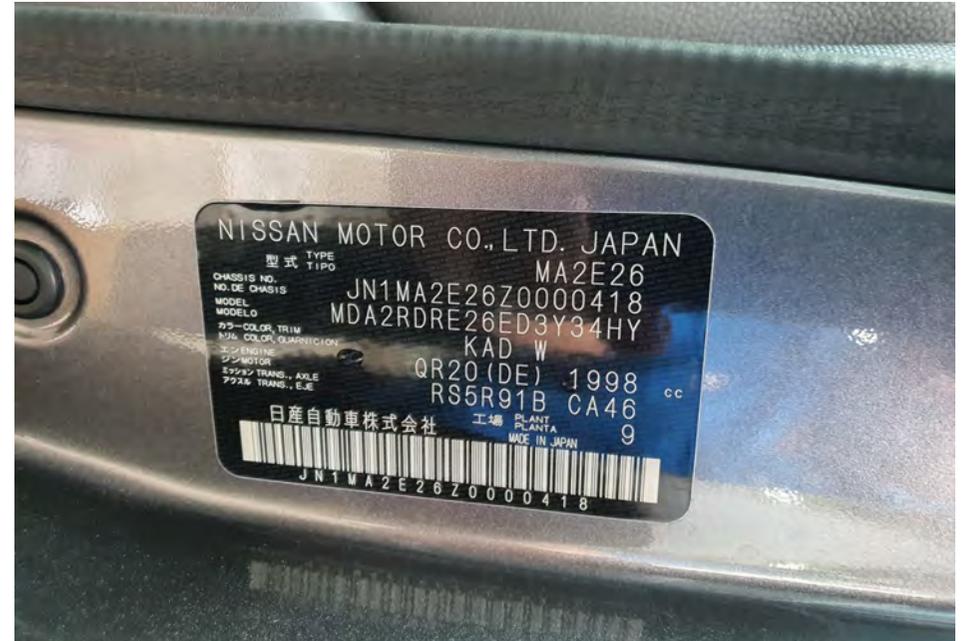
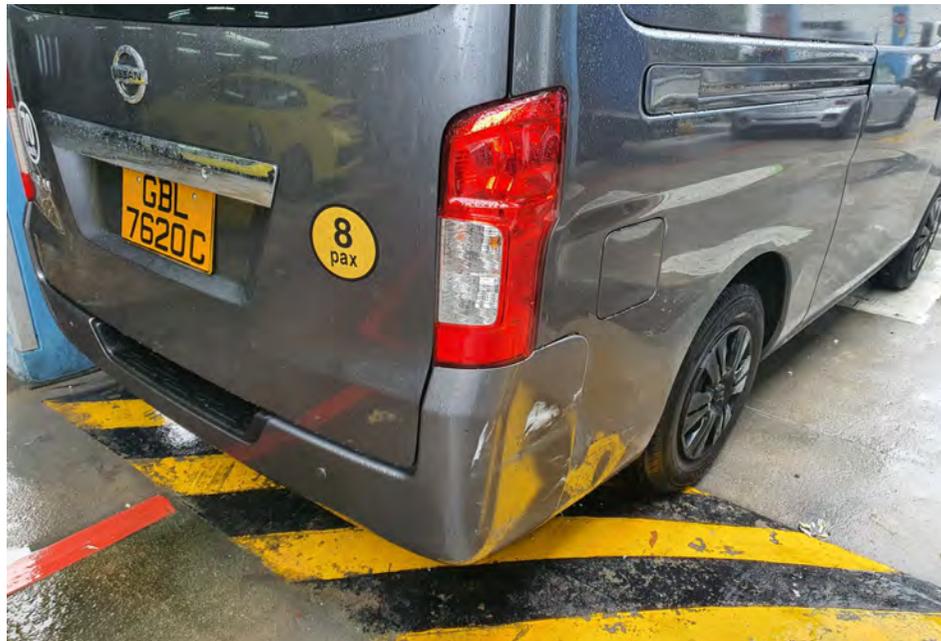
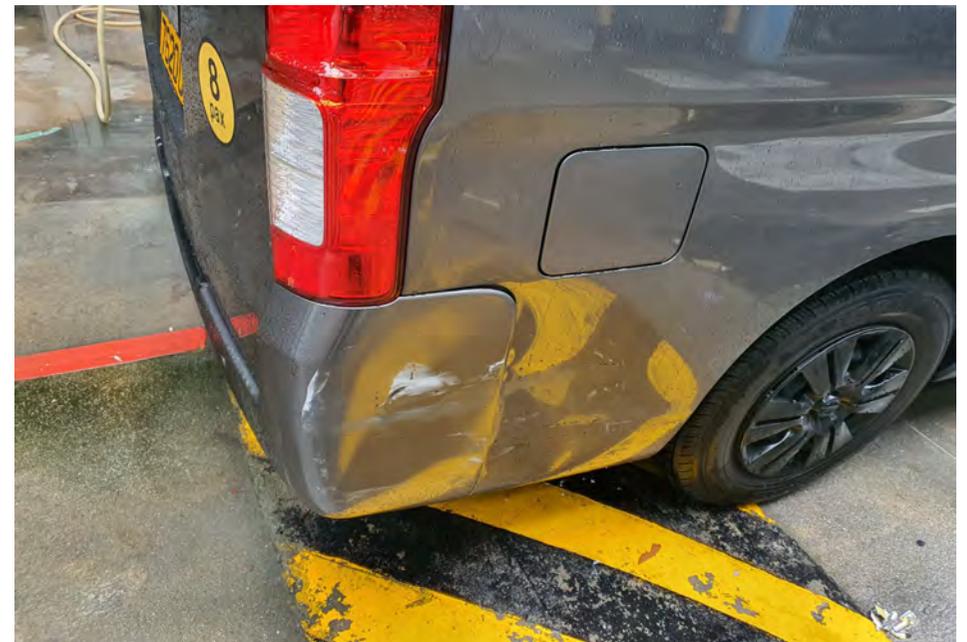
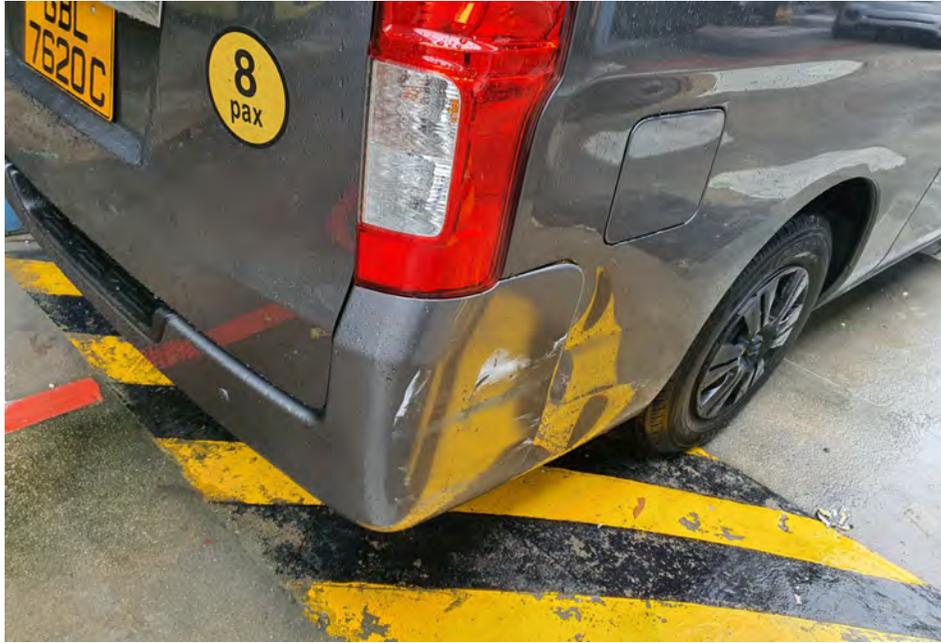
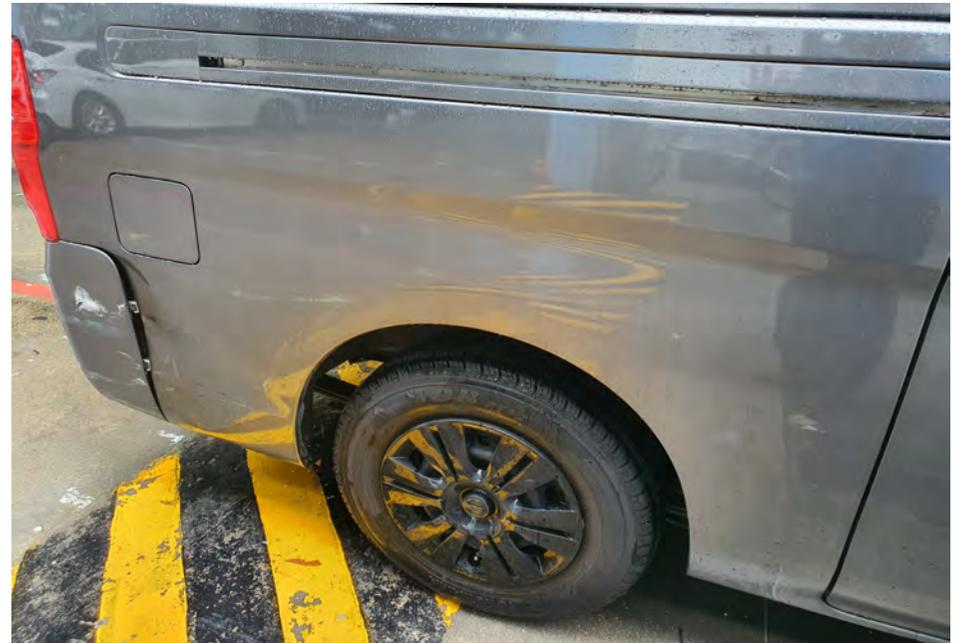
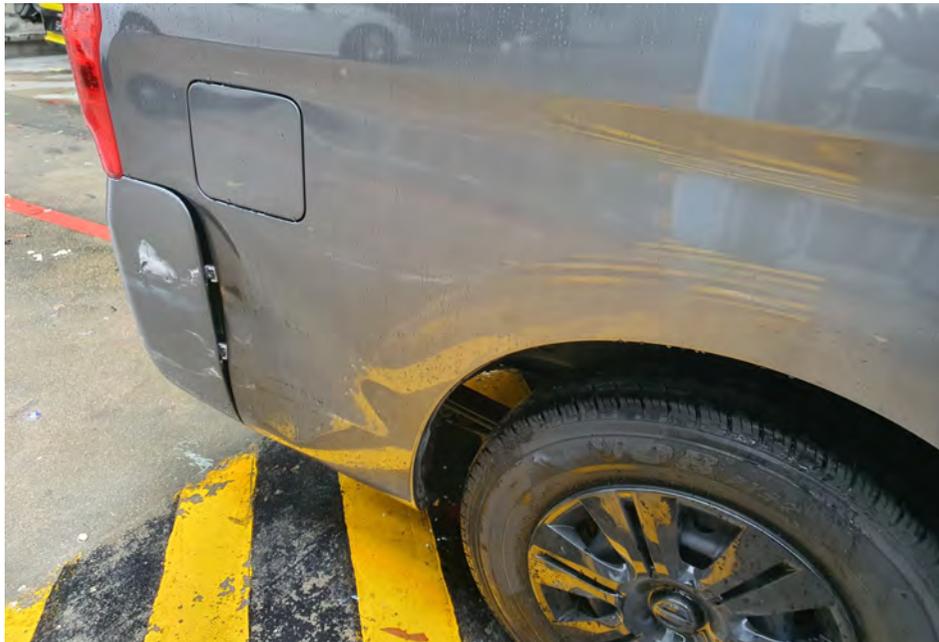
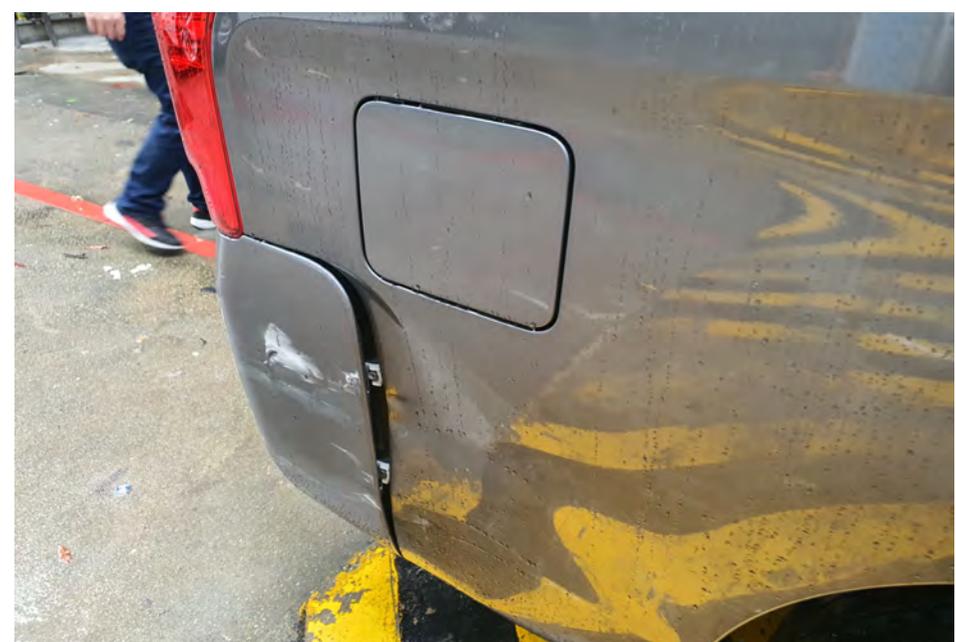
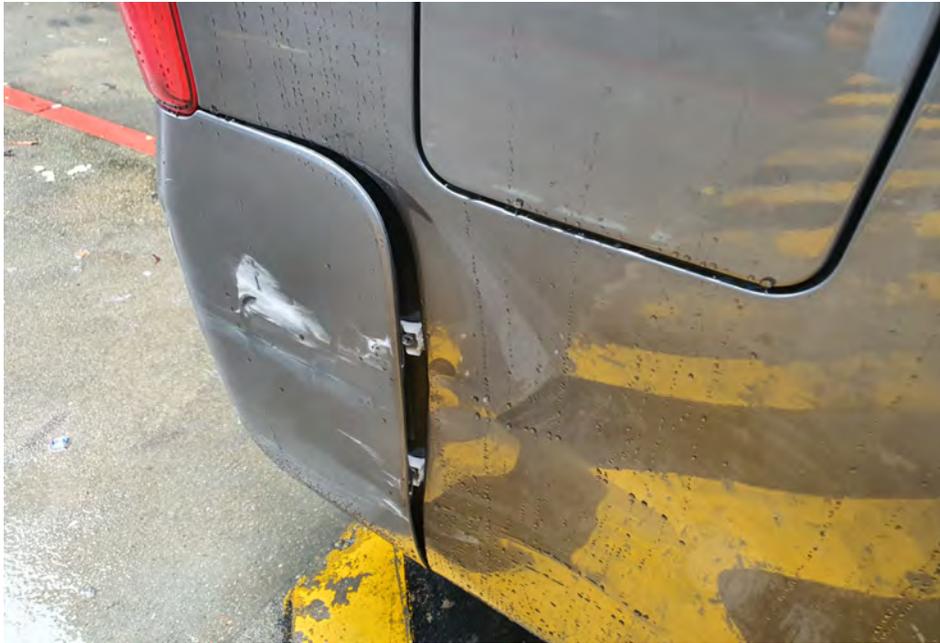
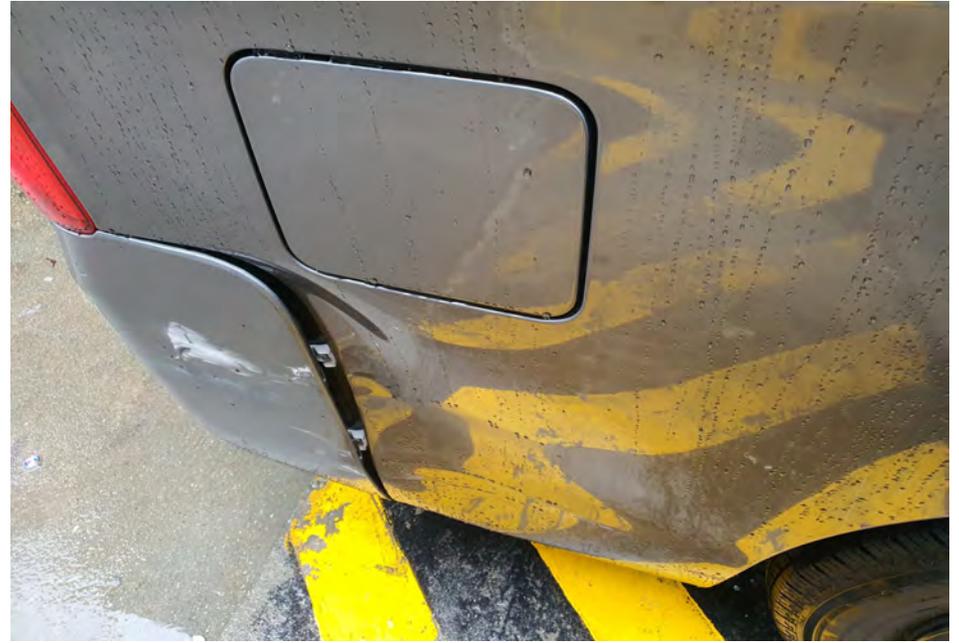
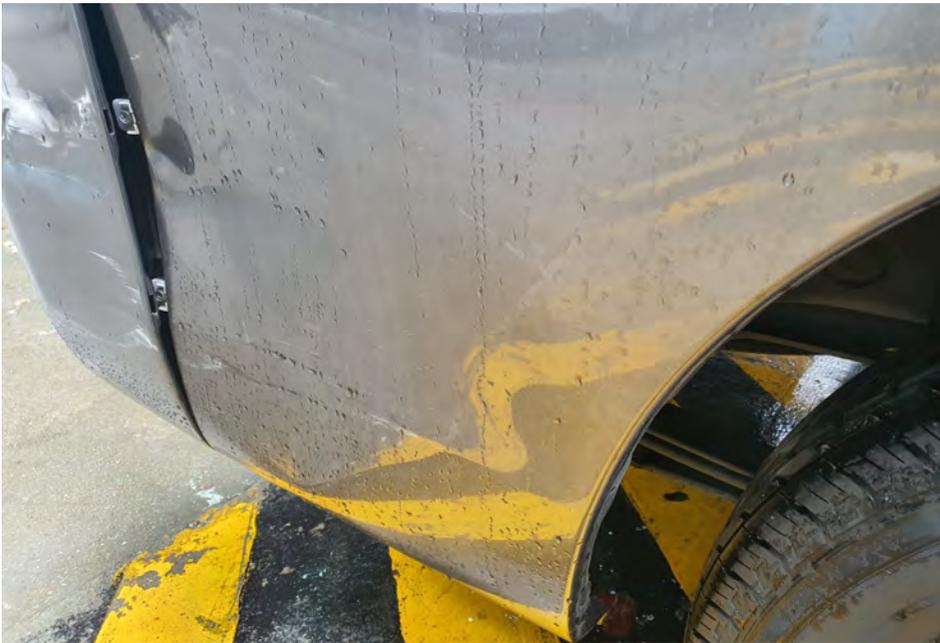
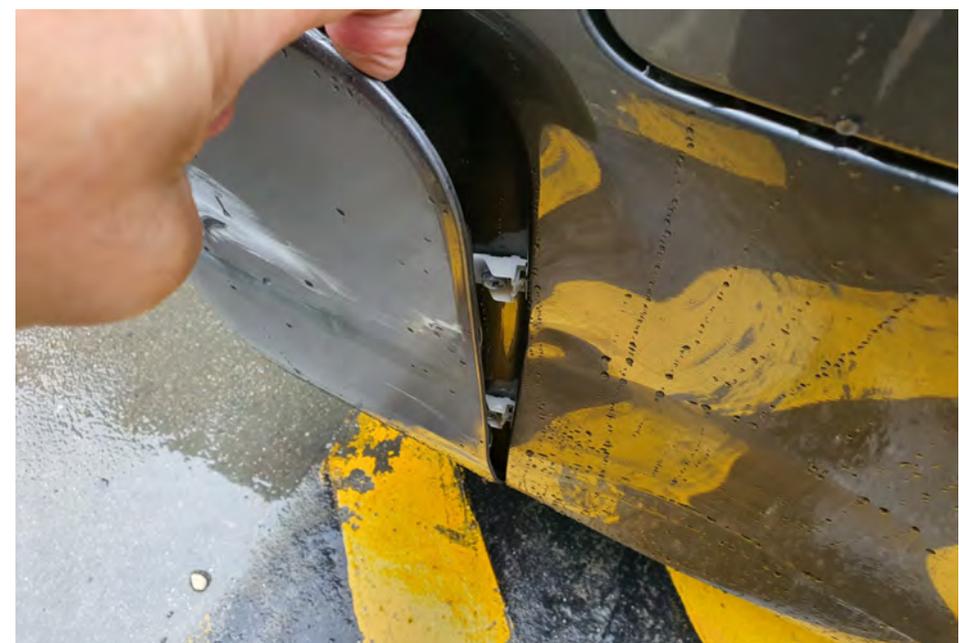
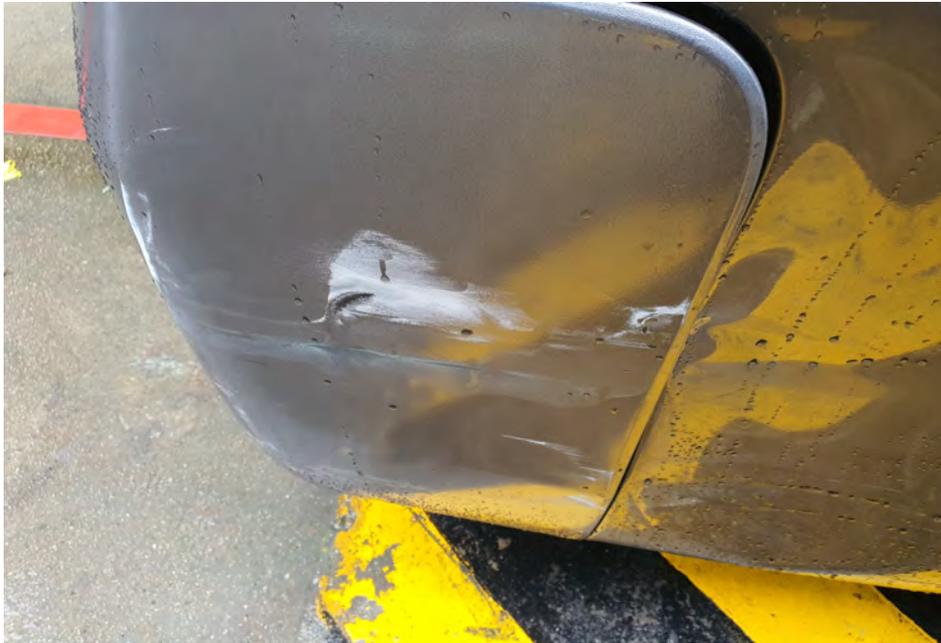
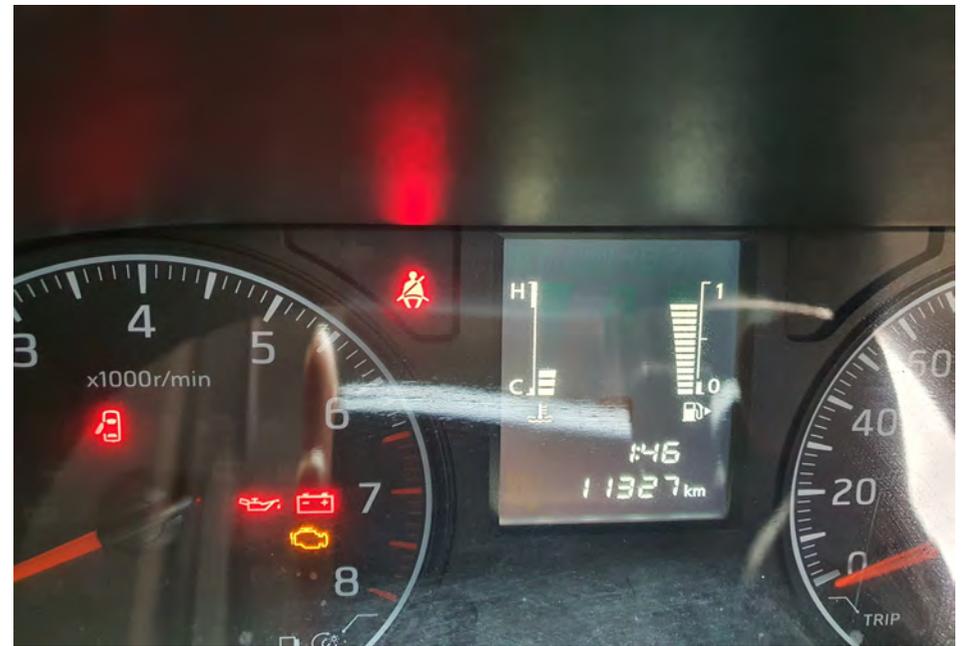
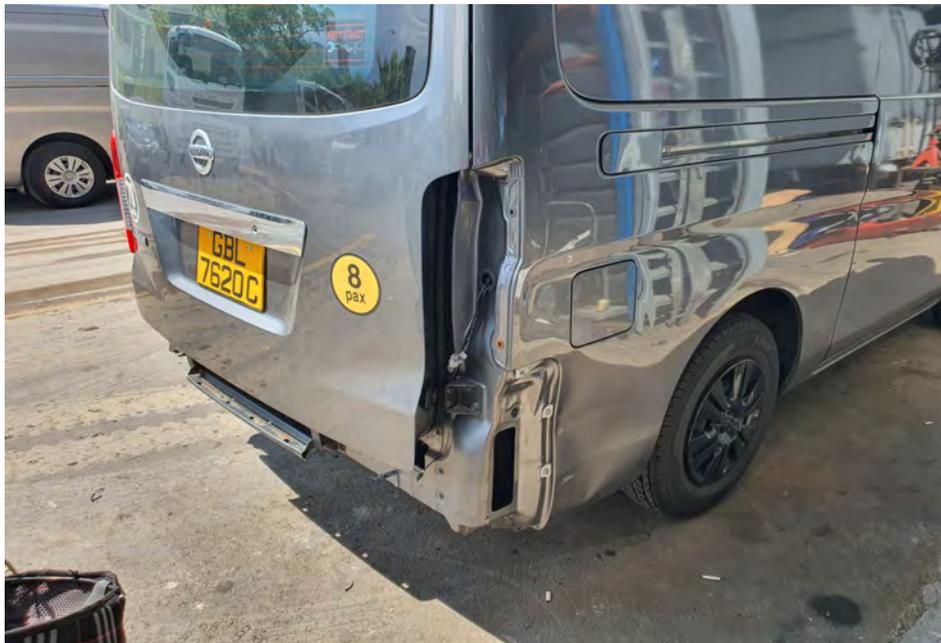
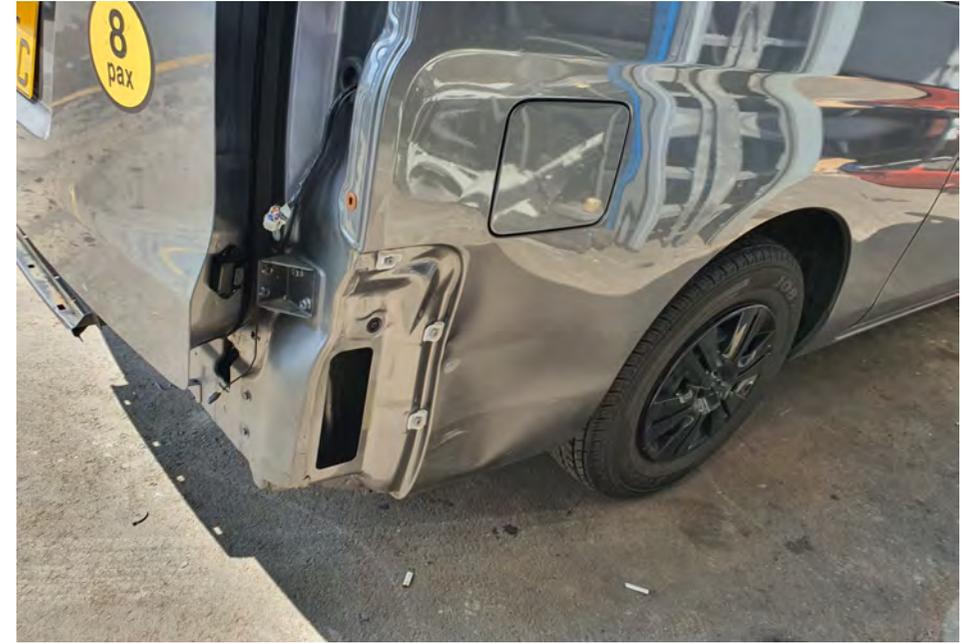
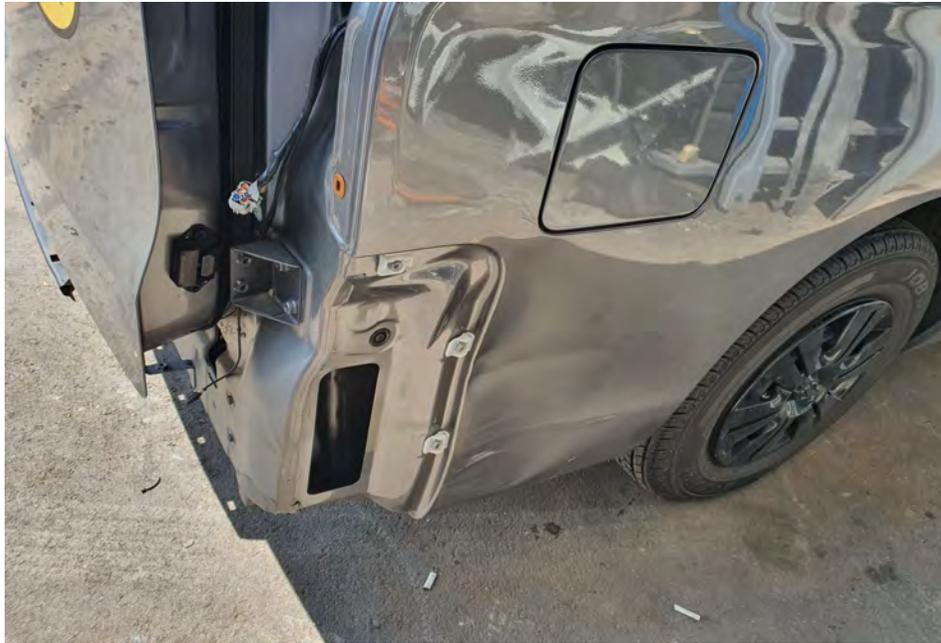
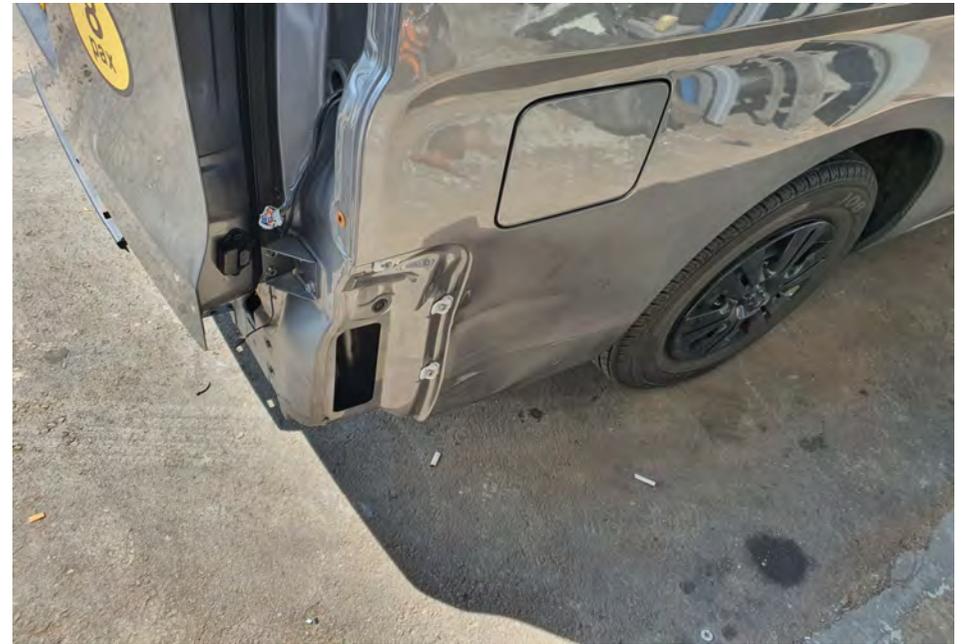
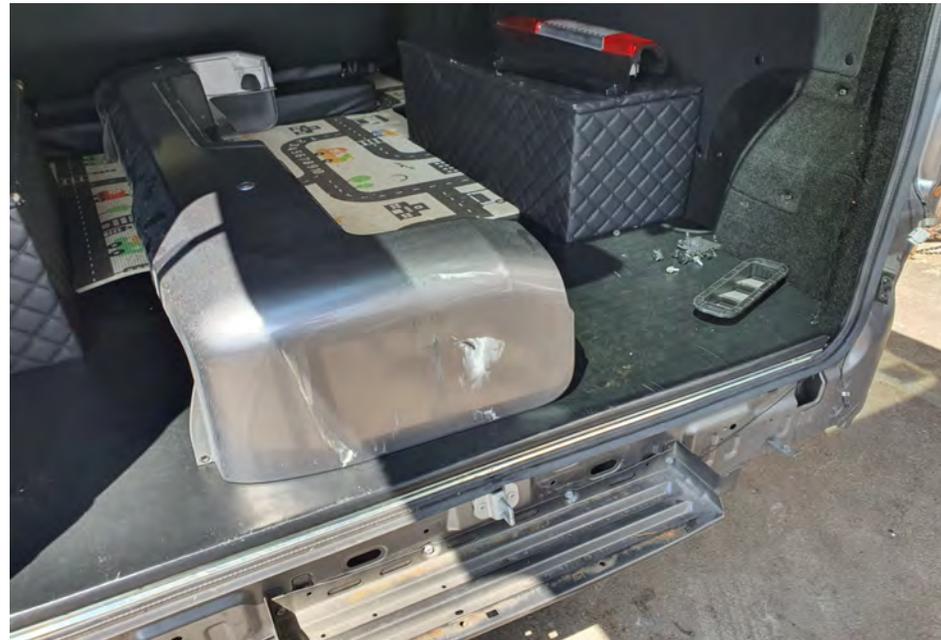
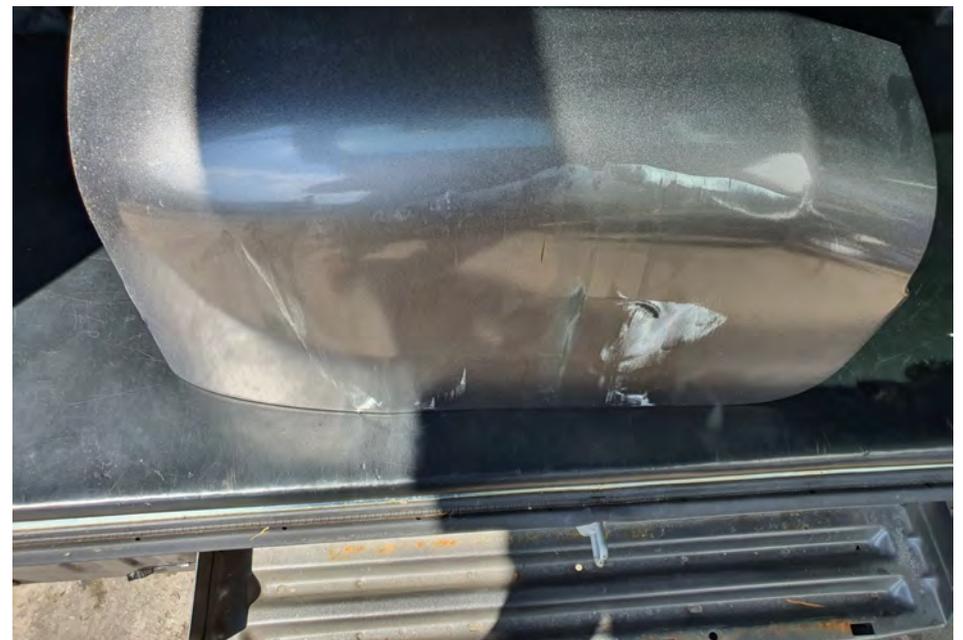
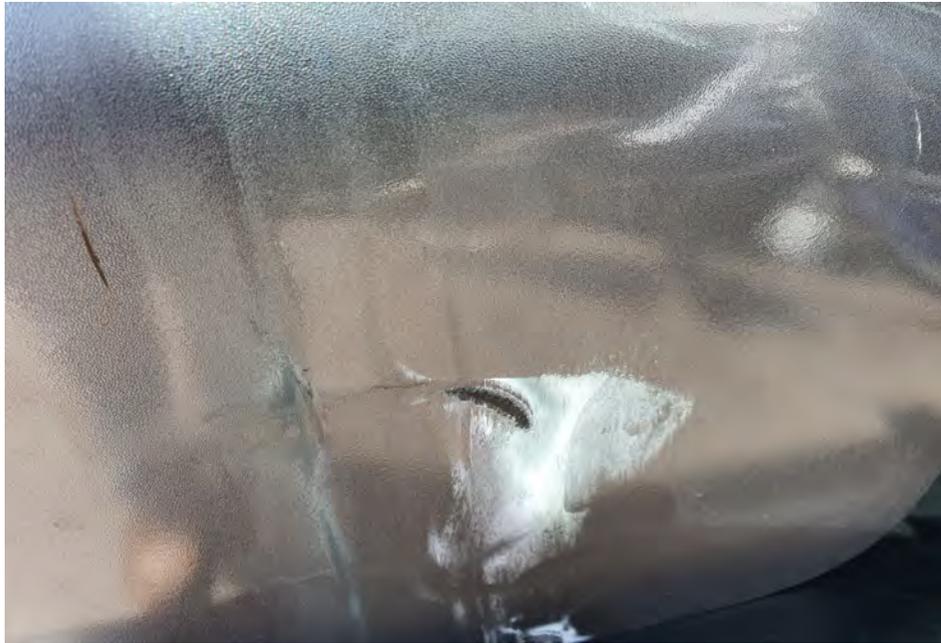
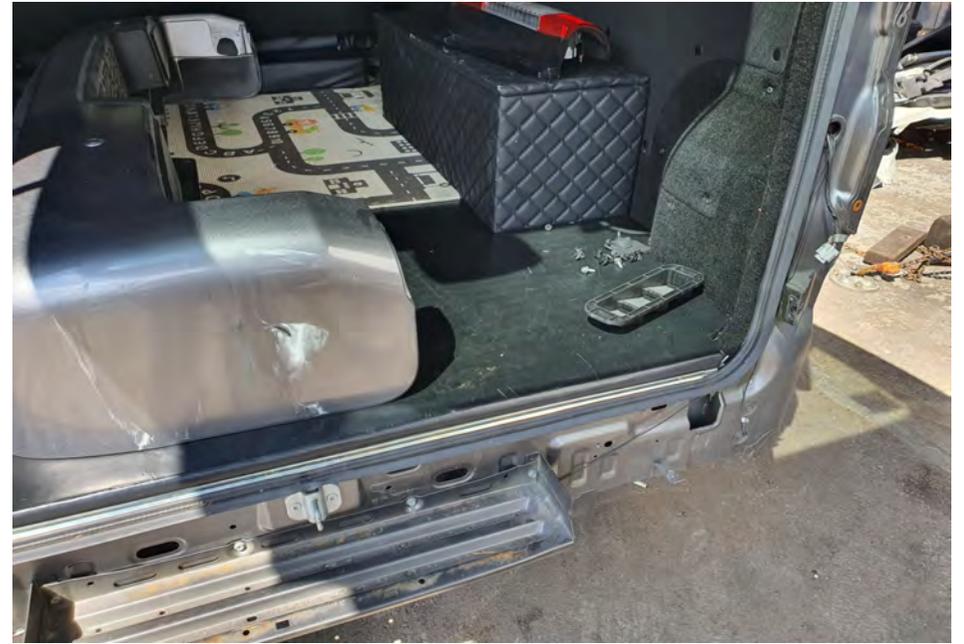
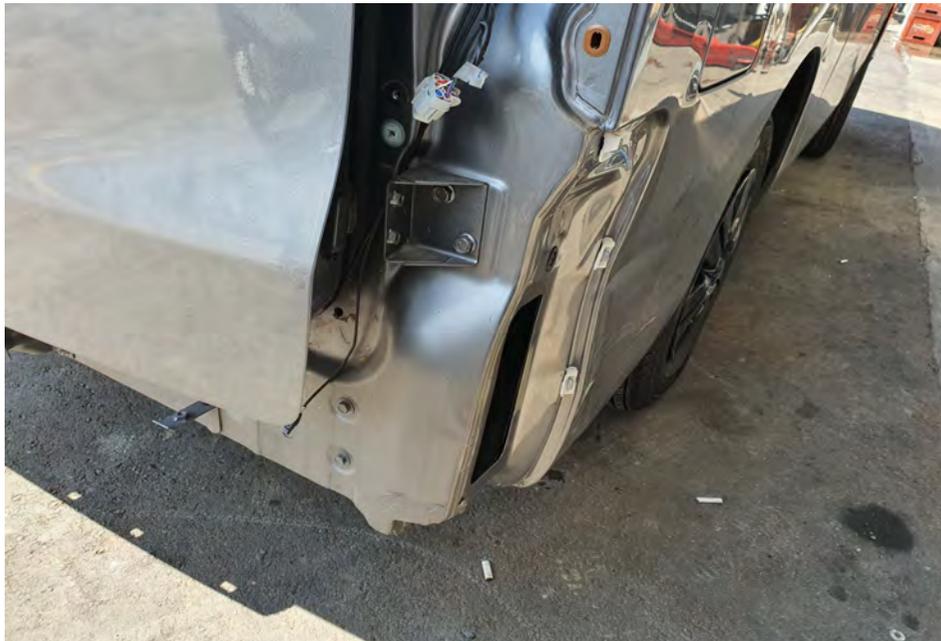
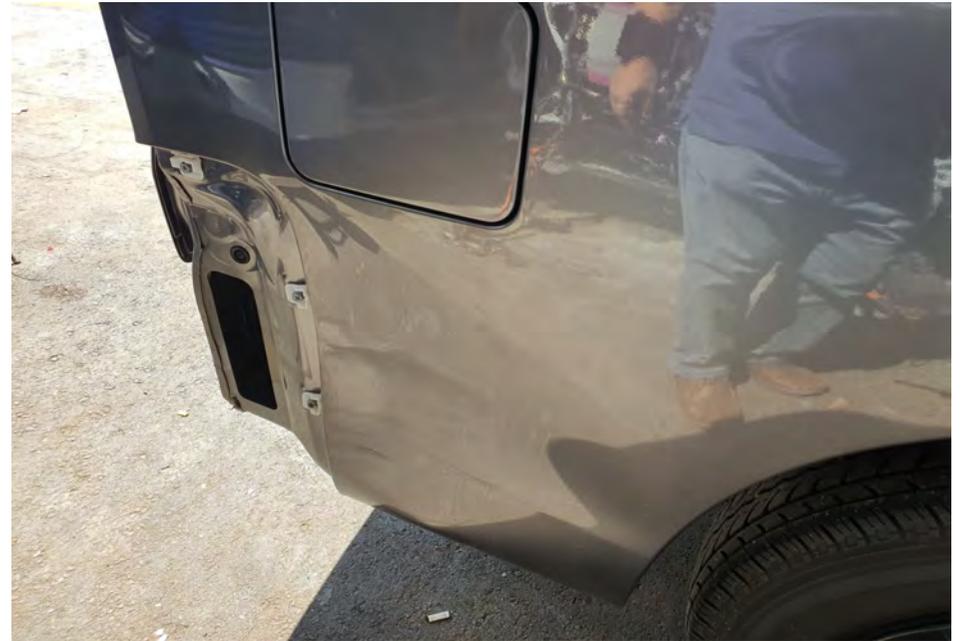
Rear bumper scraped/cut/deformed, rear RH outer panel bent, etc. Please see para. 8 of this report for more details.

(a) However, the recommended cost of repair based on lump sum basis would be **\$1,500.00**
