## VEHICLE DAMAGE INSPECTION REPORT

Our Ref: 225/TP/2021

Date of loss: 9/10/2021  
Claimant: Law Wai Keong

Reg No:	JQA3386	Make &	Toyota
Reg date:	26/3/2014	Model	Camry 2.0
Colour:	Black	Engine No:	1AZE282417
Type:	Motor Car	Chassis No:	PN153BK5107009011
Type of Claims:	Third Party	Odometer No:	120393km
		Engine Cap:	1998cc

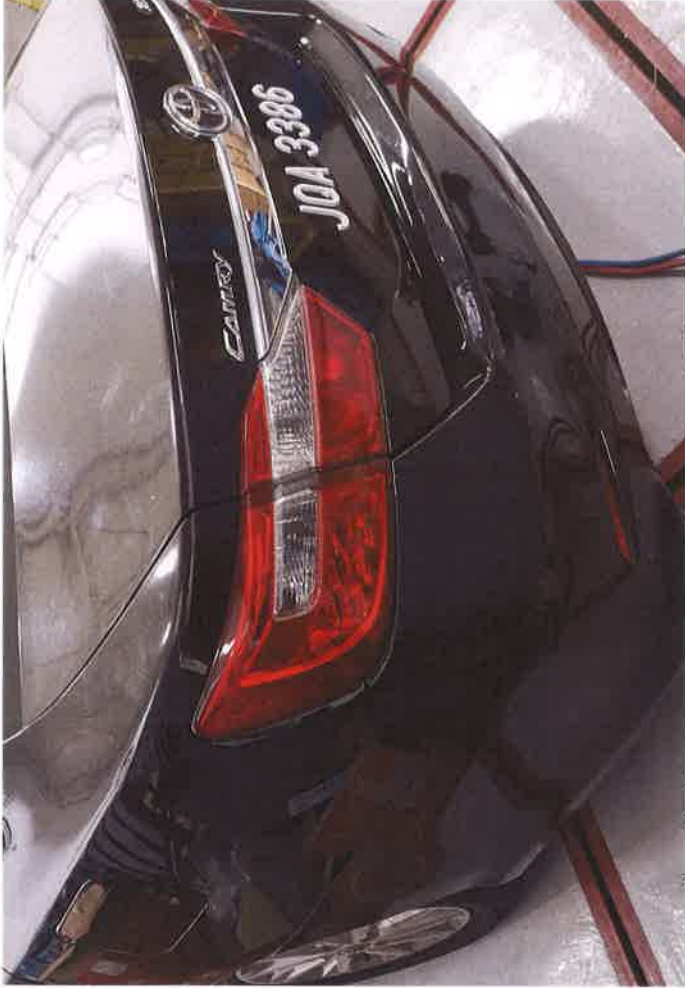
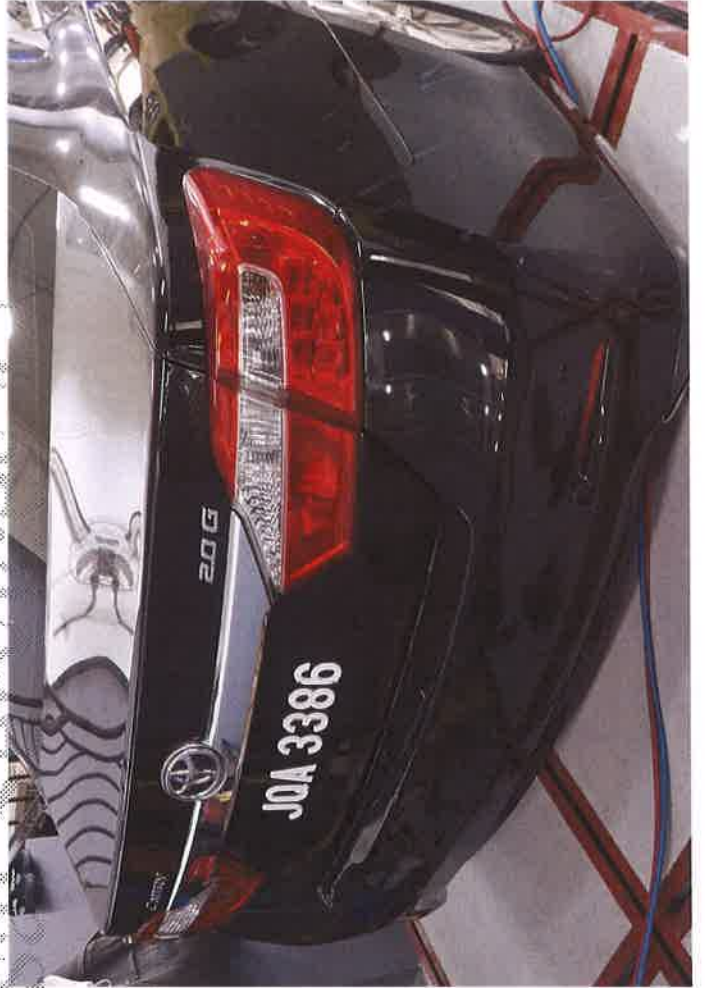
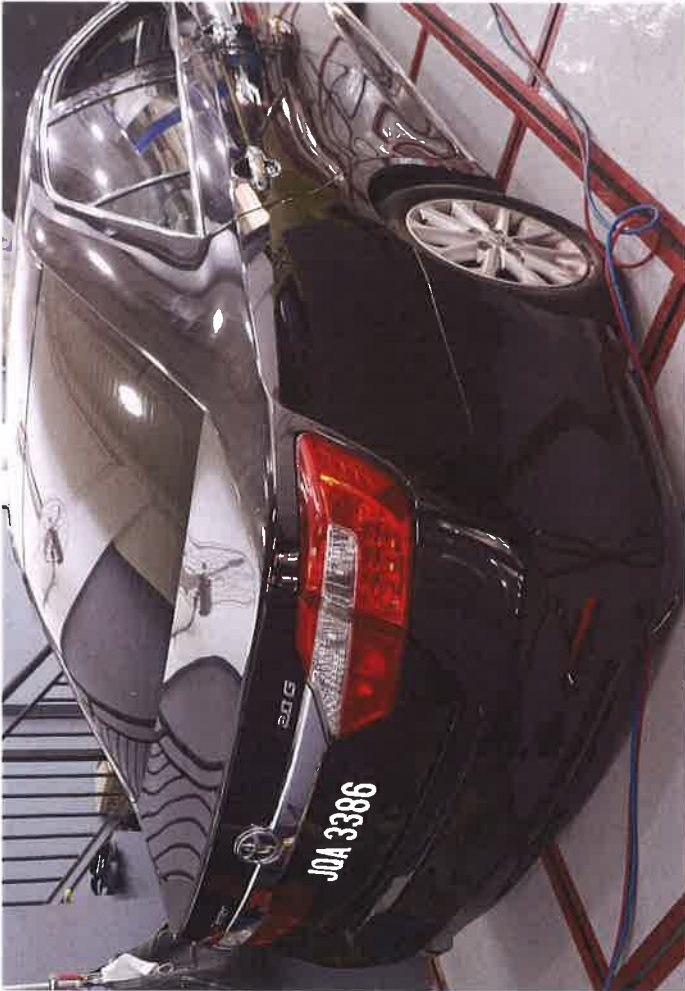
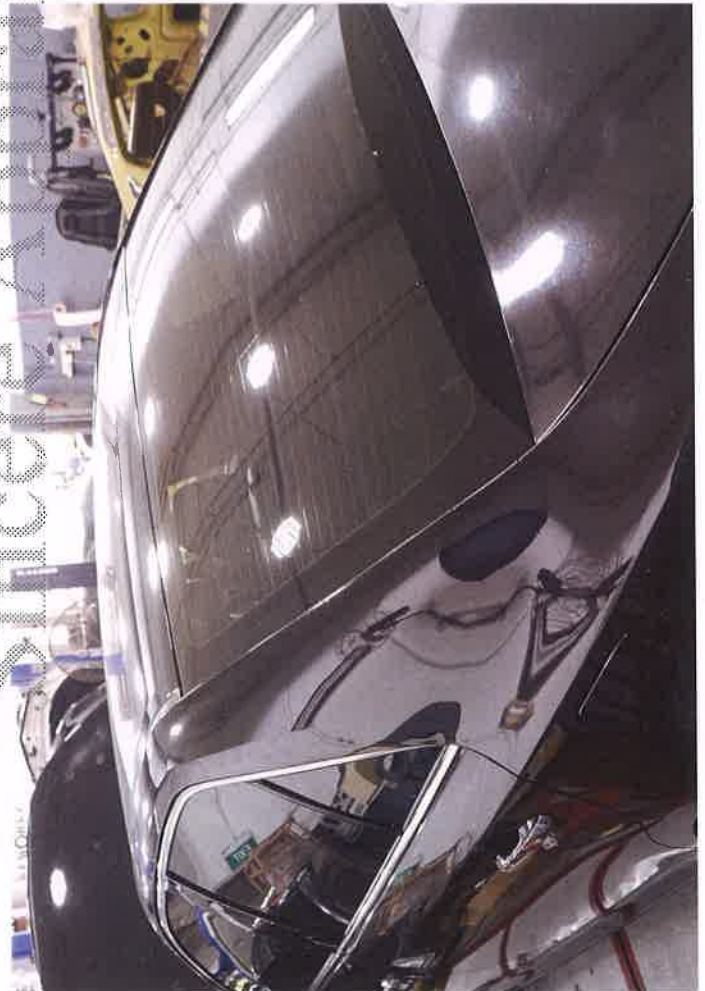
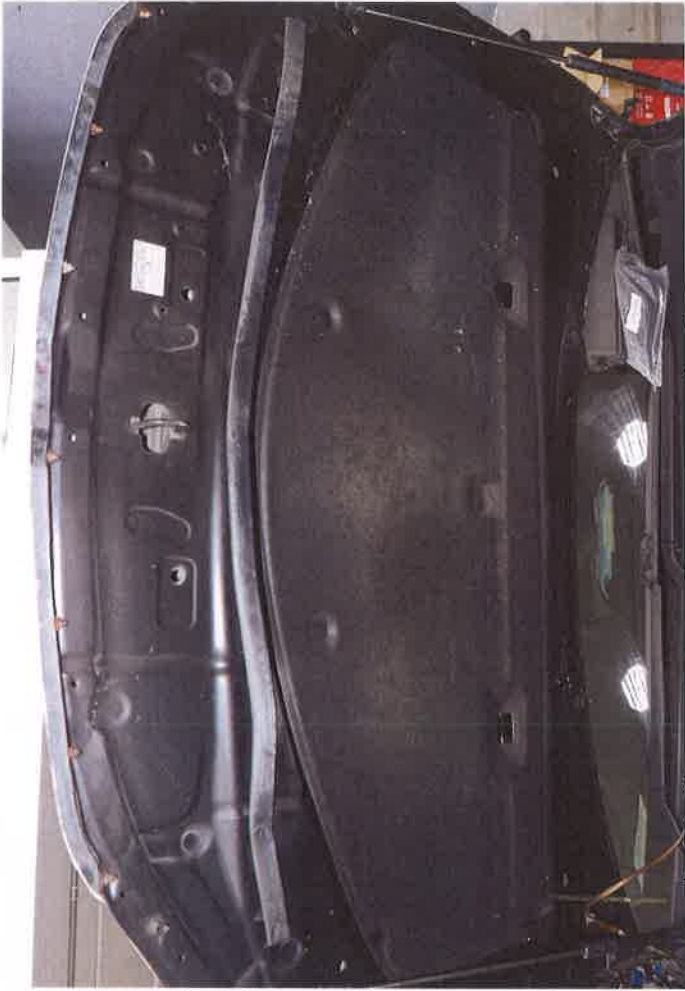
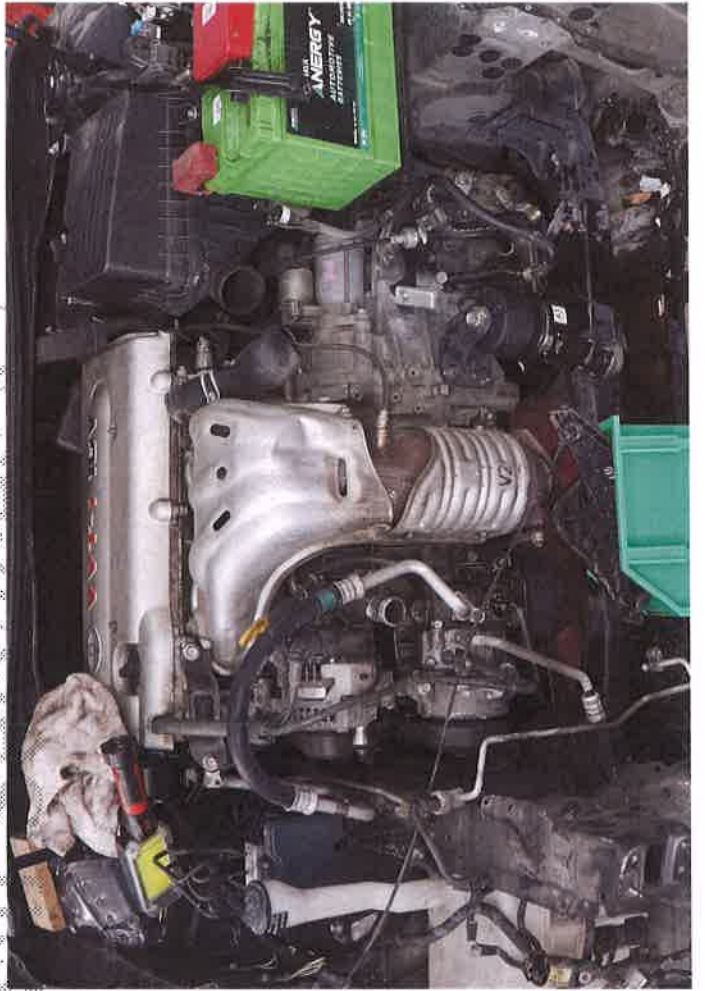
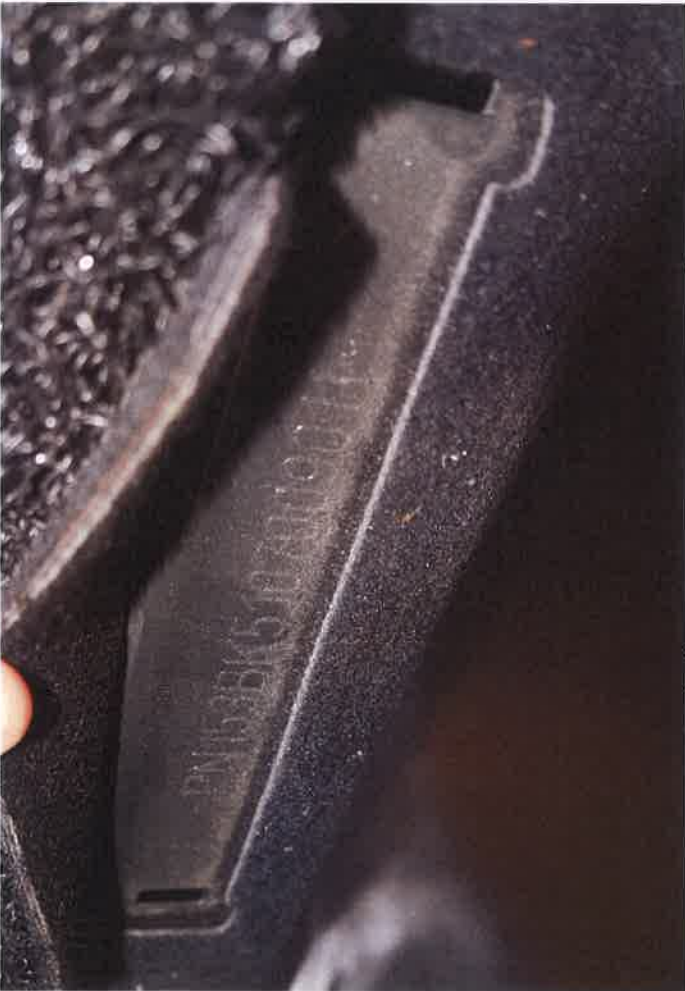
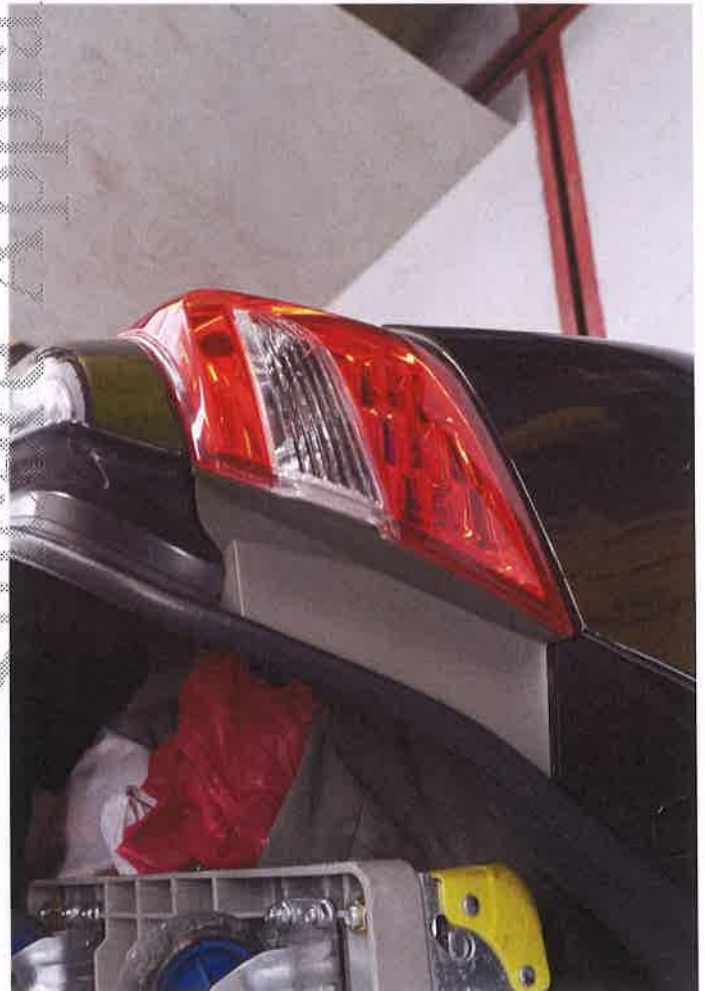
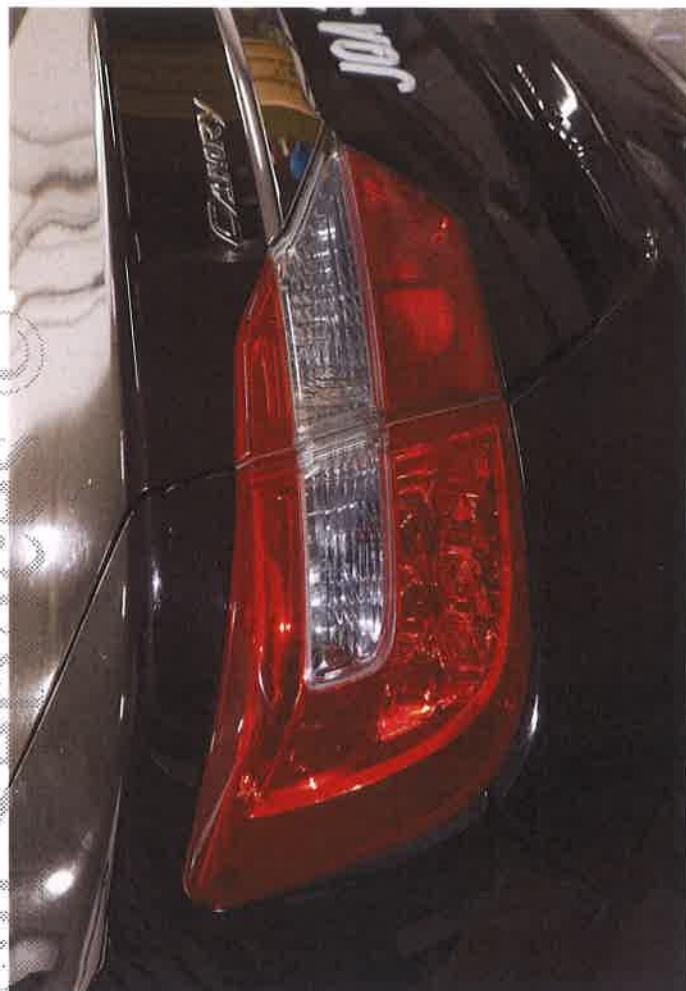
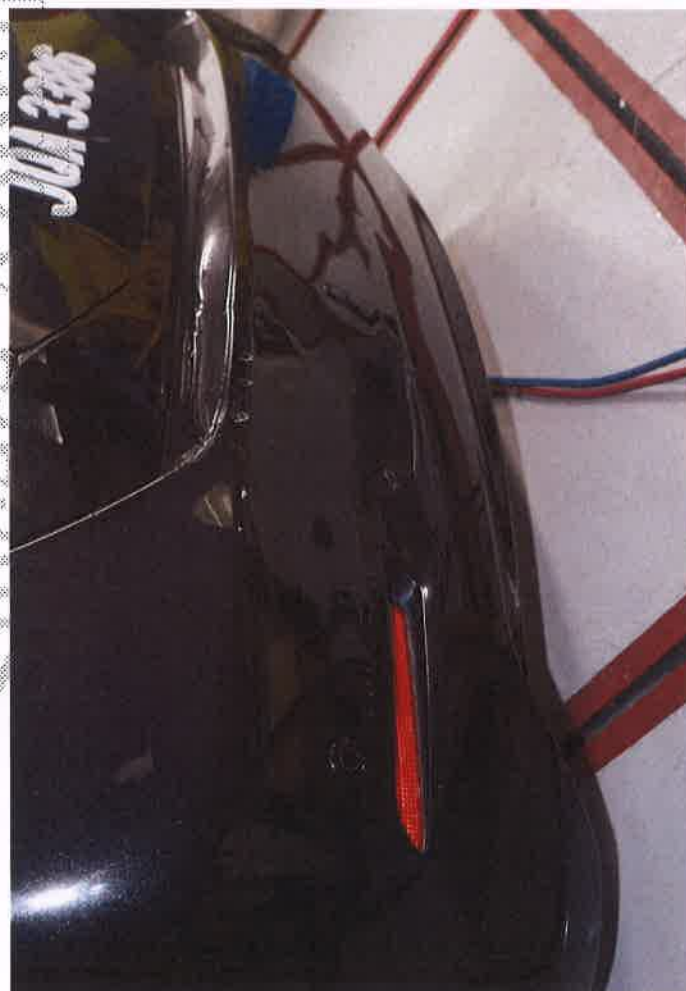
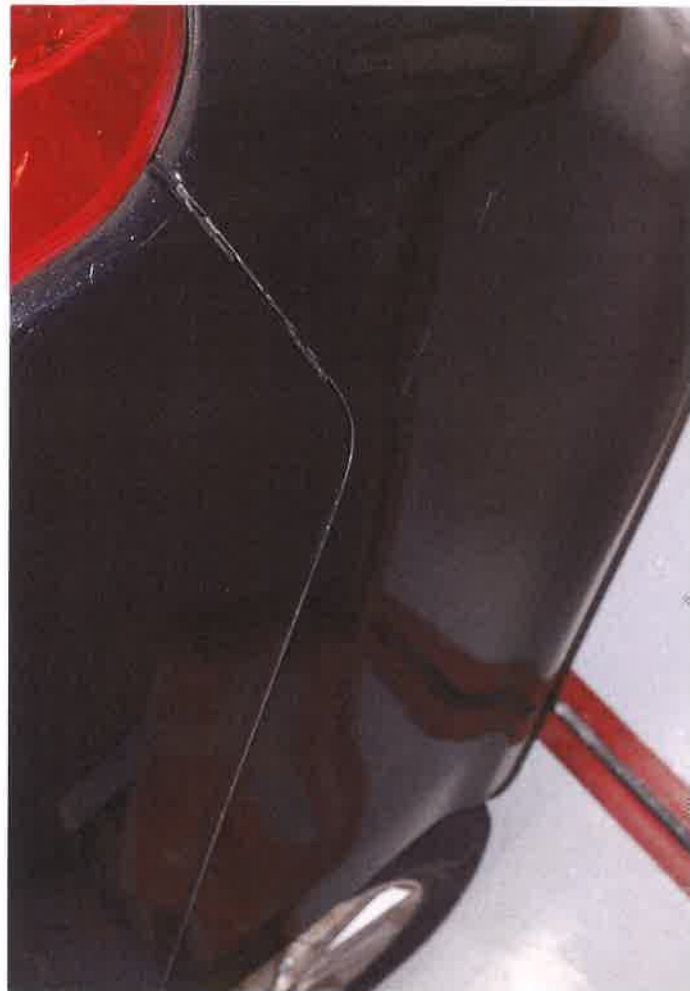
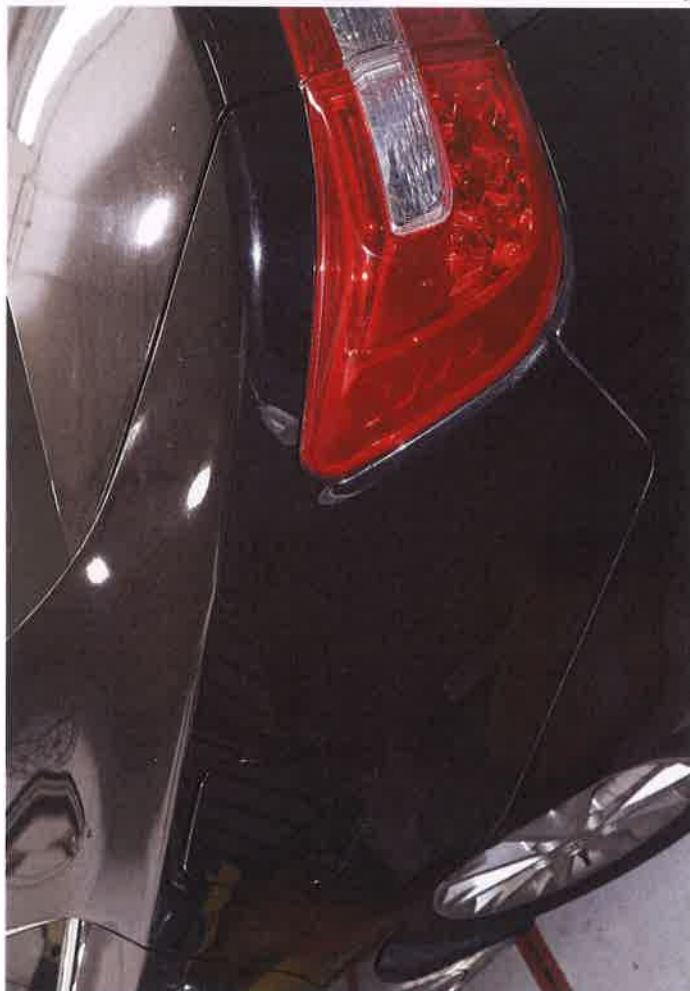
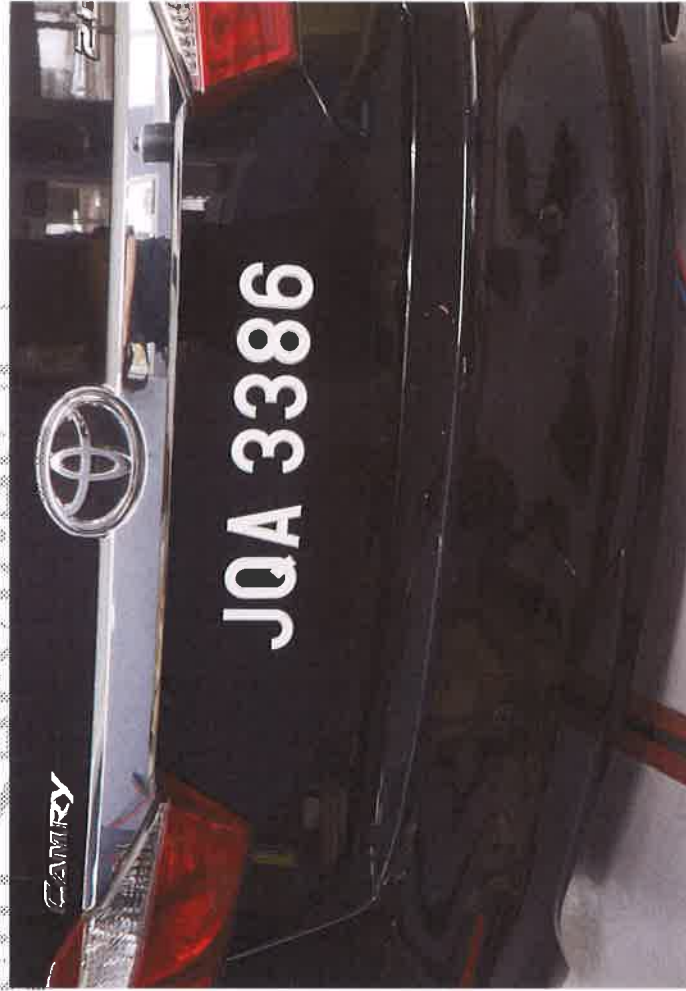
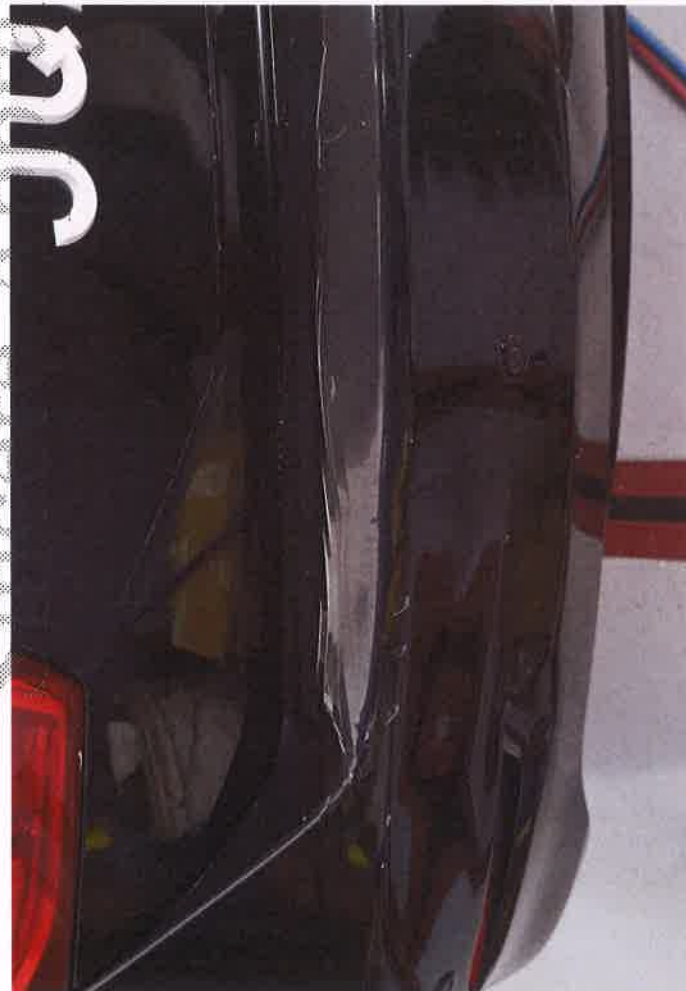
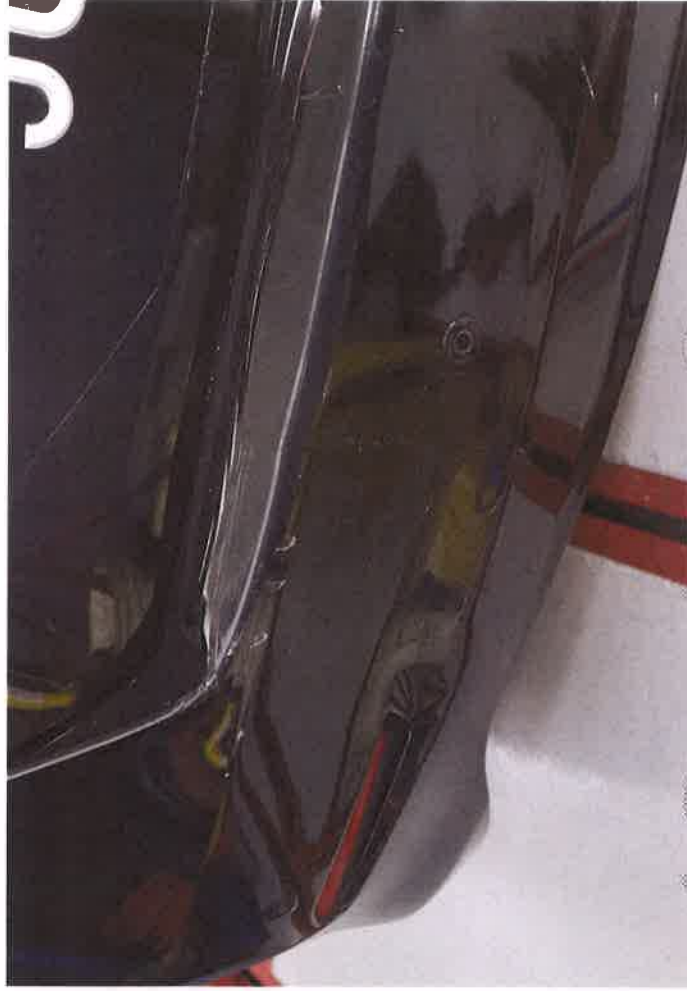
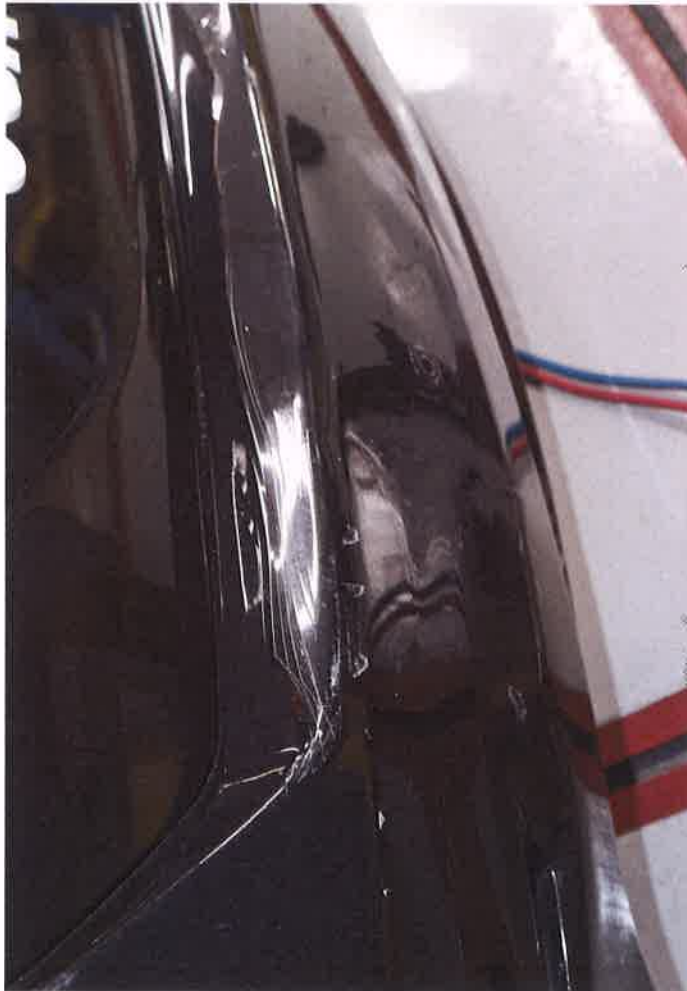
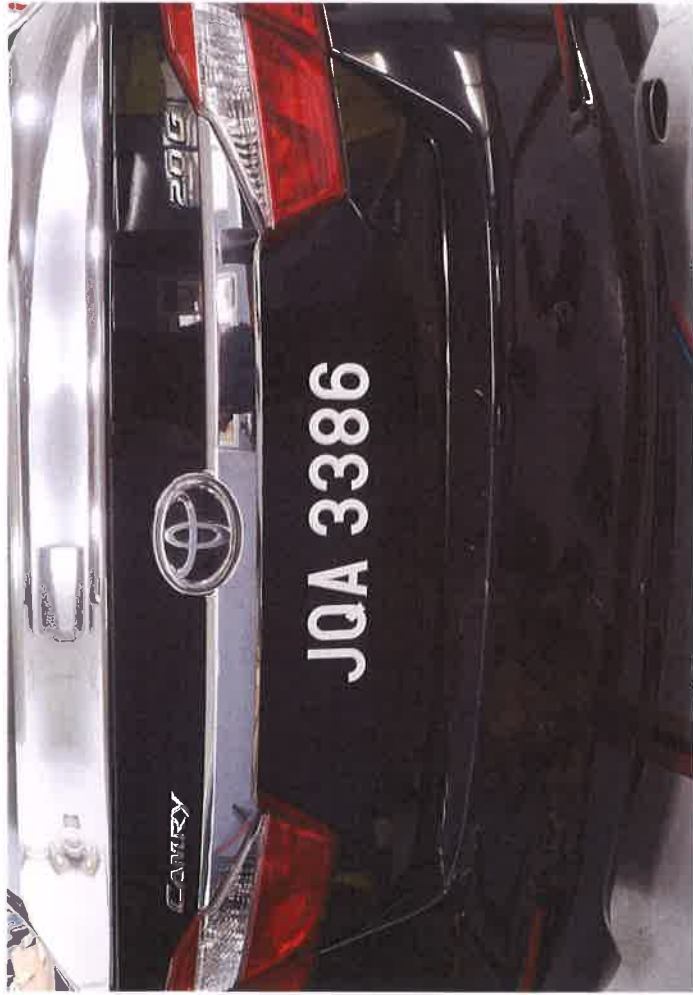
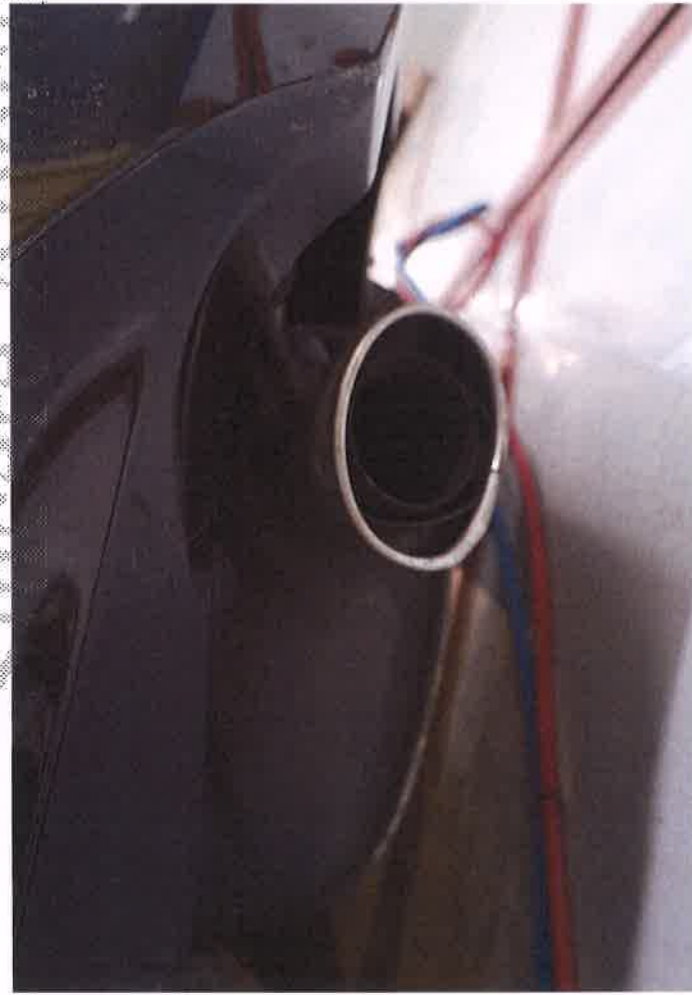
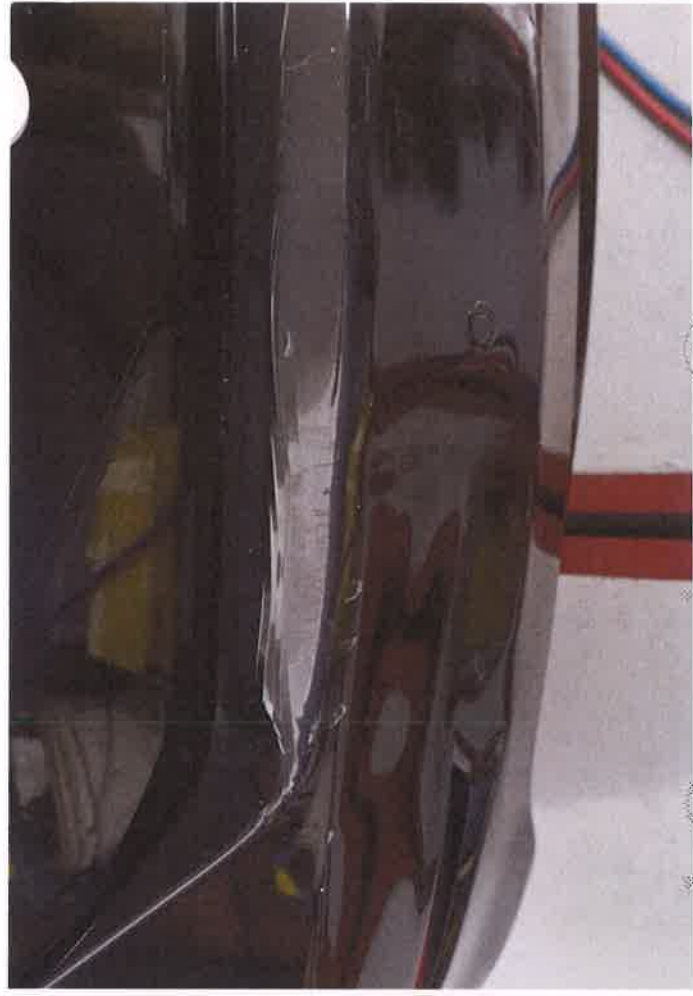
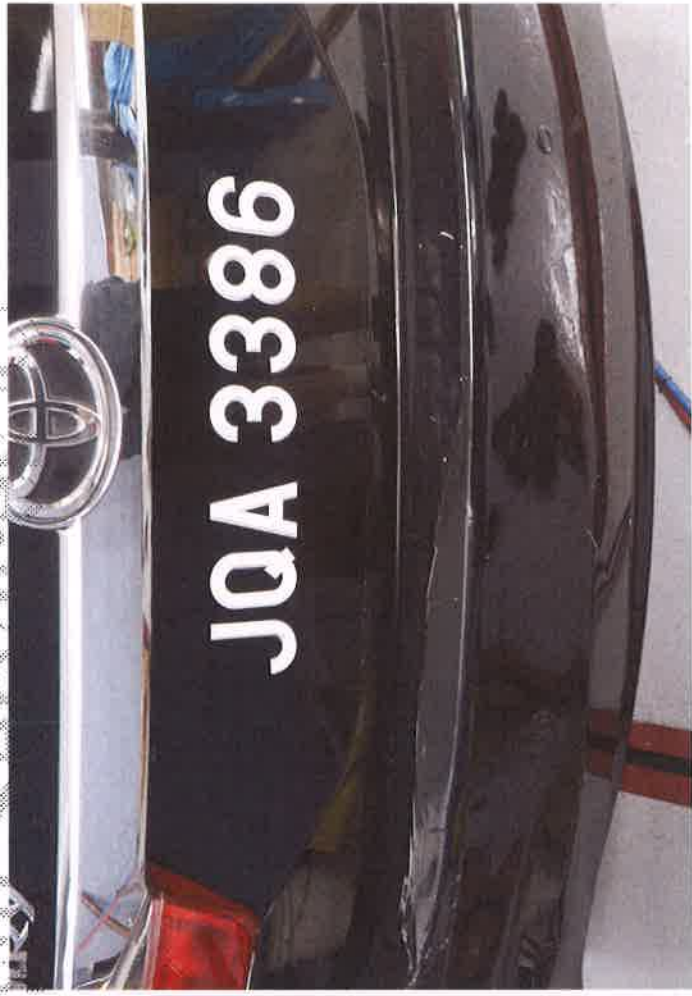
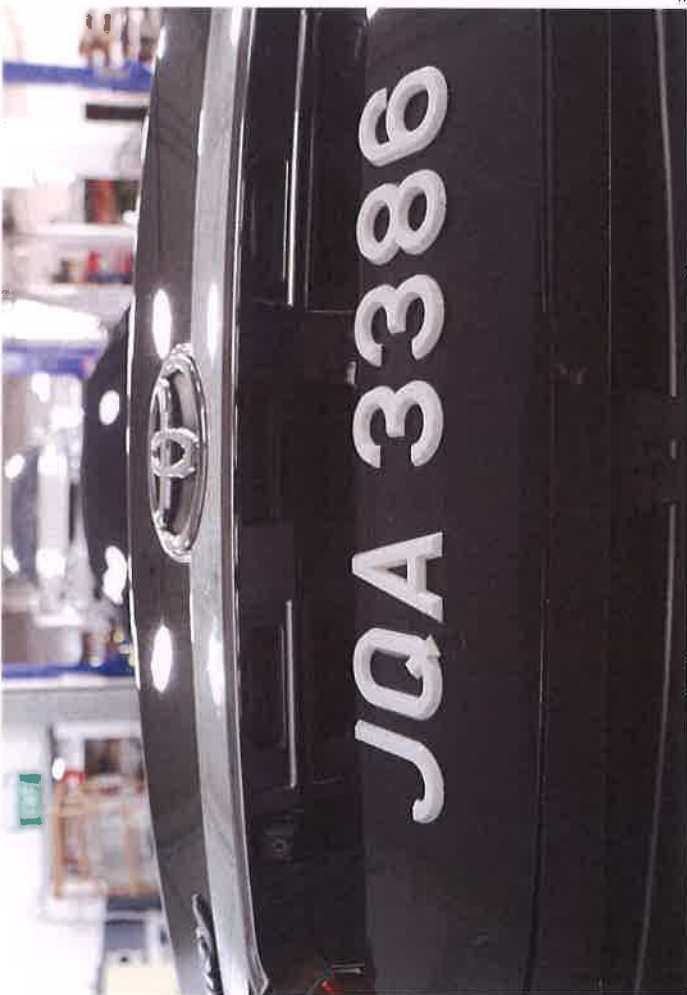
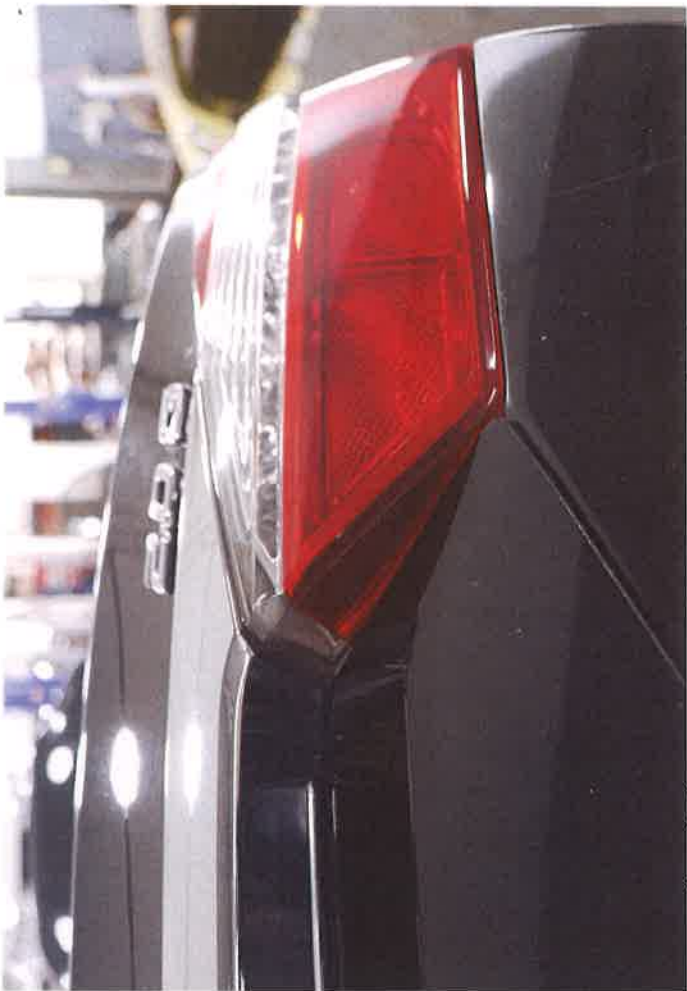
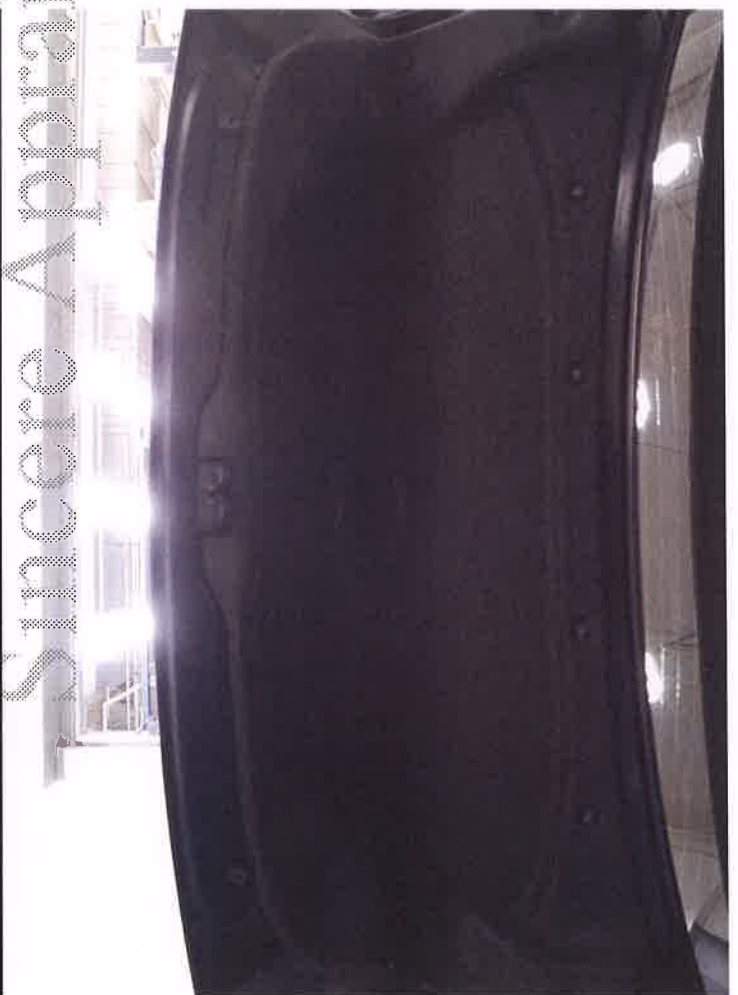
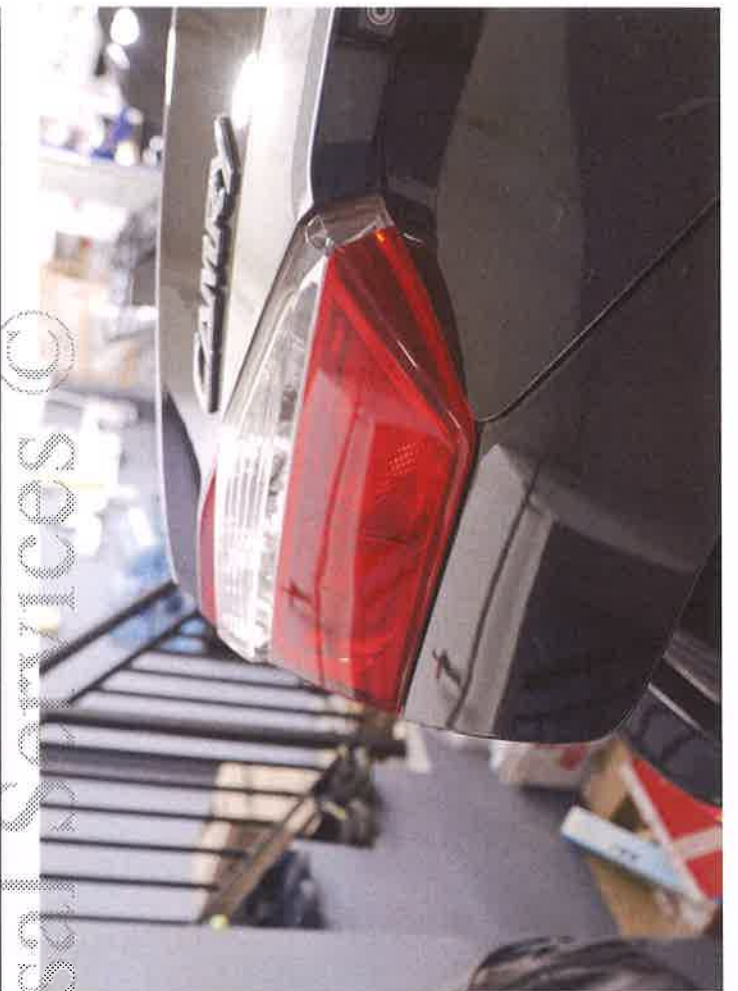
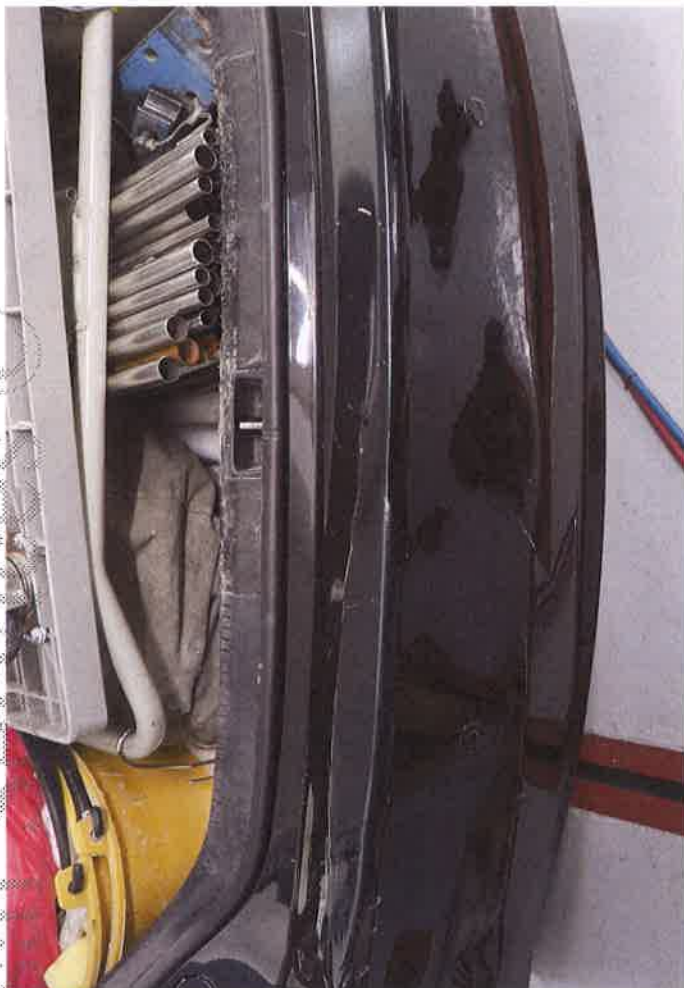
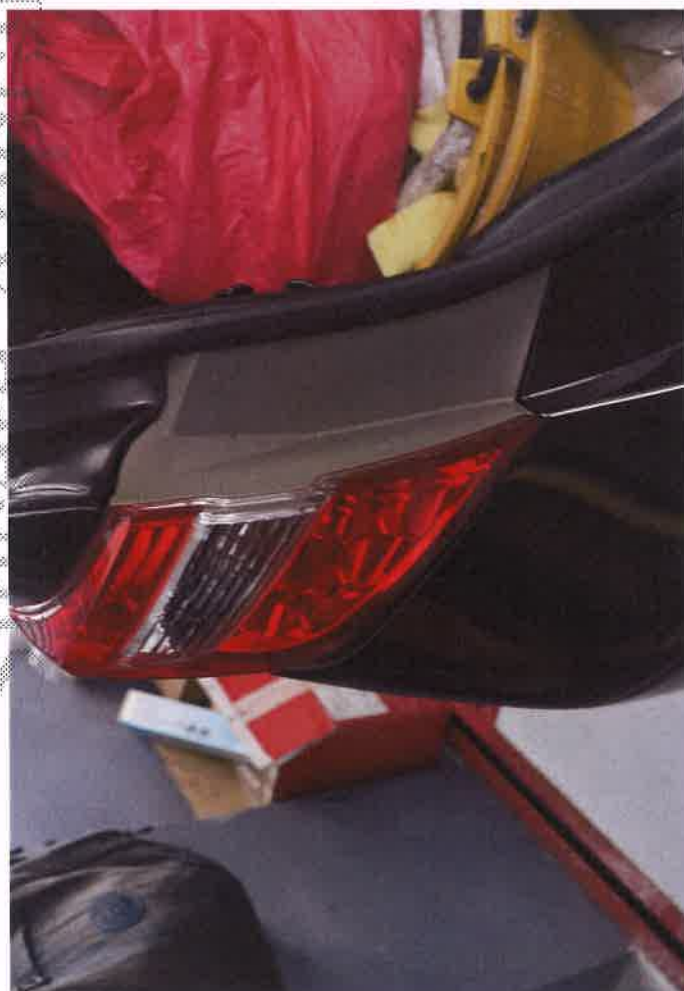
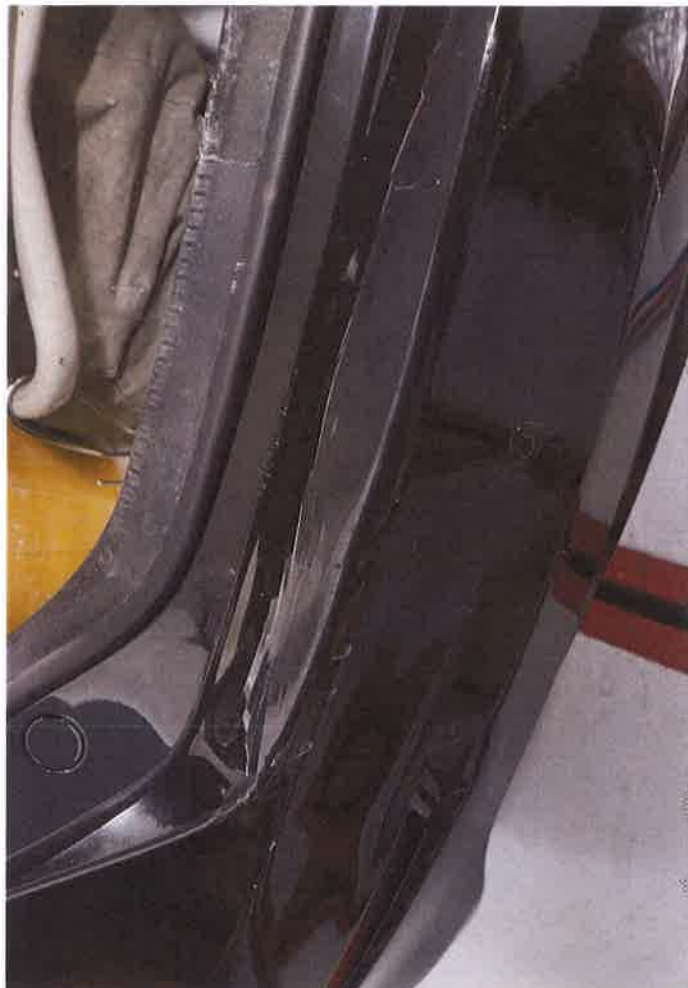
Our visual inspection of the vehicle revealed that the damages noted are at the rear portion.

We have inspected the actual damages found on the vehicle and recommend the replacement of parts and repairs accordingly. The estimated repair cost is \$8,167.05. The repairer has agreed to undertake the repairs at our adjusted lump sum amount of \$3,600.00.
