Your Ref: TP IP/09386/2023
Our Ref : CI/TPD23005782/P

Fatal Accident Investigation Team

MECHANICAL INSPECTION REPORT OF MOTOR CAR SNH 7151T

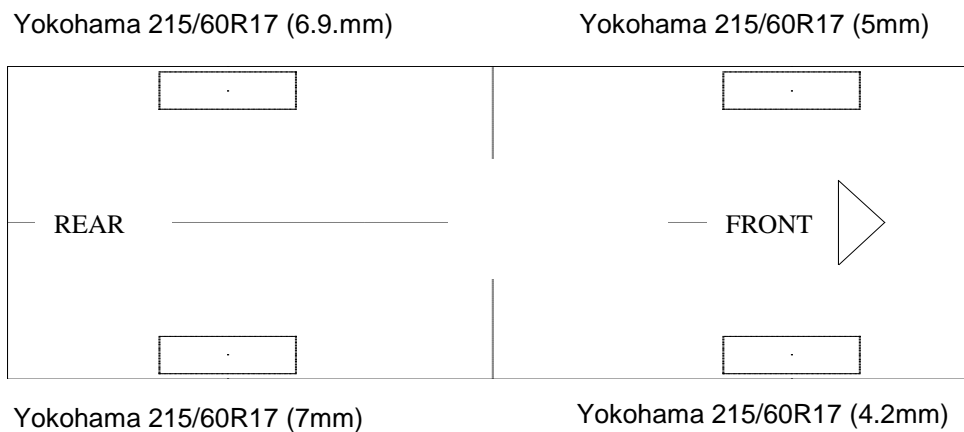
6. The condition of the Motor Car's 4 tyres was observed to be in serviceable condition. I did not find any tear, cut or burst mark(s) on the outer and the inner sidewalls as well as across the tread of the 4 tyres. The 4 tyres were also observed to be sufficiently inflated for vehicular operation. The tyre brand, tyre size and remaining tread depth of the 4 tyres were recorded as follows:-
