Your Ref: TP TP/10622/2023
Our Ref : CI/TPD23006809/P

31st July 2023

Fatal Accident Investigation Team

MECHANICAL INSPECTION REPORT OF MOTOR CAR SMQ 539U

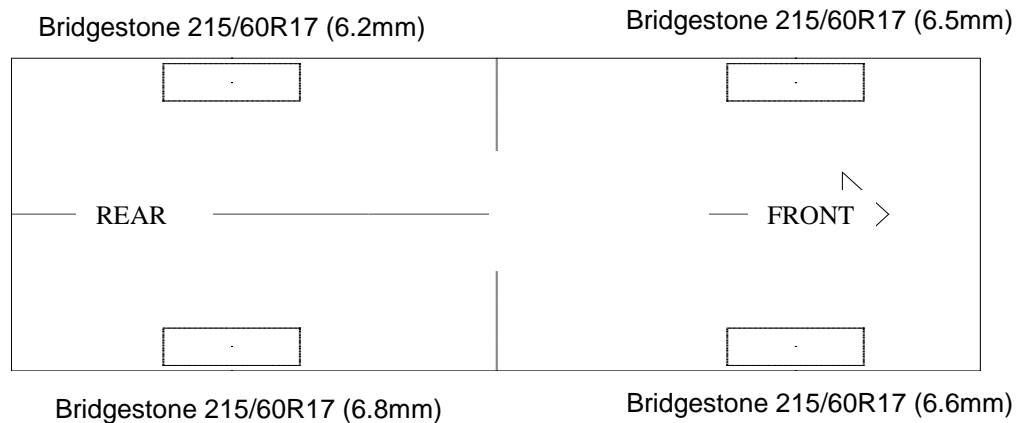
6. The 4 tyres of the Motor Car were observed to be in serviceable condition and sufficiently inflated for vehicular operation. I did not find any tear, cut or burst mark(s) on the outer and the inner sidewalls as well as across the tread of the 4 tyres. The tyre brand, tyre size and remaining tread depth of the 4 tyres of the Motor Car were recorded as follows:-
